Crimean Bridge blast: Experts assess the damage

October 10 2022, by Colin Caprani and Sam Rigby

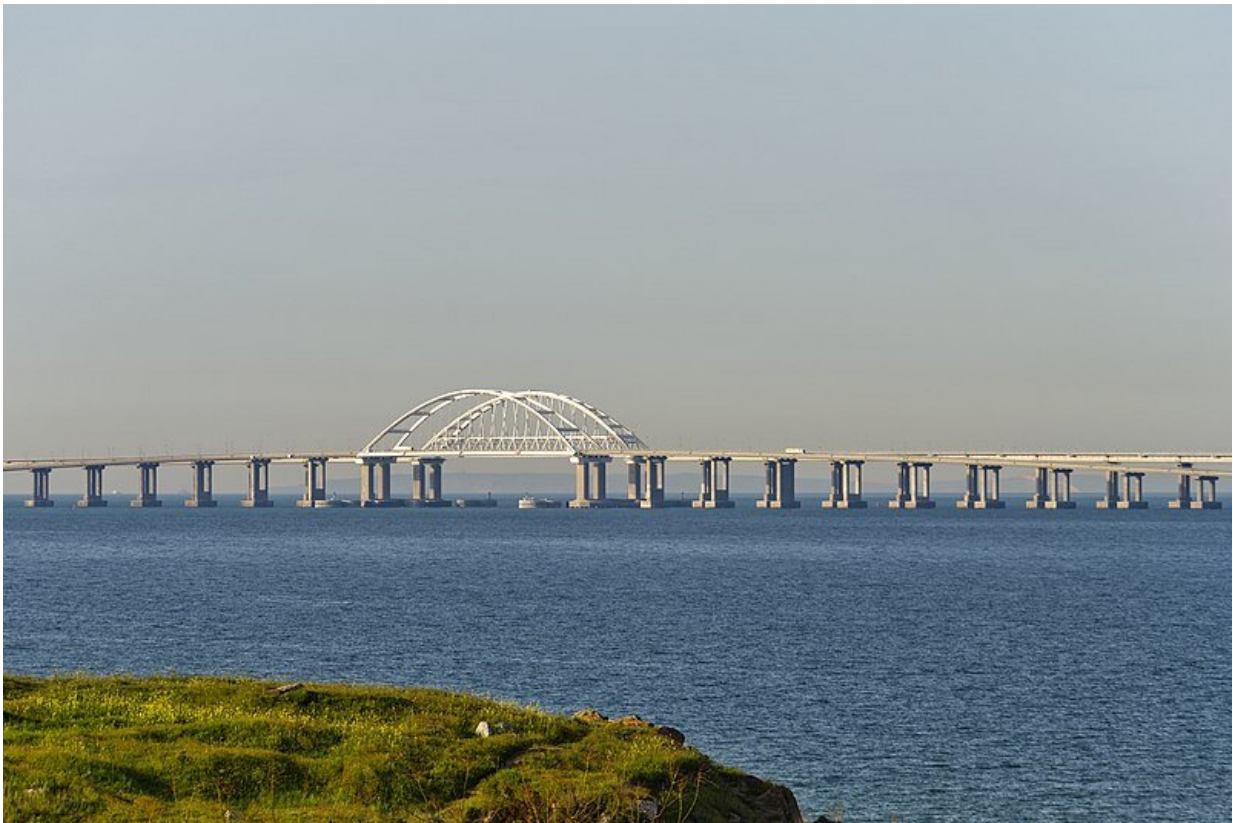
Kerch. Crimean Bridge. Credit: [Alexxx1979](#)/Wikimedia Commons, [CC BY-SA](#)
