Civil engineers use public satellite images to study why the Jagersfontein dam failed

April 5 2023

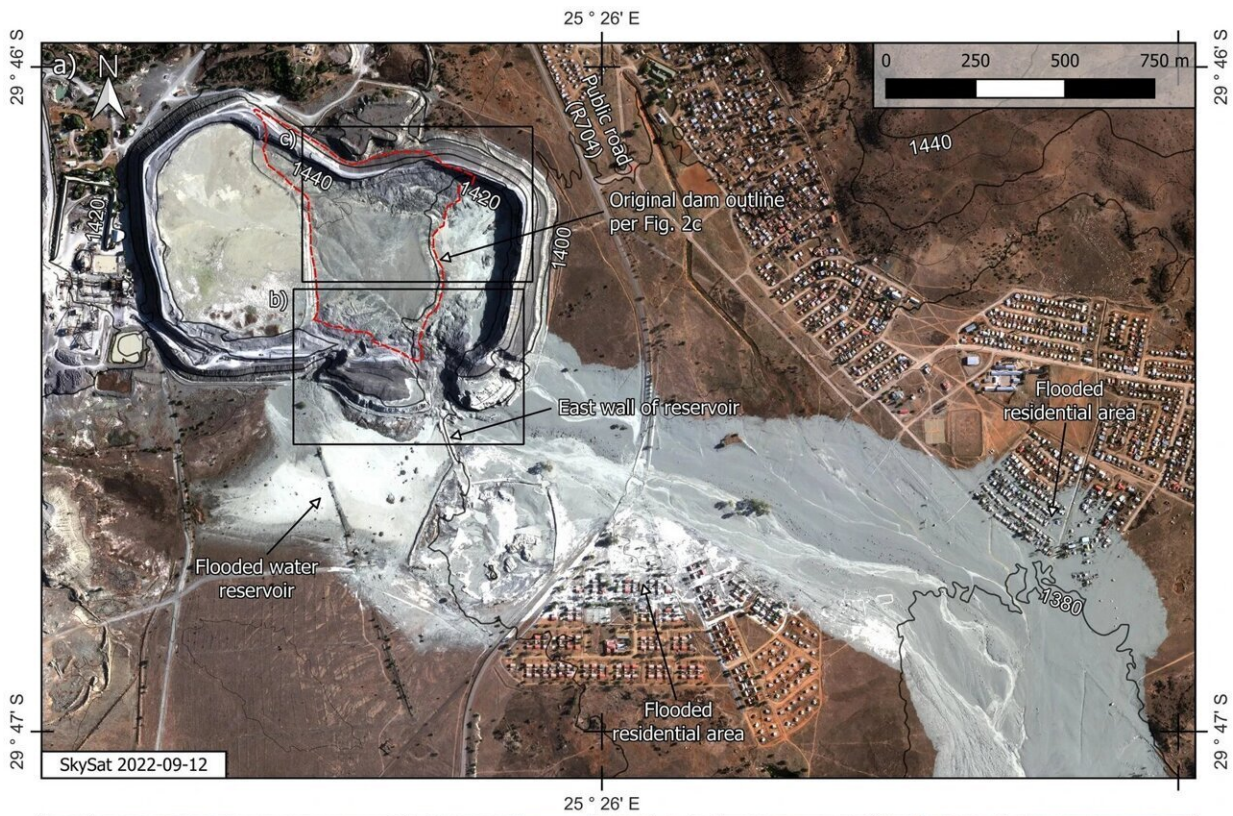
The post-failure scenario. (a) Impact on the immediate surroundings. (b) Enlargement of breached area. (c) Enlargement of collapsed northern wall. (d) Full extent of the tailings runoff. Credit: *Scientific Reports* (2023). DOI: 10.1038/s41598-023-31633-5

The study found that the history of the Jagersfontein dam deviates from best engineering practice. The deviations include mine waste deposition from predominantly one side of the dam, erosion gullies on the dam wall, and significant amounts of ponded water at times positioned against the retaining structure.

Based on the analyzed images, the study hypothesizes that percolation of water through the dam, followed by external erosion, ultimately triggered instability.
