How fire causes office-building floors to collapse

March 24 2020

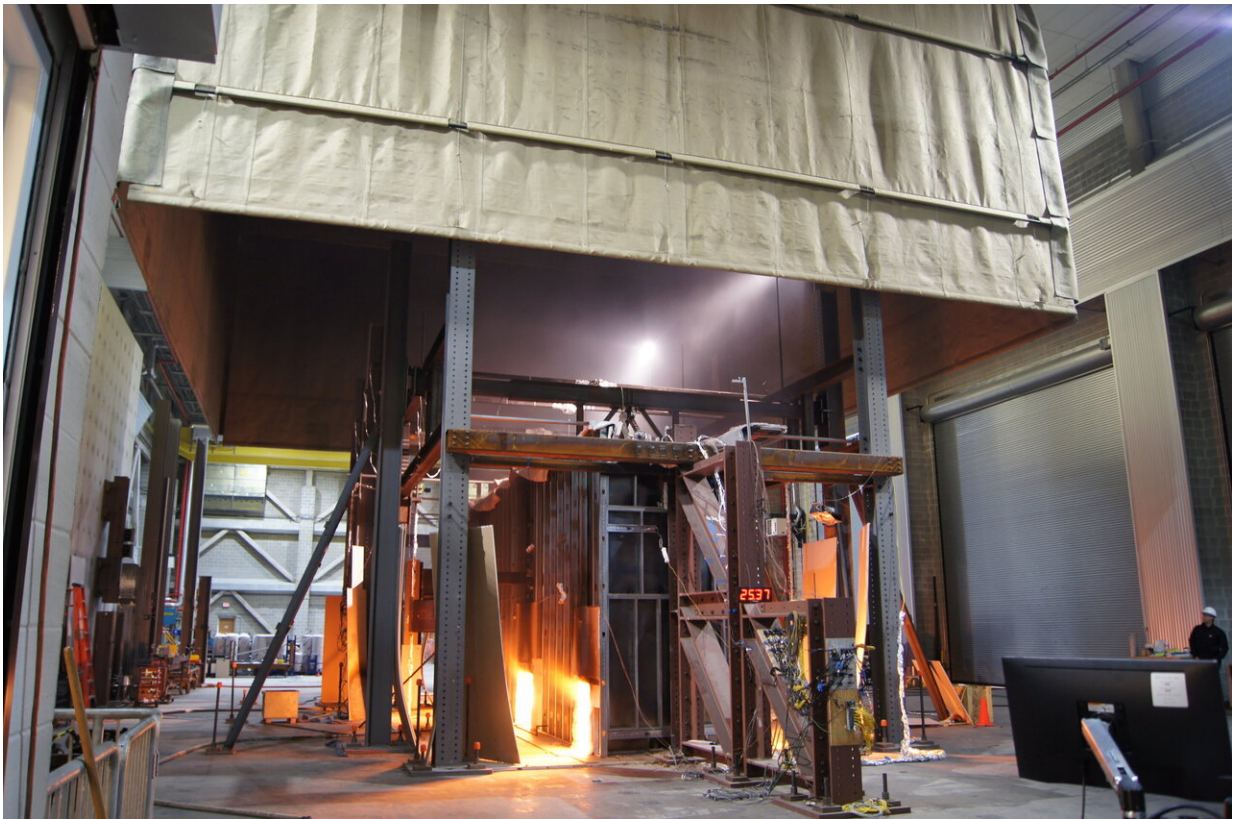
Inside a fireproof compartment, NIST researchers subjected full-scale replicas of office building floors to fires produced by three gas-fueled burners. Credit: NIST

Inside a fireproof compartment, three natural-gas fueled burners torched the floors from below, releasing heat as rapidly as a real [building](#) fire. While the compartment warmed up, various instruments measured the forces felt by the beams along with their deformation and temperature.

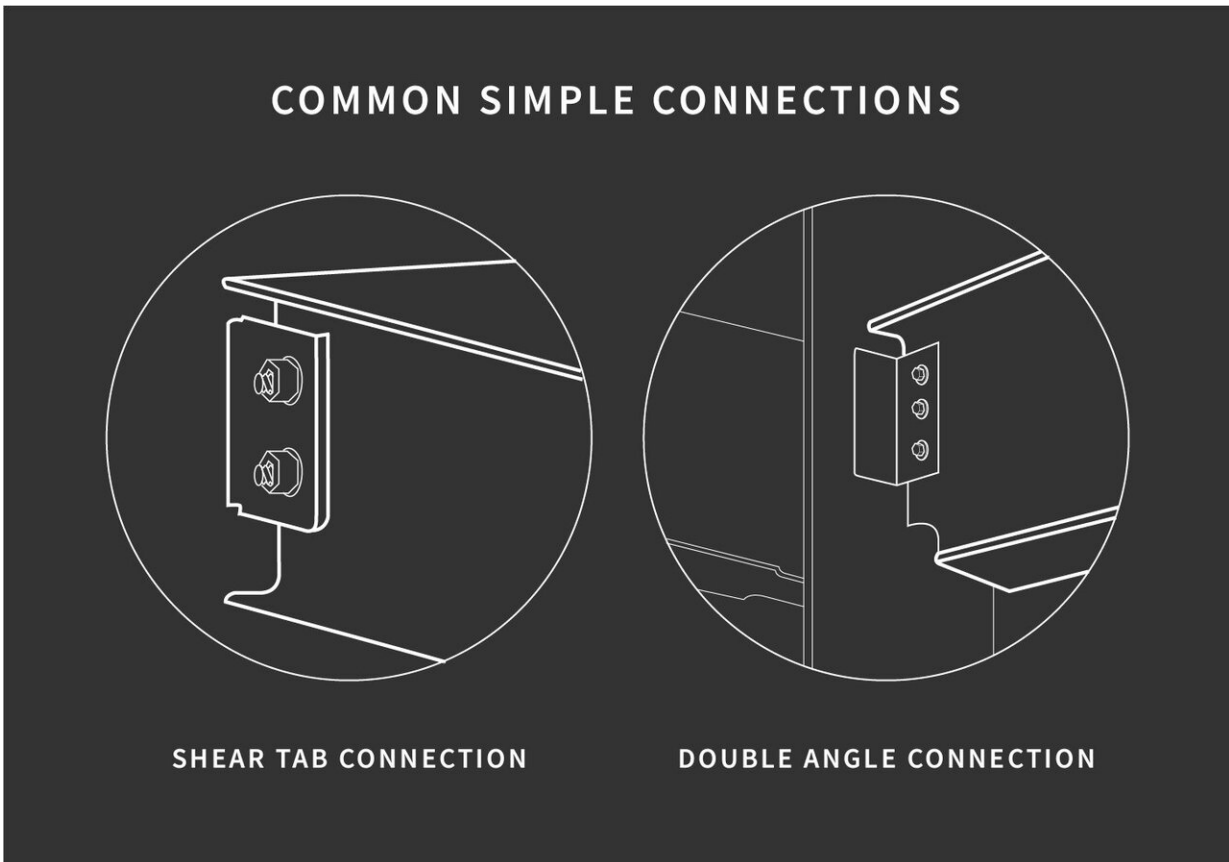
The shear tab connection (left) is a single flat plate welded to the support column and bolted onto one side of the steel beam. The double angle connection (right) is composed of two L-shaped plates, or angle legs, welded to the support column and bolted onto both sides of the steel beam. In this study, the double angle-connected beams endured greater deformations and temperatures before failing. Credit: B. Hayes/NIST

Mimicking the design of floors from high-rise office buildings, Choe and her colleagues at the NFRL formed concrete slabs atop steel beams spanning 12.8 meters (42 feet)—a typical length in office buildings and also the longest fire-tested in the United States. The floors were suspended in the air, fastened at their ends to support columns either by double angle or shear tab connections, which are differently shaped but

No floor came out of the fire tests scot-free, but some withstood more than others. After around one hour of heating, the shear tab connections of one [beam](#)—now having dipped down by more than two feet—fractured, leading to collapse. The beams with double angle connections, however, beat the heat and remained intact. That is, until they tumbled down hours after the furnaces were shut off, as the beams cooled and contracted back upwards, breaking the double angle connections.

While the study's small sample size means conclusions about buildings in general could not be drawn, Choe and her team did find that the beams with double angle connections endured greater forces and deformations from the temperature changes than those with shear tab connections.
