Coolant leak 'likely' sparked giant Tesla battery fire in Australia

September 28 2021

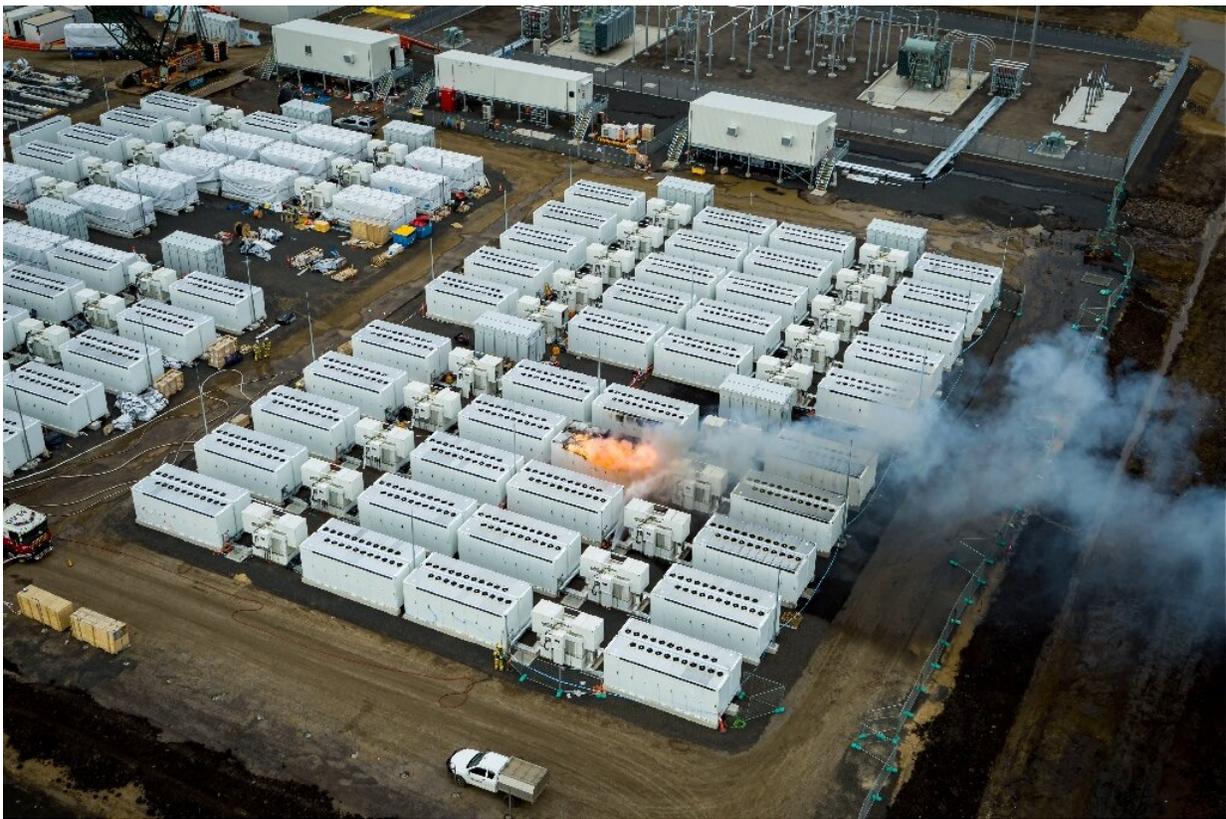
It took firefighters three days to bring the blaze under control after a fire broke out in a 13-tonne lithium 'Megapack' battery at the Geelong site.

"The most likely root cause of the incident was a leak within the Megapack cooling system that caused a [short circuit](#) that led to a fire in an electronic component," said a technical probe by the safety regulator Energy Safe Victoria.

The probe found that the first battery to catch fire was in service for 13 hours before being switched to an "offline" mode, which turned off its monitoring system and prevented alarms from being sounded.

It recommended a series of changes to prevent a new fire including checking each battery's cooling system for leaks and improving the alarm and surveillance systems.
