Robot photos appear to show melted fuel at Fukushima reactor

February 10 2022, by Mari Yamaguchi

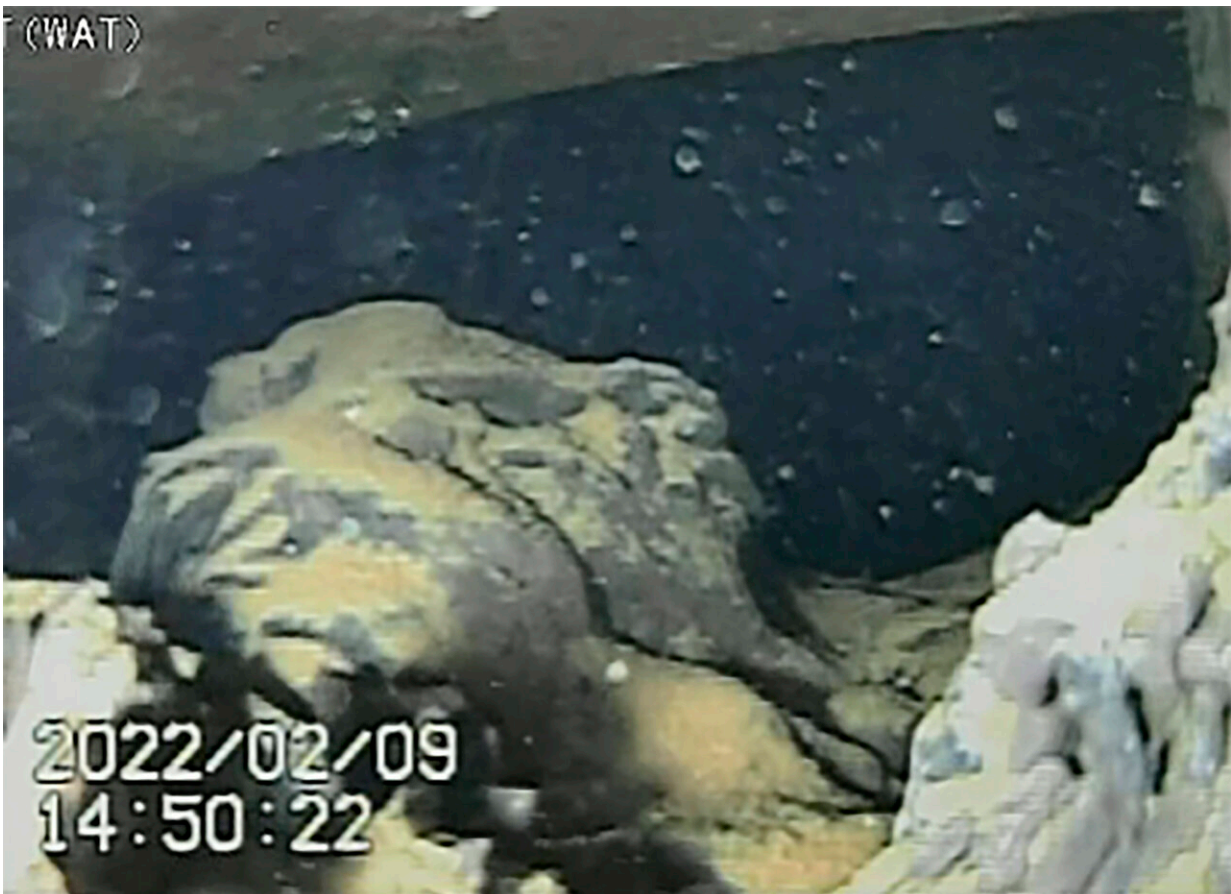
Images from a remote-controlled submersible robot show damaged areas inside the Fukushima nuclear power plant damaged in the 2011 earthquake and tsunami, Wednesday, Feb. 9, 2022, in Fukushima, Japan. The robot captured images of what appears be mounds of damaged fuel that had melted and fell to the bottom of the hardest-hit reactor at the nuclear plant for the first time since the 2011 disaster. Credit: IRID/Hitachi-GE Nuclear Energy, Ltd. via AP

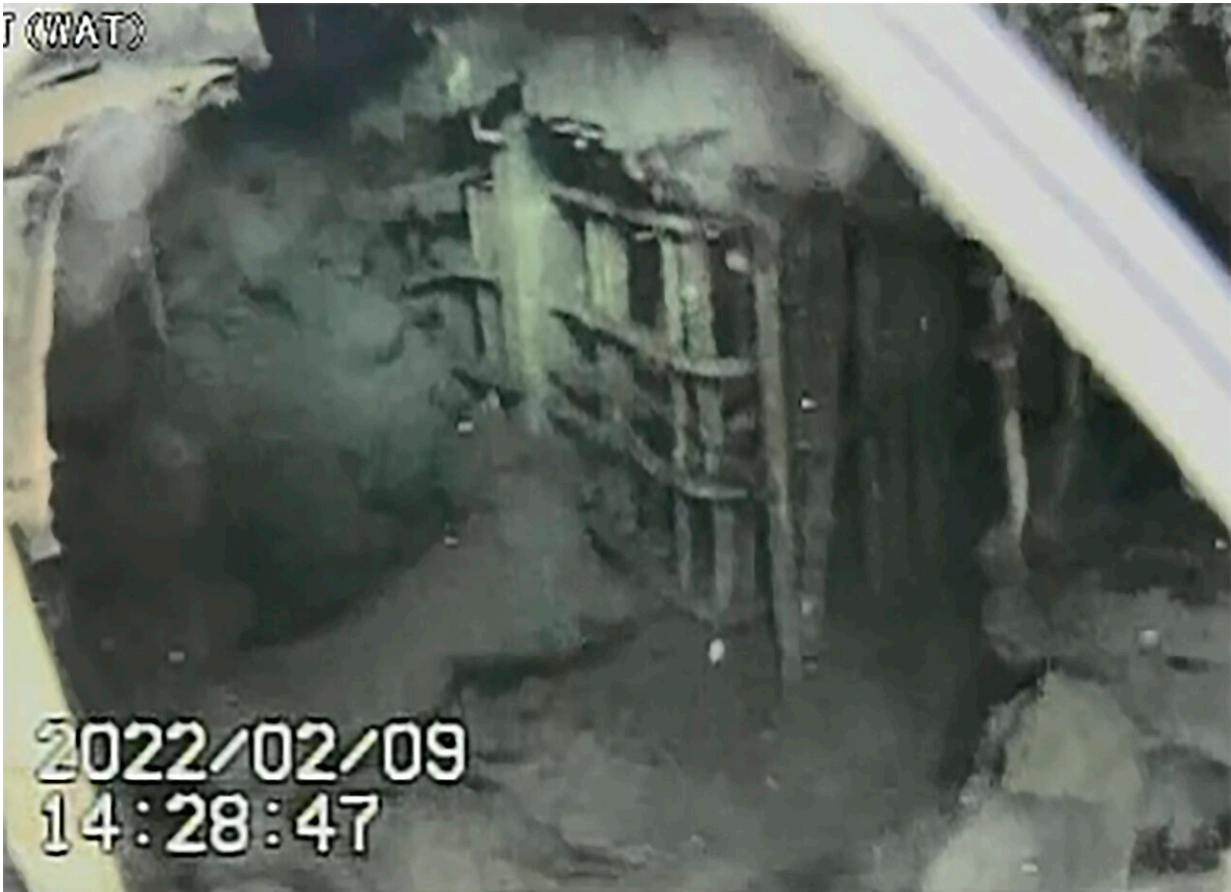
Images from a remote-controlled submersible robot show damaged areas inside the Fukushima nuclear power plant damaged in the 2011 earthquake and tsunami, Wednesday, Feb. 9, 2022, in Fukushima, Japan. The robot captured images of what appears be mounds of damaged fuel that had melted and fell to the bottom of the hardest-hit reactor at the nuclear plant for the first time since the 2011 disaster. Credit: IRID/Hitachi-GE Nuclear Energy, Ltd. via AP
