Robot photos appear to show melted fuel at Fukushima reactor

February 10 2022, by Mari Yamaguchi

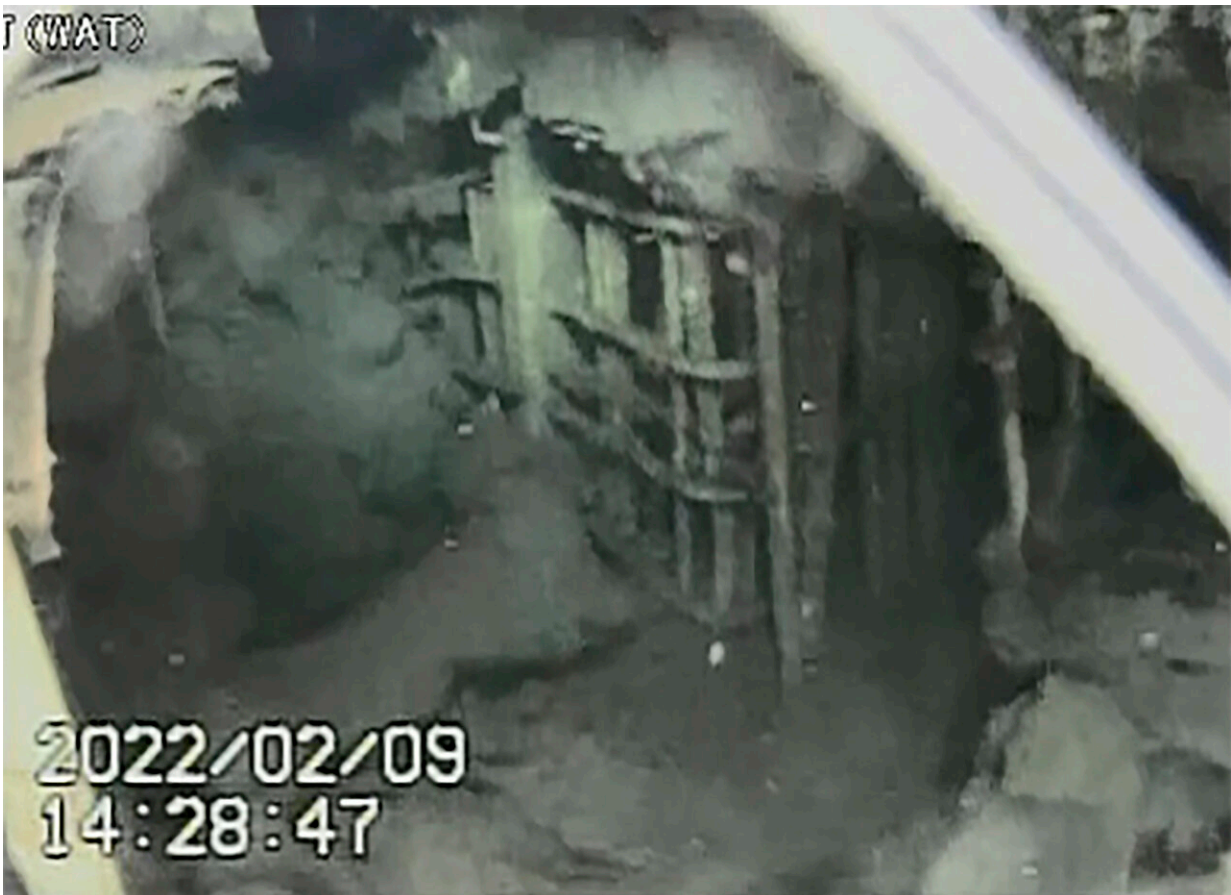
Images from a remote-controlled submersible robot show damaged areas inside the Fukushima nuclear power plant damaged in the 2011 earthquake and tsunami, Wednesday, Feb. 9, 2022, in Fukushima, Japan. The robot captured images of what appears be mounds of damaged fuel that had melted and fell to the bottom of the hardest-hit reactor at the nuclear plant for the first time since the 2011 disaster. Credit: IRID/Hitachi-GE Nuclear Energy, Ltd. via AP
