# Radioactive fuel, contaminated water: the Fukushima clean-up

March 11 2022, by Sara Hussein

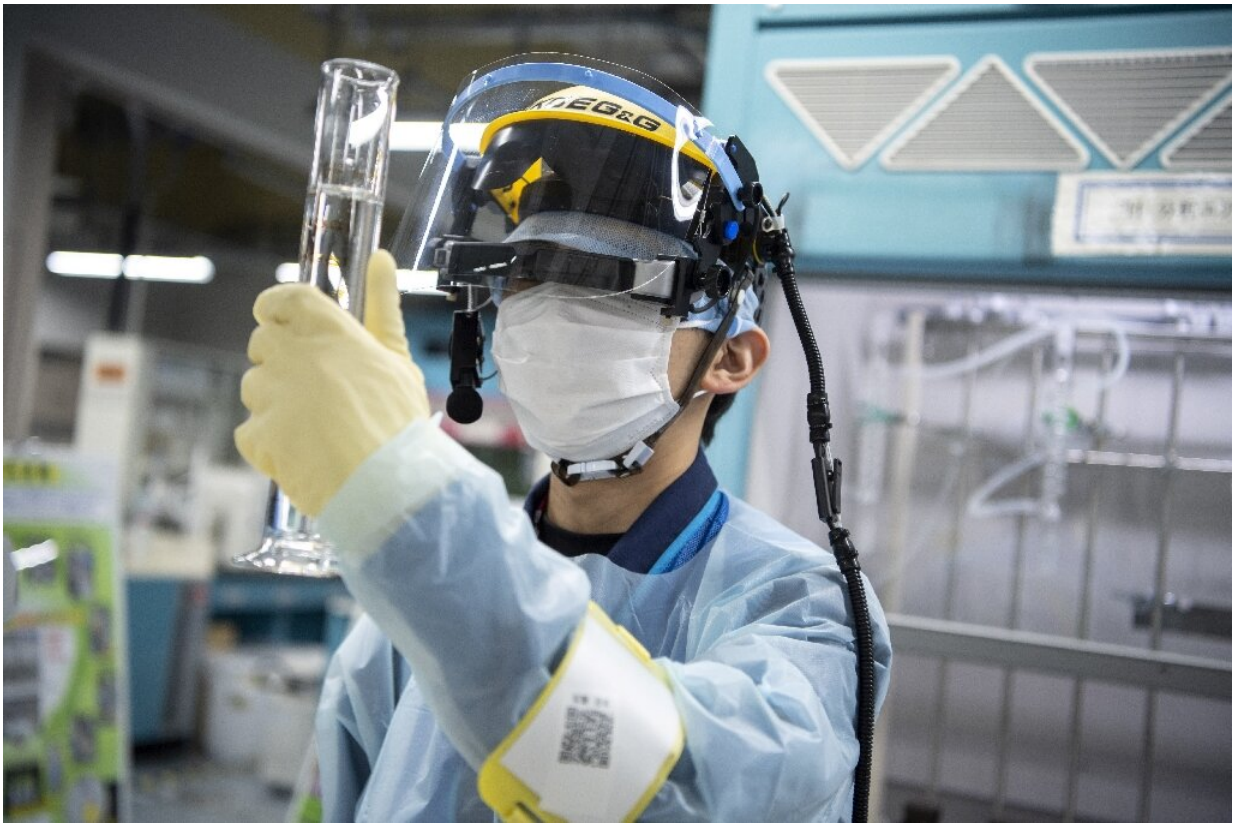
Thousands of workers at the Fukushima Daiichi nuclear plant are involved in the complex and decades-long process of decommissioning the Fukushima nuclear site.

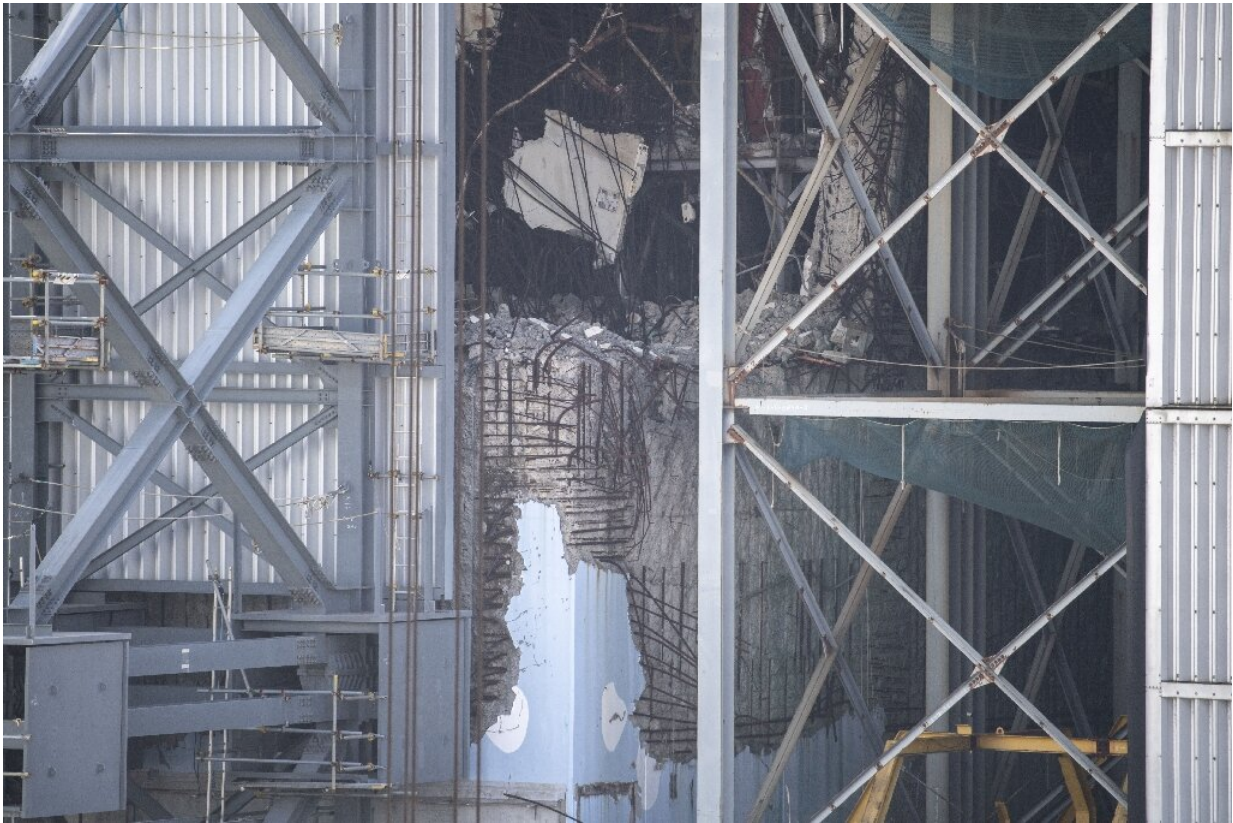
Evidence of the blasts' power is still visible at the top of unit 1, where the warped metal framework remains exposed to the air, and on unit 3 damaged walls stripped of paint sit under a new roof cover.

Evidence of the blasts' power is still visible at the top of unit 1, where the warped metal framework remains exposed to the air, and on unit 3 damaged walls stripped of paint sit under a new roof cover.

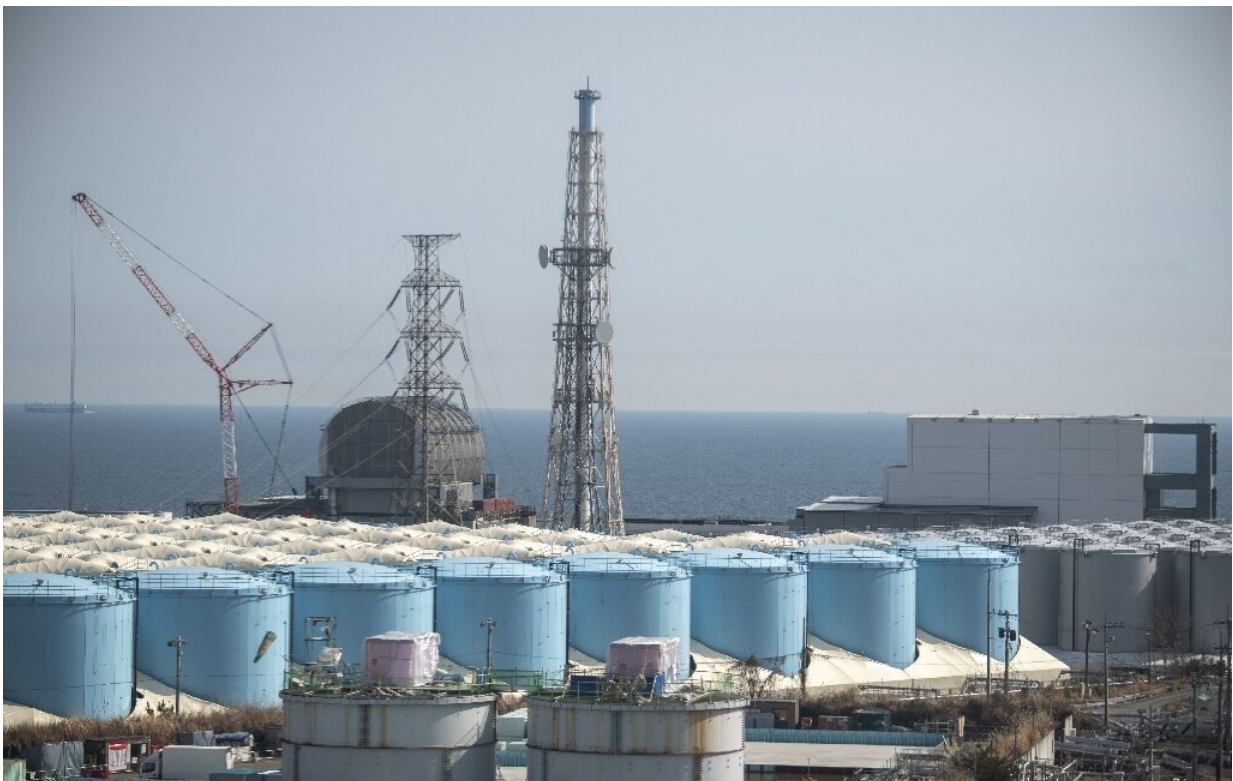
This picture taken on March 5, 2022 shows unit 3 (L) and unit 4 (C) reactor buildings and storage tanks for contaminated water at the Tokyo Electric Power Company (TEPCO) Fukushima Dai-ichi nuclear power plant.

The water is filtered to remove various radionuclides and moved to storage tanks, with 1.29 million tons on site already and space expected to run out in around a year.

The white, grey and blue tanks dominate much of the site, between a few pine and cherry trees that survived the accident and decontamination.

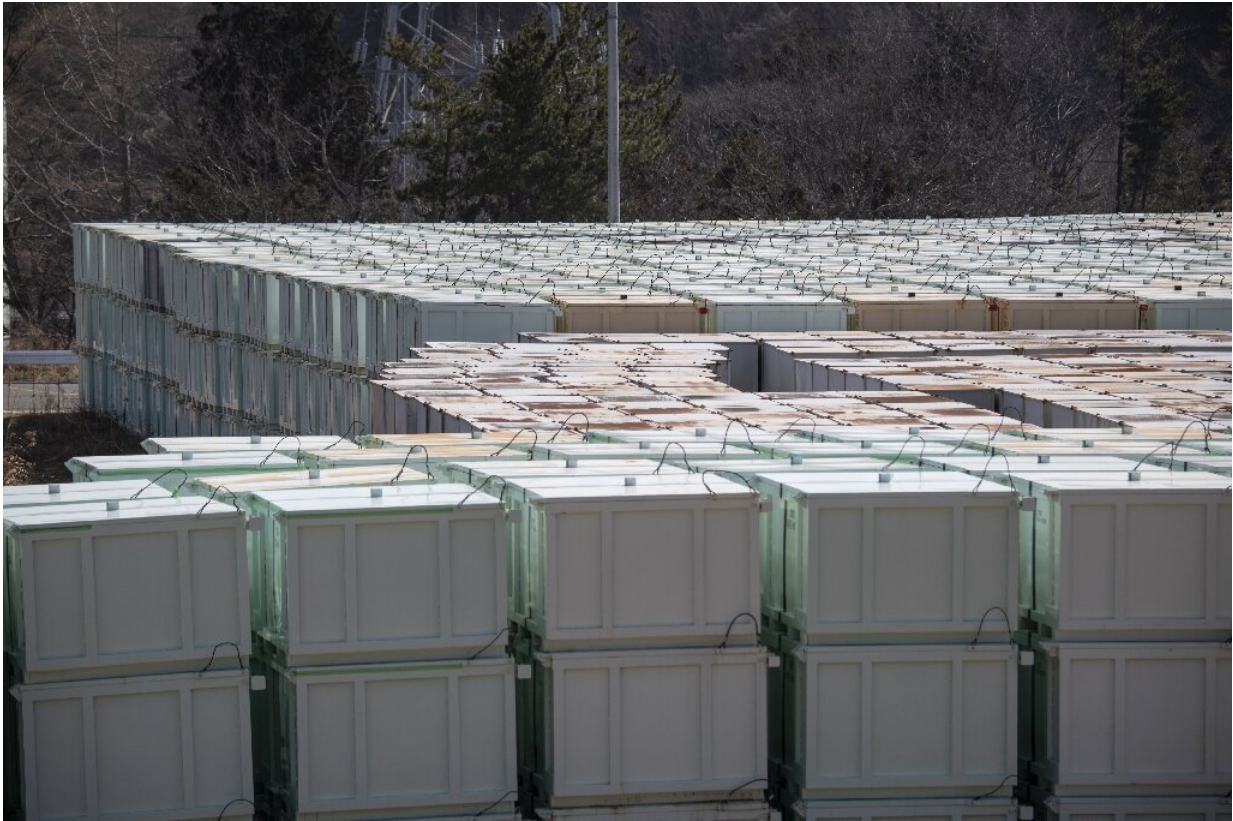
Boxes containing irradiated waste at the Fukushima plant.
