# Radioactive fuel, contaminated water: the Fukushima clean-up

March 11 2022, by Sara Hussein

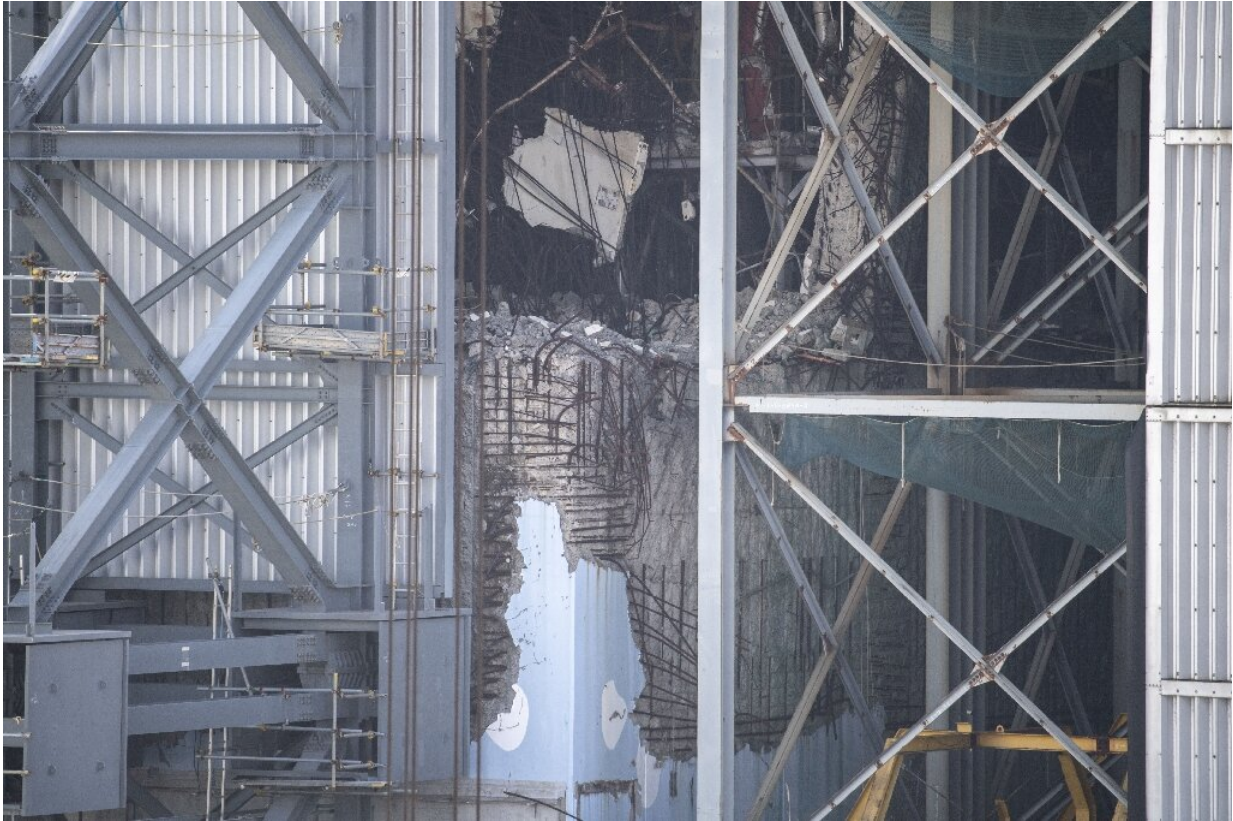
Evidence of the blasts' power is still visible at the top of unit 1, where the warped metal framework remains exposed to the air, and on unit 3 damaged walls stripped of paint sit under a new roof cover.

Evidence of the blasts' power is still visible at the top of unit 1, where the warped metal framework remains exposed to the air, and on unit 3 damaged walls stripped of paint sit under a new roof cover.
