# Reason for multi-billion Euro construction damage elucidated

December 20 2022

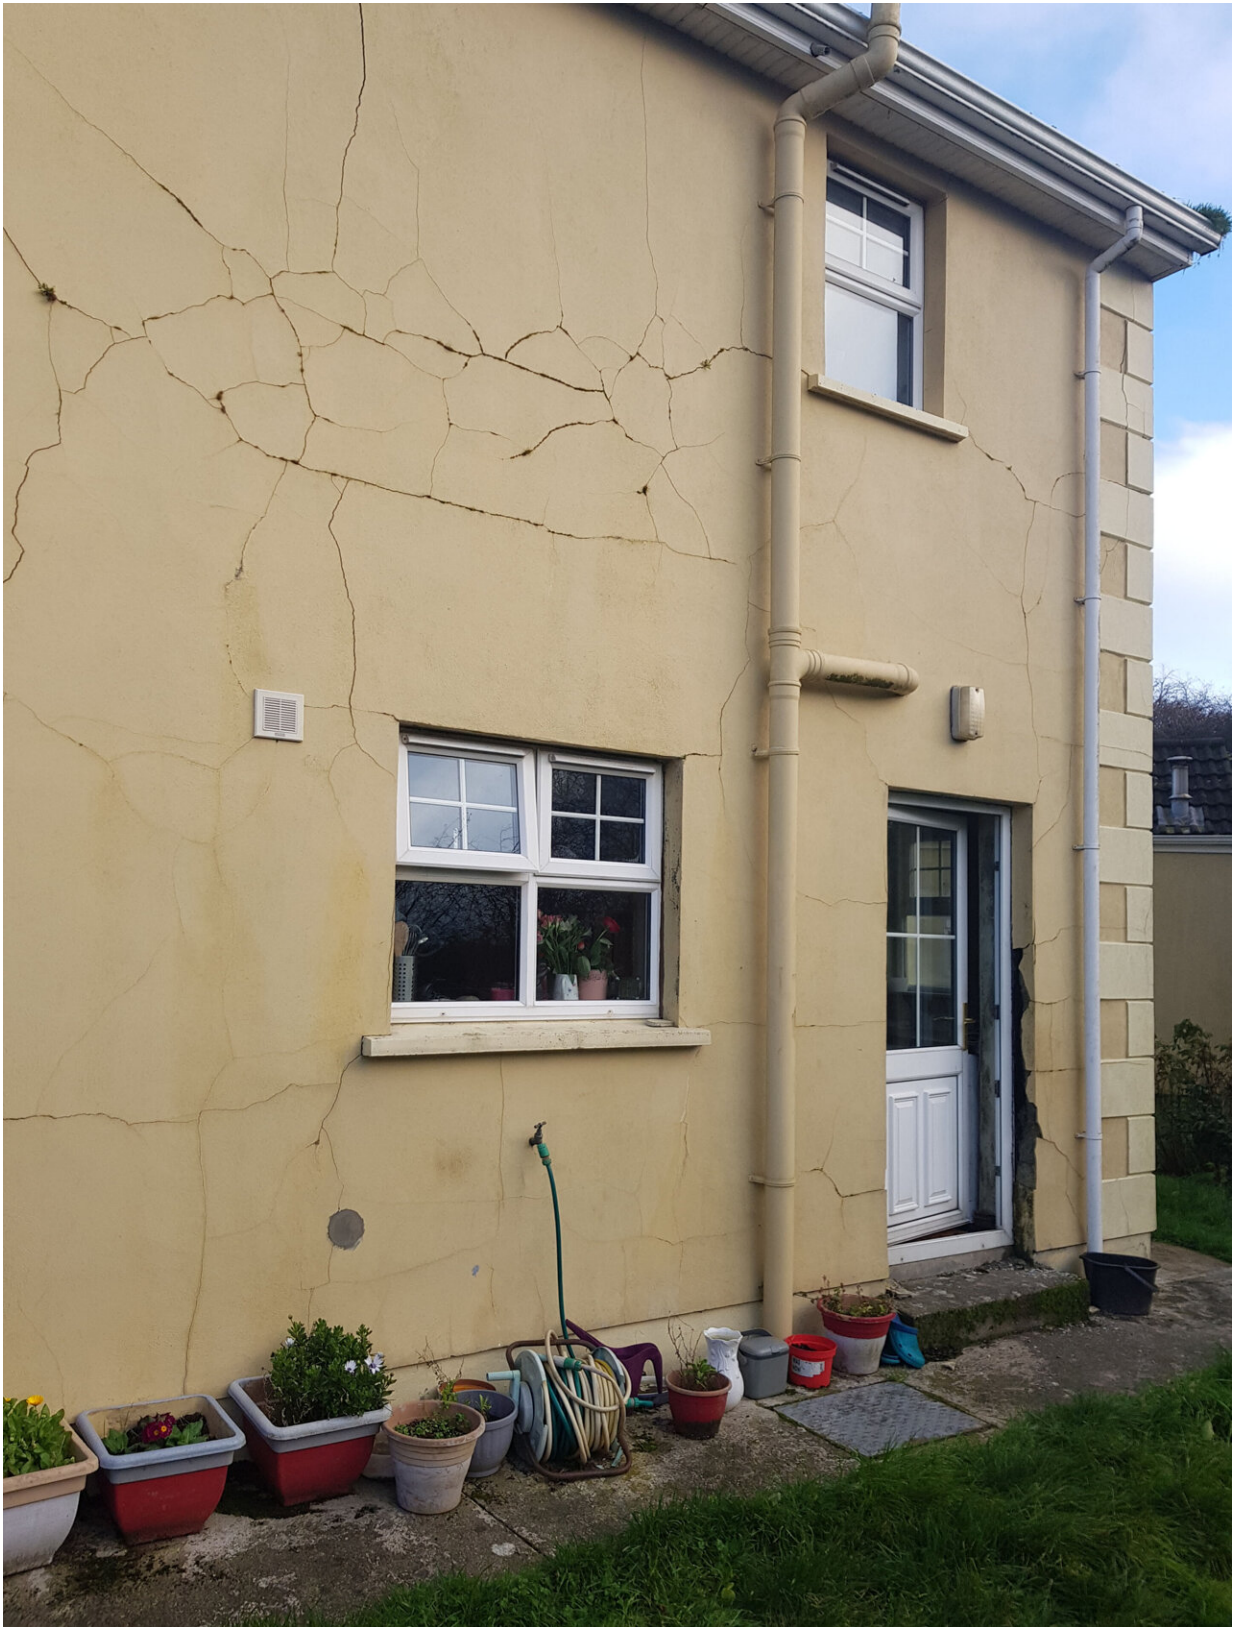
Cracks all the way up to the roof: a typical case of damage in Donegal County, Ireland. Image: Andreas Leemann/Empa

The visual inspection on site had already contradicted this assumption. Typical cracks caused by cold run parallel to the walls, while in this case they only ran vertically from the surface into the walls—often upwards from the floor up to the roof. In some cases, they had even continued downward from the top, where the influence of cold is less severe.
