Investigating the mystery of the last standing grain bin after 2020 windstorm

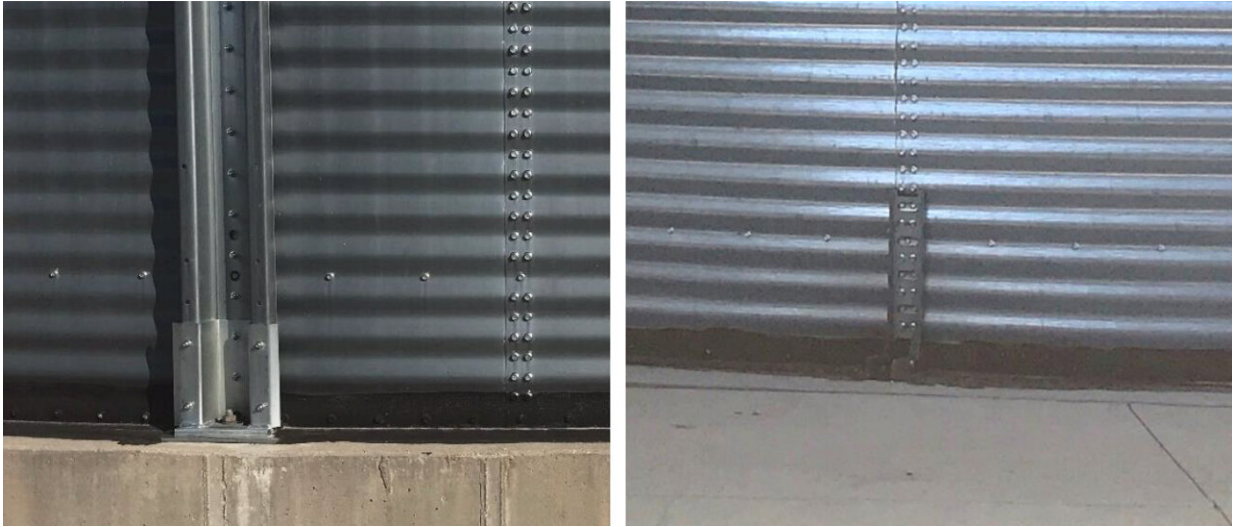
A vertical stiffener on a commercial bin (left), as compared with an anchorage clip found on a typical farm bin (right). Credit: Christine Wittich

But their differences went beyond their nomenclature. Wittich and Praeuner's study indicated that the commercial bin benefited from so-called vertical stiffeners: steel channels, running all the way from the roof to the foundation, that help redistribute loads from the former to the latter and reinforce a wall against buckling. The farm bins lacked those stiffeners and, as the derecho made all too clear, the additional wind resistance they can provide.

Though vertical stiffeners are partly intended to curb costs by allowing for thinner walls and extending the lifespans of their bins, the team's study suggests that the component might also prove the key between withstanding versus succumbing to winds of 100-plus miles per hour.

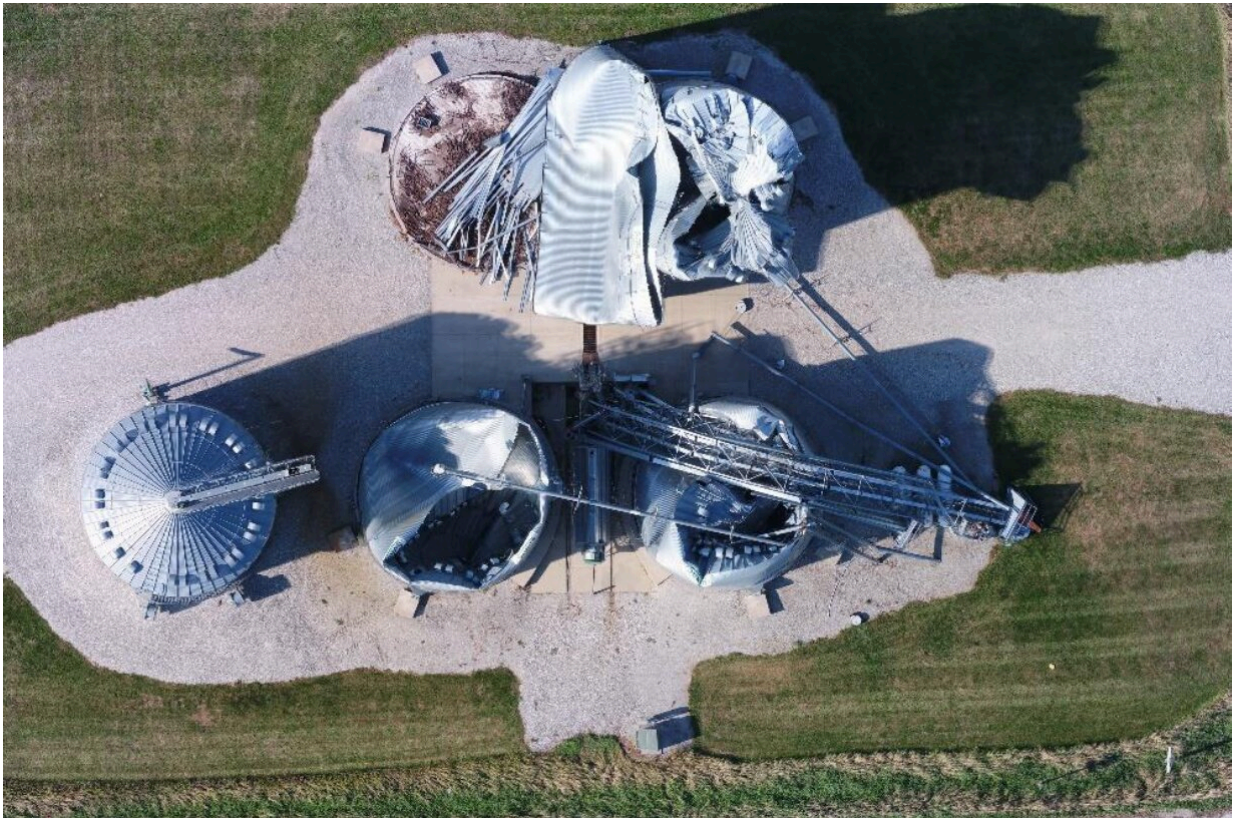
A bird's-eye photo of the post-derecho site. Credit: Christine Wittich / Richard Wood

The derecho struck especially hard along the Interstate 80 corridor of Iowa. While conducting "structural reconnaissance" in the east-central portion of the Hawkeye State, Nebraska U's Christine Wittich came across a unique case study: an interconnected group of five grain bins, all empty, that were identical in height and diameter. Four of the bins had been destroyed—roofs ripped off, [walls](#) buckled, foundations compromised. The other? Totally intact.

On closer inspection, Wittich and Husker undergrad Benjamin Praeuner discovered that the four demolished structures were labeled as "farm bins," of the sort usually sold to smaller operations. Though the same in size and purpose, the one surviving structure was instead classified as a "commercial bin," a type generally marketed toward larger-scale operations.
