# Investigating the mystery of the last standing grain bin after 2020 windstorm

December 1 2022, by Scott Schrage

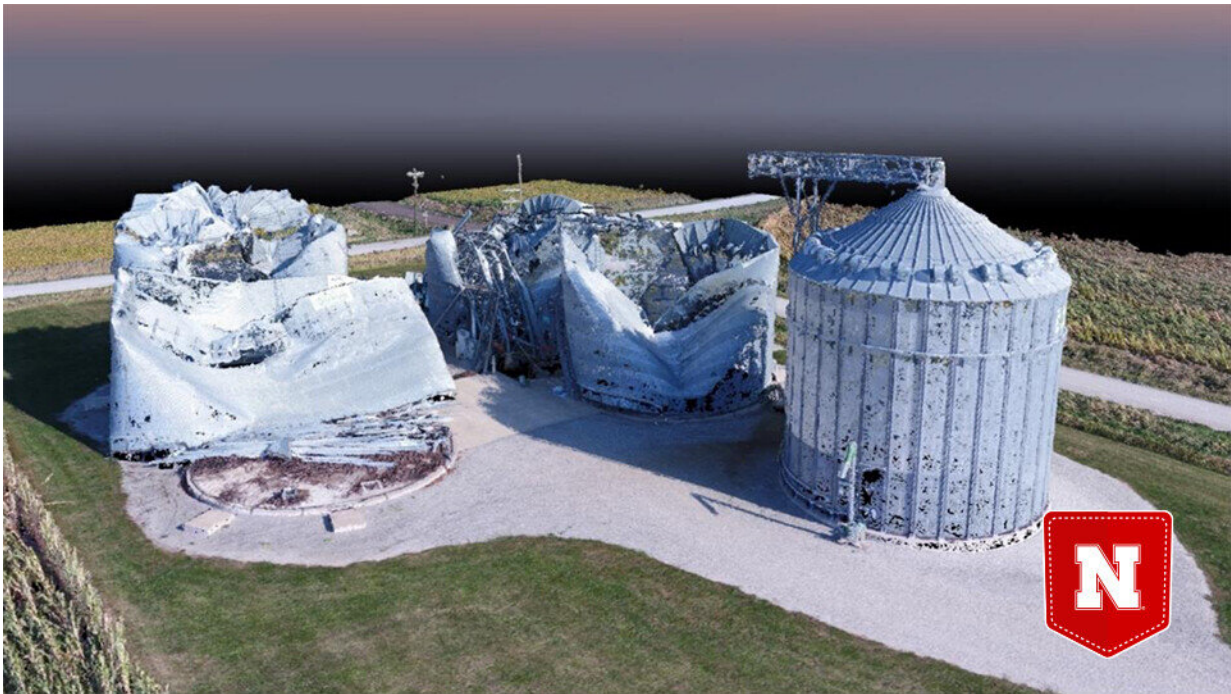
A 3D rendering of grain bins following an August 2020 windstorm. The rendering was produced with the aid of lidar—near-infrared laser beams fired at the structures by a drone flying above the site. Credit: University of Nebraska-Lincoln

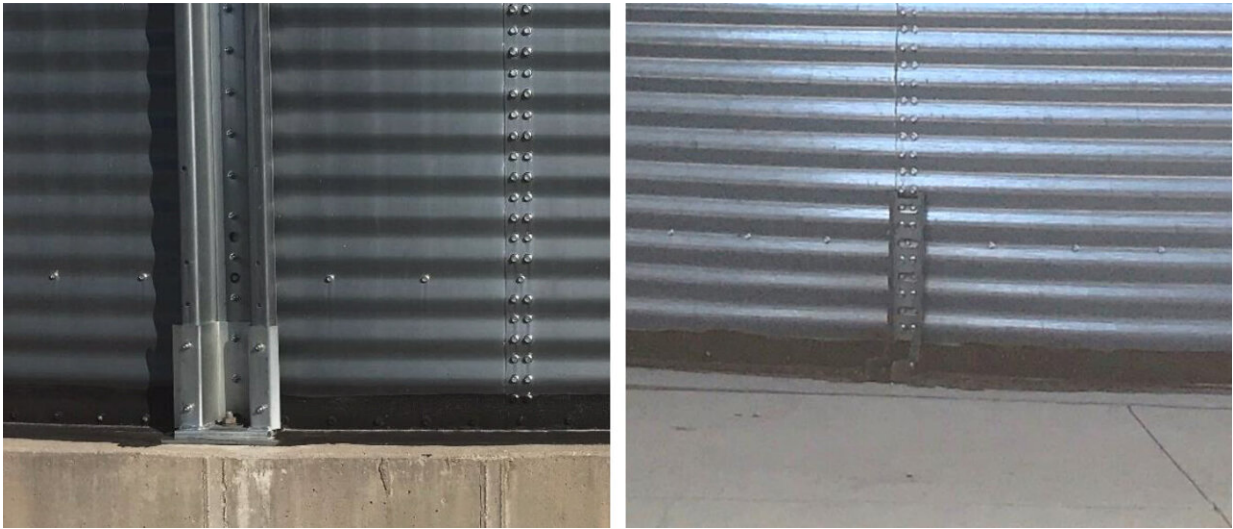
A vertical stiffener on a commercial bin (left), as compared with an anchorage clip found on a typical farm bin (right). Credit: Christine Wittich

But their differences went beyond their nomenclature. Wittich and Praeuner's study indicated that the commercial bin benefited from so-called vertical stiffeners: steel channels, running all the way from the roof to the foundation, that help redistribute loads from the former to the latter and reinforce a wall against buckling. The farm bins lacked those stiffeners and, as the derecho made all too clear, the additional wind resistance they can provide.

Though vertical stiffeners are partly intended to curb costs by allowing for thinner walls and extending the lifespans of their bins, the team's study suggests that the component might also prove the key between withstanding versus succumbing to winds of 100-plus miles per hour.

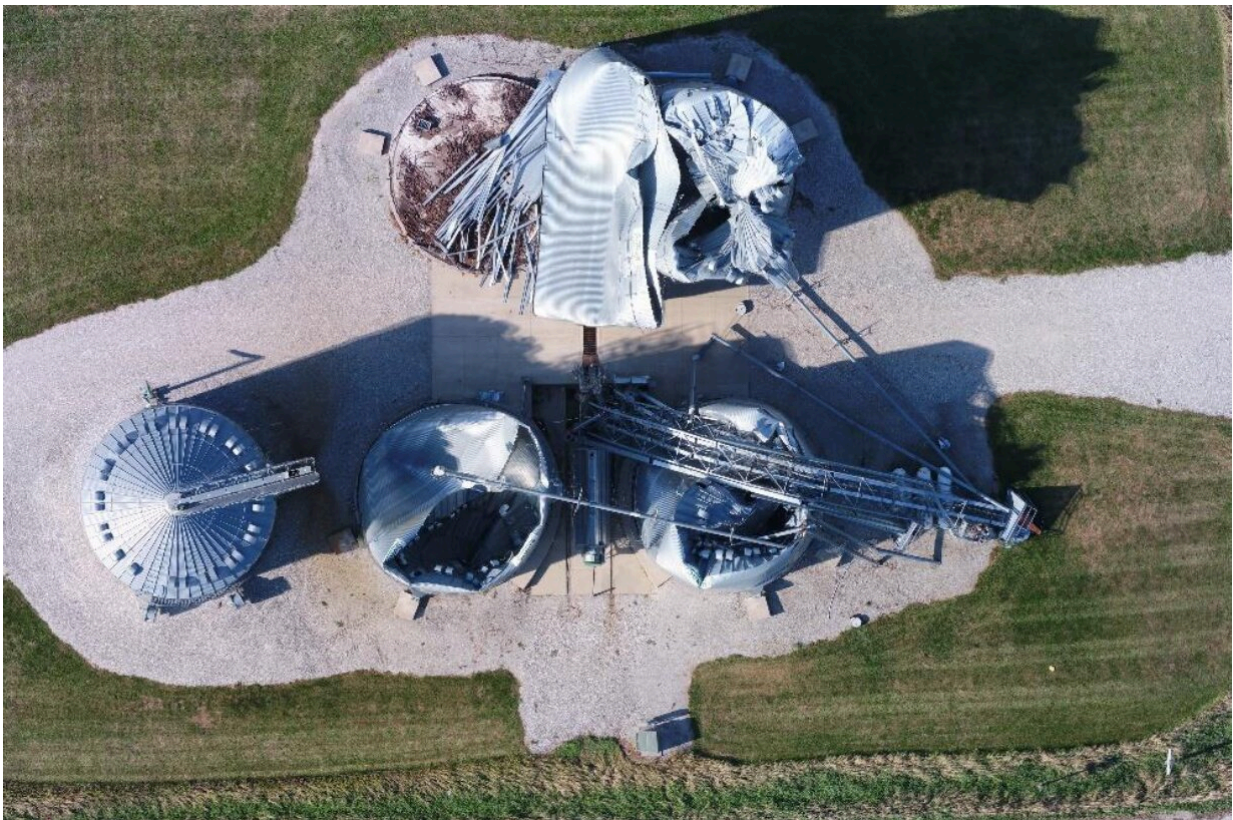
A bird's-eye photo of the post-derecho site. Credit: Christine Wittich / Richard Wood

The derecho struck especially hard along the Interstate 80 corridor of Iowa. While conducting "structural reconnaissance" in the east-central portion of the Hawkeye State, Nebraska U's Christine Wittich came across a unique case study: an interconnected group of five grain bins, all empty, that were identical in height and diameter. Four of the bins had been destroyed—roofs ripped off, [walls](#) buckled, foundations compromised. The other? Totally intact.

On closer inspection, Wittich and Husker undergrad Benjamin Praeuner discovered that the four demolished structures were labeled as "farm bins," of the sort usually sold to smaller operations. Though the same in size and purpose, the one surviving structure was instead classified as a "commercial bin," a type generally marketed toward larger-scale operations.
