# New images from inside Fukushima reactor spark safety worry

April 4 2023, by Mari Yamaguchi

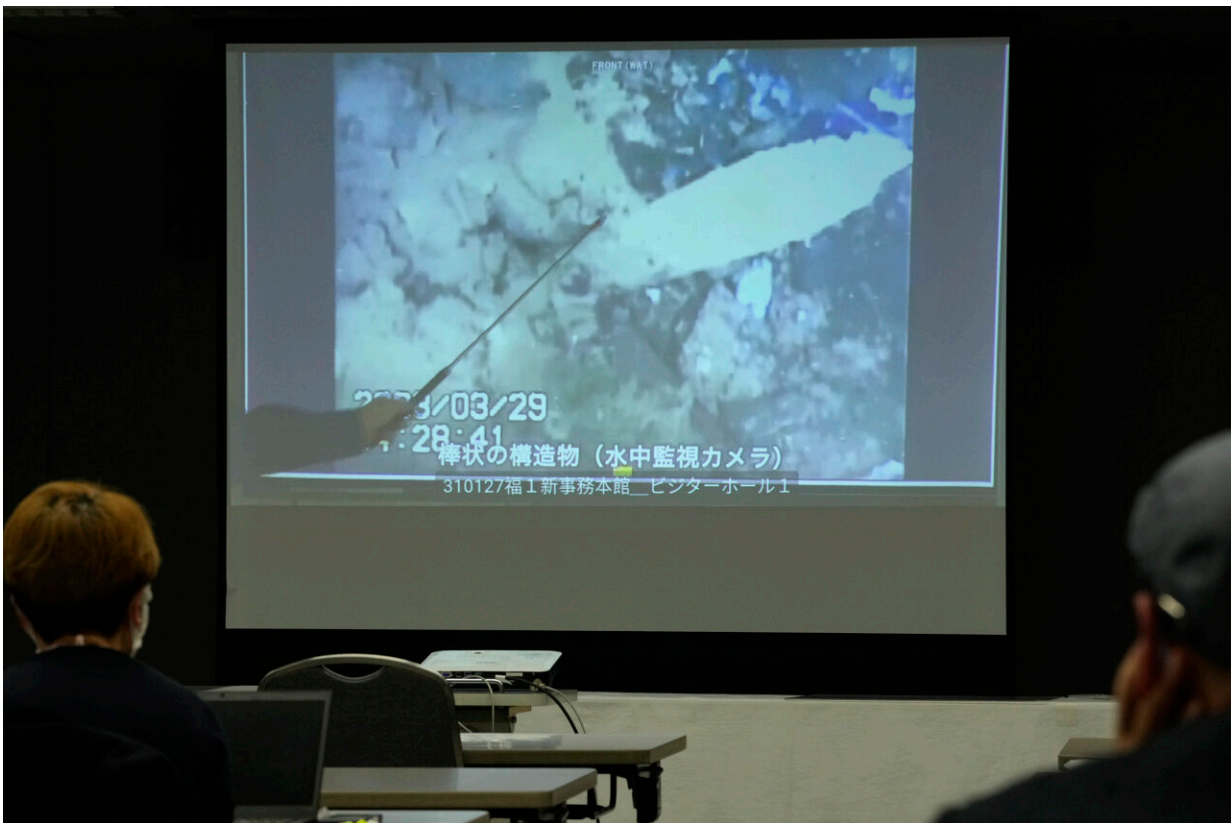
A spokesperson of the Tokyo Electric Power Company Holdings (TEPCO) shows photos captured by a robotic probe inside one of the three melted reactors at the tsunami-wrecked Fukushima nuclear power plant, during a news conference at the TEPCO headquarters in Tokyo, Tuesday, April 4, 2023. Images captured by a robotic probe inside one of the three melted reactors at the tsunami-wrecked Fukushima nuclear power plant showed exposed steel bars in the main supporting structure and its thick external concrete wall largely missing near its bottom, triggering concerns about its earthquake resistance in case of

another major disaster. Credit: AP Photo/Shuji Kajiyama

Images captured by a robotic probe inside one of the three melted reactors at Japan's wrecked [Fukushima nuclear power plant](#) showed exposed steel bars in the main supporting structure and parts of its thick external concrete wall missing, triggering concerns about its earthquake resistance in case of another major disaster.

An approximately five-minute video—part of 39-hour-long images captured by the robot—showed that the 120-centimeter (3.9-foot) -thick concrete exterior of the pedestal was significantly damaged near its bottom, exposing the steel reinforcement inside.

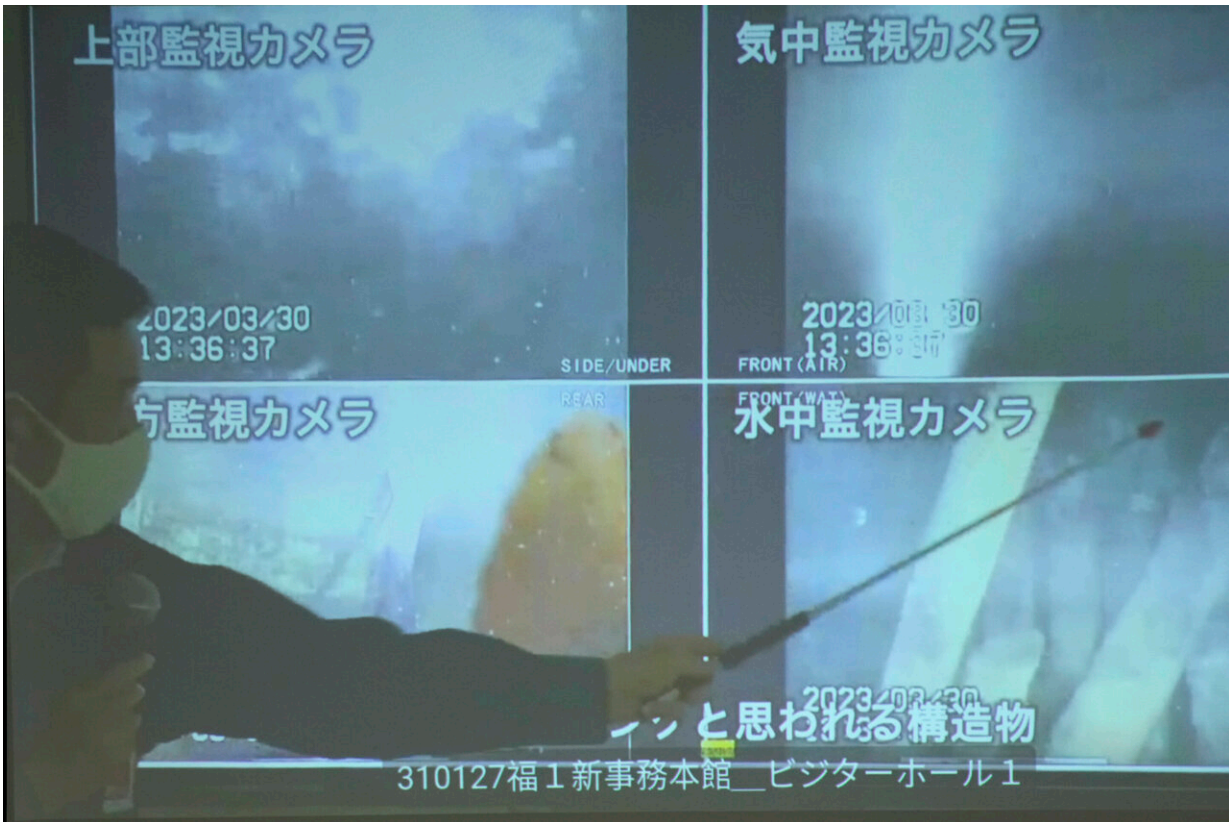
A spokesperson of the Tokyo Electric Power Company Holdings (TEPCO) shows photos captured by a robotic probe inside one of the three melted reactors at the tsunami-wrecked Fukushima nuclear power plant, during a news conference at the TEPCO headquarters in Tokyo, Tuesday, April 4, 2023. Those robotic images showed exposed steel bars in the main supporting structure and its thick external concrete wall largely missing near its bottom, triggering concerns about its earthquake resistance in case of another major disaster. Credit: AP Photo/Shuji Kajiyama

The images of the exposed steel reinforcement have triggered concerns about the reactor's safety.
