Location of MV Blythe Star shipwreck found, ending 50-year mystery

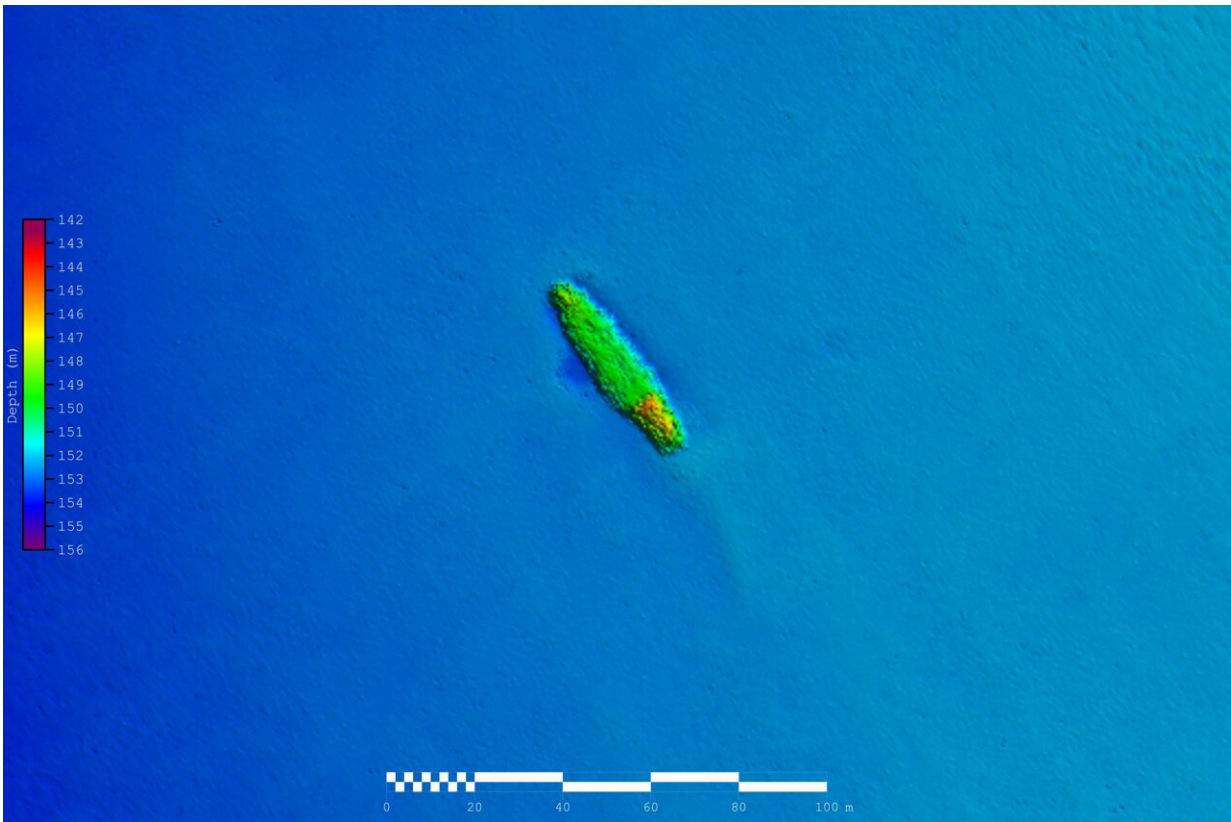
Bathymetric (seafloor mapping) overview of MV Blythe Star on the seafloor.
Credit: CSIRO.

The investigation by RV Investigator involved the systematic mapping of the unidentified shipwreck using multibeam echosounders and then a visual inspection using two underwater camera systems. The [mapping data](#) and video imagery collected by RV Investigator was able to confirm that the shipwreck was the MV Blythe Star.

The wreck of the MV Blythe Star is located approximately 10.5 km west of South West Cape, Tasmania and lies in 150 meters of water. The investigation showed the vessel is intact and sitting upright on the seafloor, with its bow pointing northwest. The visual inspection using the underwater cameras was able to identify key features to confirm the

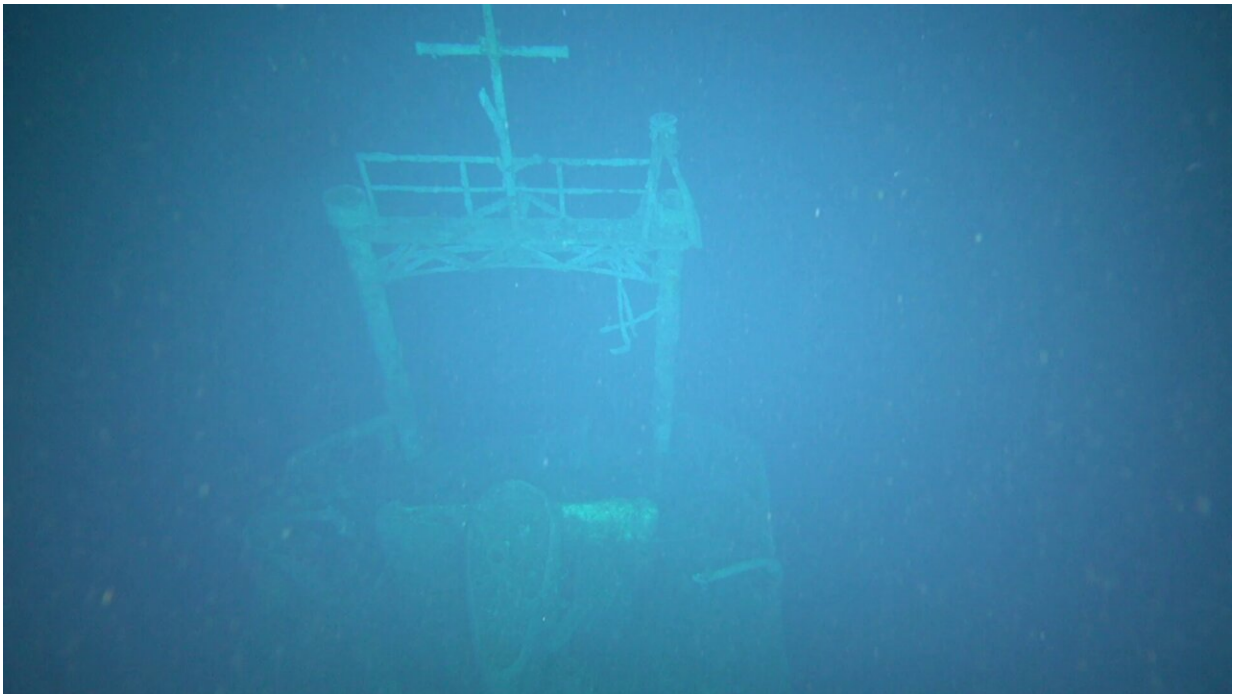
wreck was the MV Blythe Star. This included identifying part of the vessel name—"STAR"—on the ship's bow.

The wreck was covered with a minimal growth of algae and seaweed, and some structures showed signs of damage, particularly on the stern. Most notably, the vessel's wheelhouse is no longer present. Various marine life was observed on and around the wreck including crayfish, schools of fish and several fur seals, which were filmed swimming around the wreck.
