# Neutrons prove 'Bond villain' did not cause Arecibo telescope collapse

August 15 2023

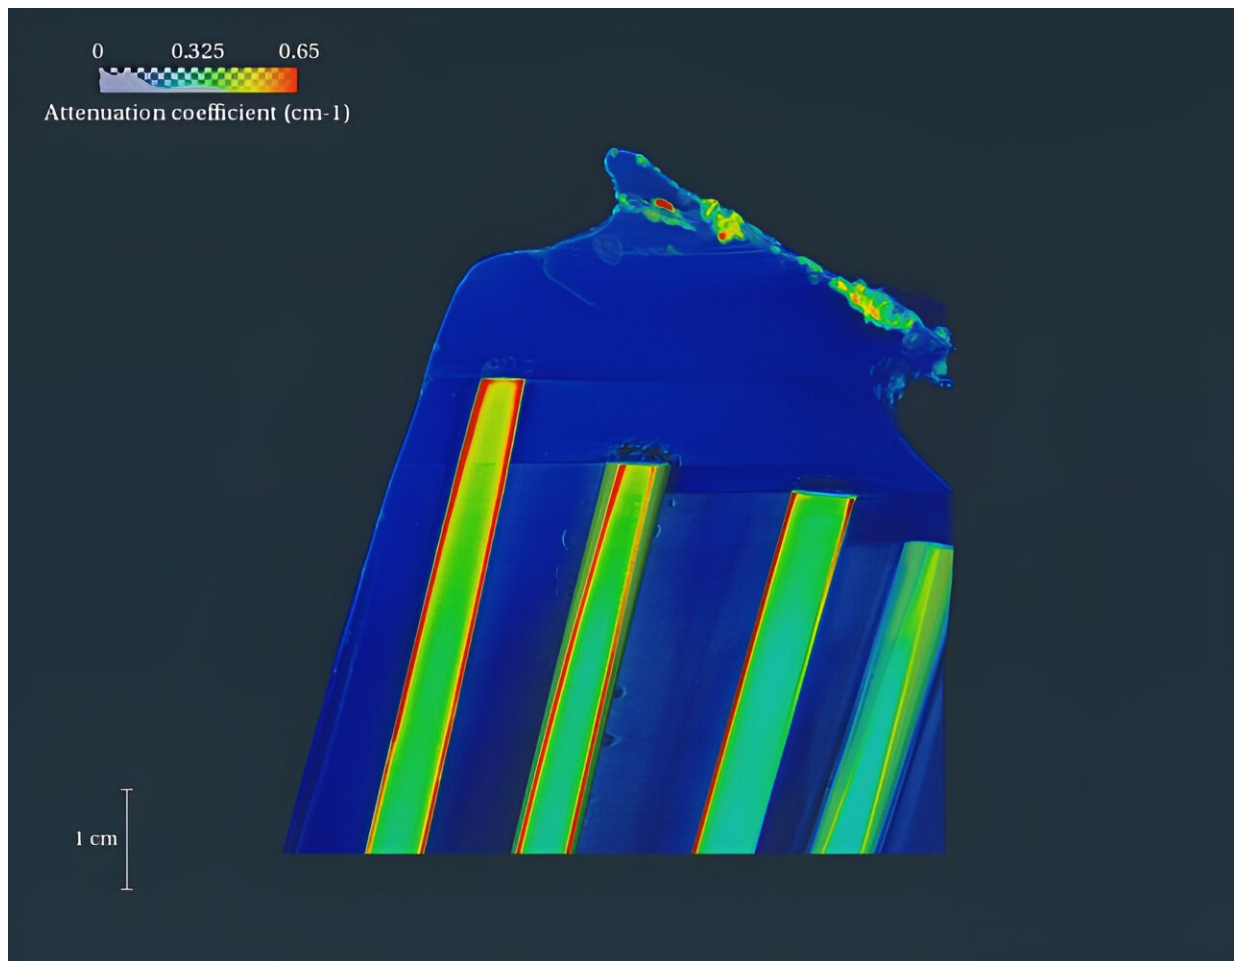
A virtual slice of a cable socket from the neutron imaging study shows arrows indicating voids around the wires caused by cable slippage. Credit: Adrian Brügger, Columbia University

Inside the failed sockets, the zinc casting that held the cable wires in place experienced significant material flow, or creep, allowing some of the wires to slip.

The neutron imaging revealed that the zinc flowed slowly under stress when the splayed-out cable wires alone could no longer resist the tension on the cables. The sockets failed because the zinc continued to flow until the cables entirely pulled out of the sockets.

"Our analysis detected significant slippage of wires in the region of interest, on the order of multiple wire diameters," Brügger said. "This indicates that the wires slipped at some point, but it cannot be surmised whether this slipping occurred during the structural failure event or before."
