Images taken deep inside melted Fukushima reactor show damage, but leave many questions unanswered

March 19 2024, by Mari Yamaguchi

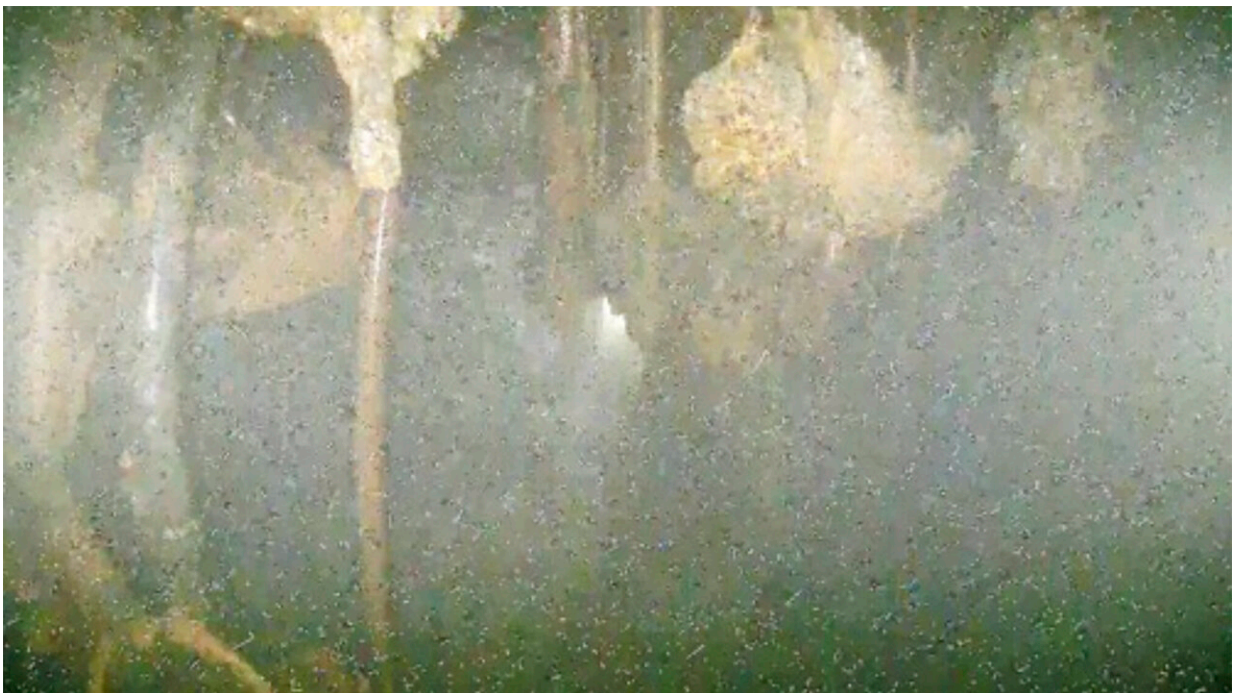
This image was taken a drone and provided by Tokyo Electric Power Company Holdings (TEPCO) shows displaced equipment and misshapen materials inside the No. 1 reactor as a drone probes the inside of the worst-hit reactor at the wrecked Fukushima Daiichi nuclear power plant in Okuma town, northeastern Japan, on March 14, 2024. Images taken by two miniature drones sent inside a badly damaged reactor at the Fukushima nuclear plant show displaced key control equipment and other materials but leave many questions unanswered, underscoring the daunting task of decommissioning the plant. Credit: TEPCO via AP

The high-definition color images captured by the drones show brown objects with various shapes and sizes dangling from various locations in the pedestal. Parts of the control-rod drive mechanism, which controls the nuclear chain reaction, and other equipment attached to the core were dislodged.

TEPCO officials said they were unable to tell from the images whether the dangling lumps were melted fuel or melted equipment without obtaining other data such as [radiation levels](#). The drones did not carry dosimeters to measure radiation because they had to be lightweight and maneuverable.

The [drone](#) cameras could not see the bottom of the reactor core, in part because of the darkness of the containment vessel, officials said. Information from the probe could help future investigations of the melted debris which are key to developing technologies and robots for its removal, they said.

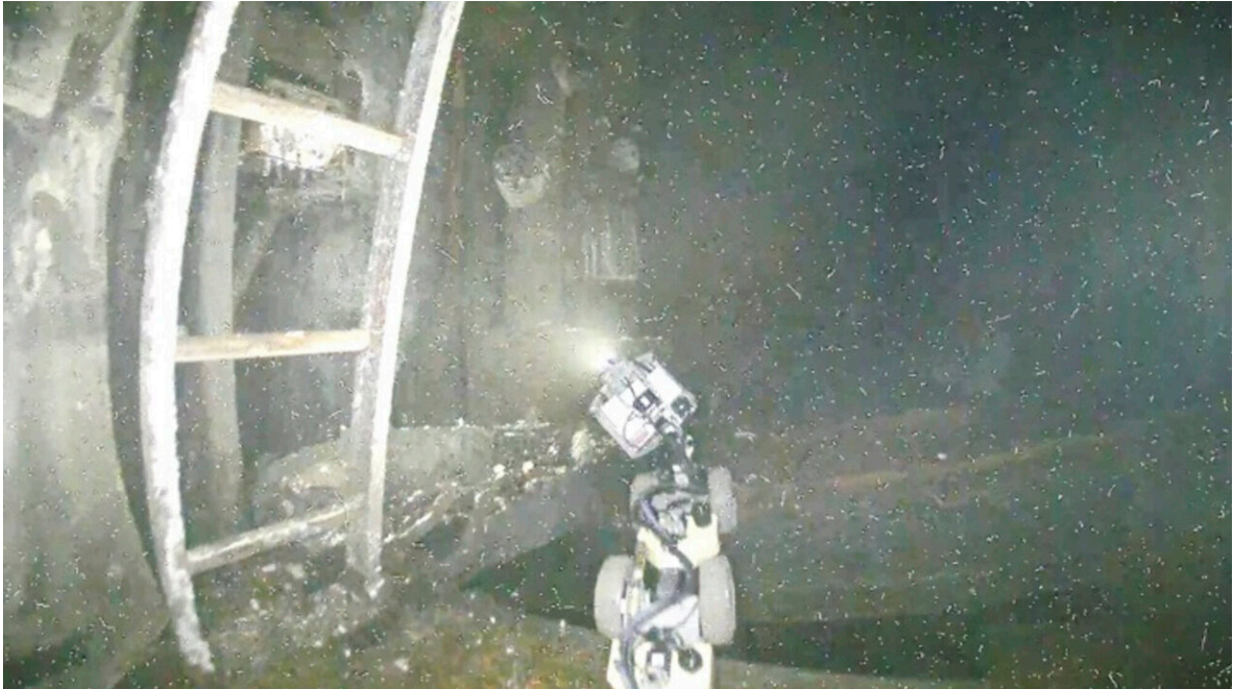
This image taken by a drone and provided by Tokyo Electric Power Company Holdings (TEPCO) shows the snake-shaped robot designed to assist a drone inside the No. 1 reactor as a drone probes inside of the worst-hit reactor at the wrecked Fukushima Daiichi nuclear power plant in Okuma town, northeastern Japan, on March 14, 2024. Credit: TEPCO via AP

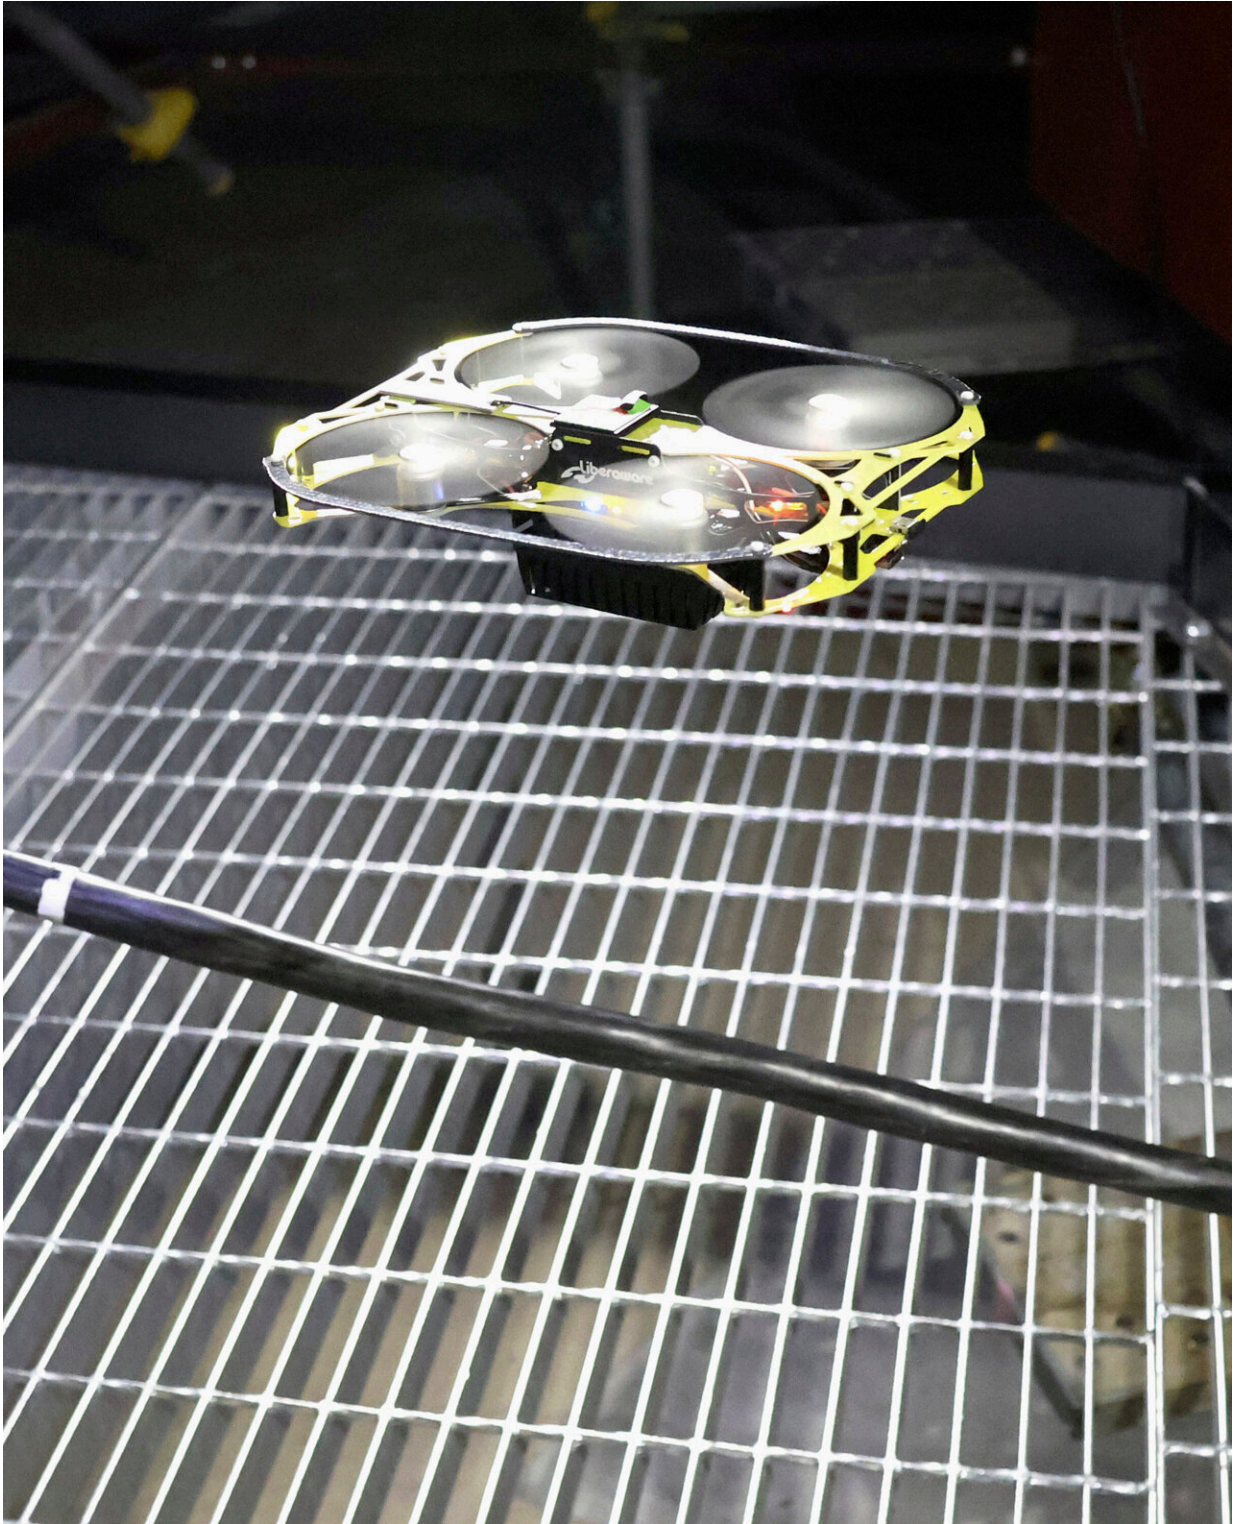
This photo shows a drone designed to probe at the crippled Fukushima Daiichi nuclear power plant, while in demonstration in Naraha town, northeast of Japan,
