Study uncovers a potential driver of premature solar panel failures

10 March 2020, by Jonathan Griffin

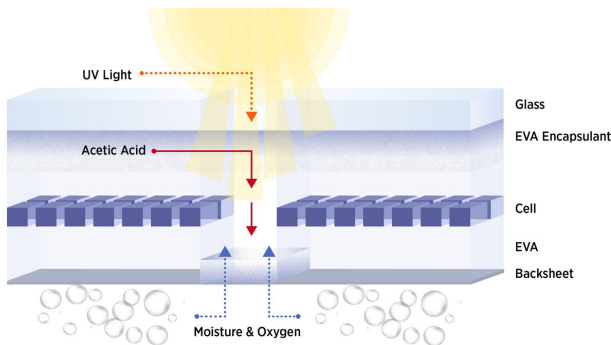
Although moisture and water wear away at the entire outer surface of backsheets, they crack more quickly in the area between solar cells where sunlight shines through. NIST researchers propose that degradation is worse there because acetic acid, which forms when sunlight hits the the rubbery upper layers, can pass between the solar cells towards the backsheets, causing them to decay from the inside out. Credit: N. Hanacek/NIST

How could the quality of the walled-off interior diminish more quickly than the exposed outer layer? Gu and her team speculated that the sunlight-induced degradation of the top side of the encapsulant—a film that surrounds the solar cells—produced damaging chemicals that descended toward the backsheets, speeding up their decay. If true, the proposed mechanism would explain why cracks form in between solar cells, as chemicals could find passage to the back through these regions.

The researchers identified [acetic acid](#) as a prime suspect, as it is known to be harmful to polyamide and is produced during the degradation of a polymer commonly used as an encapsulant, called ethylene vinyl acetate (EVA). To test their hypothesis, the researchers stowed several polyamide strips away in vials of acetic acid and then, after five months, analyzed how they decayed compared with strips placed in either air or water.

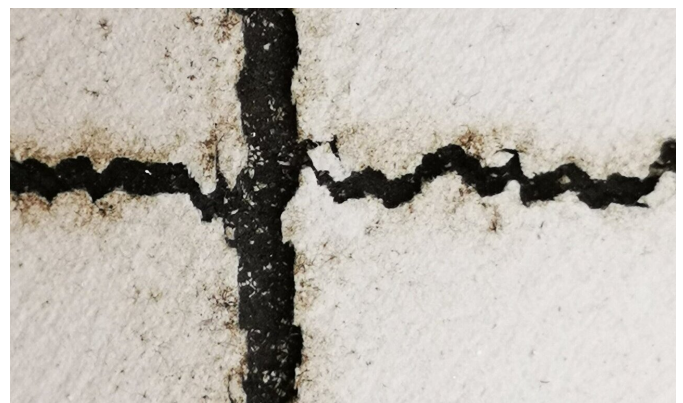
Cracks often form on solar panel backsheets in straight lines, along the gaps between solar cells. Credit: NIST

Cracks in backsheets often show up first near certain features—such as the grid-shaped space in between the blue or black electricity-producing [solar cells](#)—and can eventually propagate through the entire thickness of a sheet. These defects make way for oxygen and moisture to infiltrate and damage the interior where the cells lie and also allow [electrical current](#) to escape, increasing risks of electrocution.
