# Study uncovers a potential driver of premature solar panel failures

March 10 2020, by Jonathan Griffin

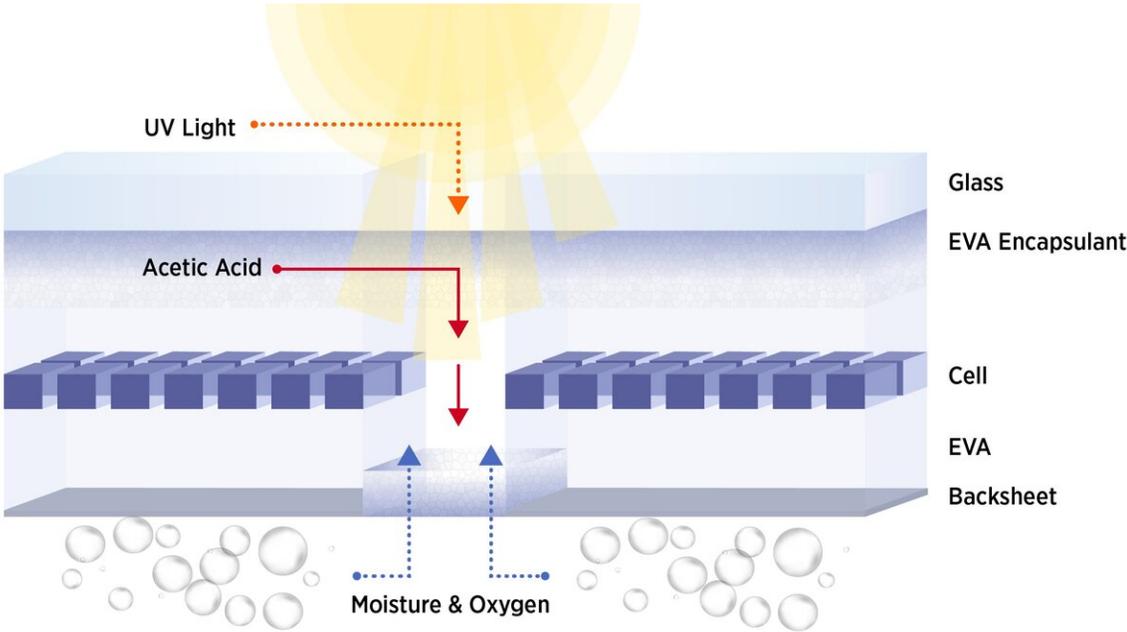
Although moisture and water wear away at the entire outer surface of backsheets, they crack more quickly in the area between solar cells where sunlight shines through. NIST researchers propose that degradation is worse there because acetic acid, which forms when sunlight hits the the rubbery upper layers, can pass between the solar cells towards the backsheets, causing them to decay from the inside out. Credit: N. Hanacek/NIST

How could the quality of the walled-off interior diminish more quickly than the exposed outer layer? Gu and her team speculated that the sunlight-induced degradation of the top side of the encapsulant—a film that surrounds the solar cells—produced damaging chemicals that descended toward the backsheets, speeding up their decay. If true, the proposed mechanism would explain why cracks form in between solar cells, as chemicals could find passage to the back through these regions.

The researchers identified [acetic acid](#) as a prime suspect, as it is known to be harmful to polyamide and is produced during the degradation of a polymer commonly used as an encapsulant, called ethylene vinyl acetate (EVA). To test their hypothesis, the researchers stowed several polyamide strips away in vials of acetic acid and then, after five months, analyzed how they decayed compared with strips placed in either air or water.

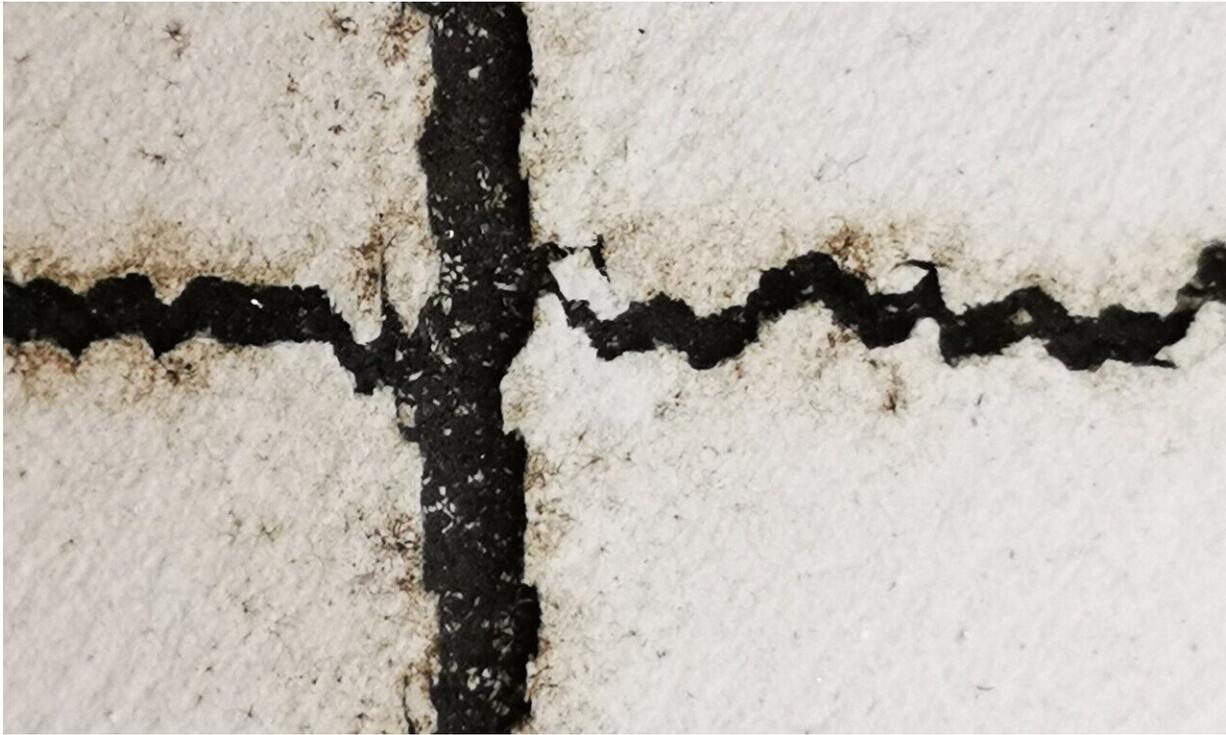
Cracks often form on solar panel backsheets in straight lines, along the gaps between solar cells. Credit: NIST

Cracks in backsheets often show up first near certain features—such as the grid-shaped space in between the blue or black electricity-producing [solar cells](#)—and can eventually propagate through the entire thickness of a sheet. These defects make way for oxygen and moisture to infiltrate and damage the interior where the cells lie and also allow [electrical current](#) to escape, increasing risks of electrocution.
