How fire causes office-building floors to collapse

24 March 2020

More information: Lisa Choe et al, Behavior and Limit States of Long-Span Composite Floor Beams with Simple Shear Connections Subject to Compartment Fires: Experimental Evaluation, *Journal of Structural Engineering* (2020). DOI: [10.1061/\(ASCE\)ST.1943-541X.0002627](https://doi.org/10.1061/(ASCE)ST.1943-541X.0002627)

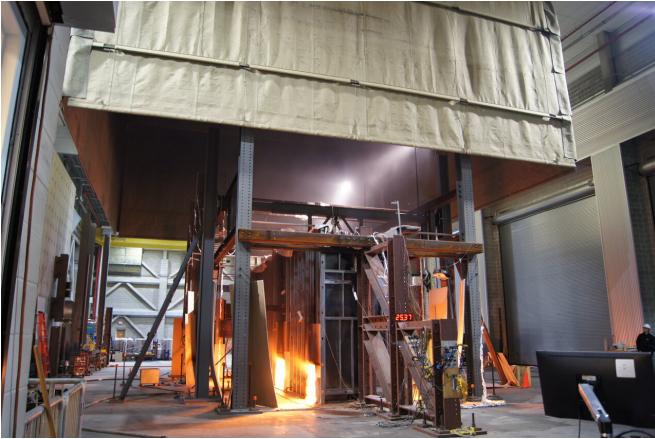
Inside a fireproof compartment, NIST researchers subjected full-scale replicas of office building floors to fires produced by three gas-fueled burners. Credit: NIST

Inside a fireproof compartment, three natural-gas fueled burners torched the floors from below, releasing heat as rapidly as a real [building](#) fire. While the compartment warmed up, various instruments measured the forces felt by the beams along with their deformation and temperature.

As temperatures within the compartment surpassed 1,000 C, the expanding beams, having been constrained between two support columns, began to buckle near their ends.

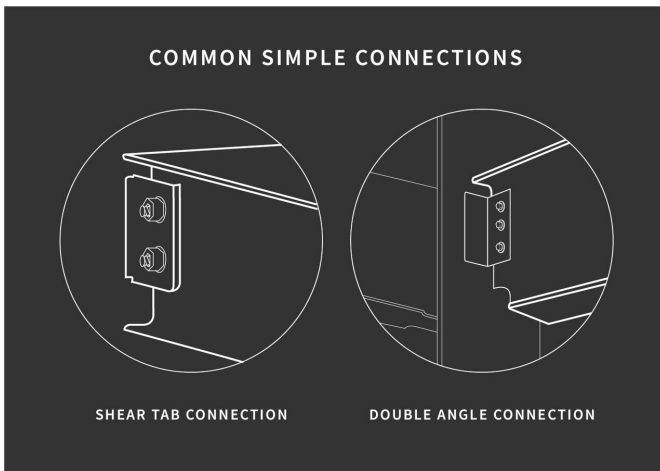
The shear tab connection (left) is a single flat plate welded to the support column and bolted onto one side of the steel beam. The double angle connection (right) is composed of two L-shaped plates, or angle legs, welded to the support column and bolted onto both sides of the steel beam. In this study, the double angle-connected beams endured greater deformations and temperatures before failing. Credit: B. Hayes/NIST

formed concrete slabs atop steel beams spanning 12.8 meters (42 feet)—a typical length in office buildings and also the longest fire-tested in the United States. The floors were suspended in the air, fastened at their ends to support columns either by double angle or shear tab connections, which are differently shaped but both commonplace.

No floor came out of the fire tests scot-free, but some withstood more than others. After around one hour of heating, the shear tab connections of one [beam](#)—now having dipped down by more than two feet—fractured, leading to collapse. The beams with double angle connections, however, beat the heat and remained intact. That is, until they tumbled down hours after the furnaces were shut off, as the beams cooled and contracted back upwards, breaking the double angle connections.

While the study's small sample size means conclusions about buildings in general could not be drawn, Choe and her team did find that the beams with double angle connections endured greater forces and deformations from the temperature changes than those with shear tab connections.
