How fire causes office-building floors to collapse

More information: Lisa Choe et al, Behavior and Limit States of Long-Span Composite Floor Beams with Simple Shear Connections Subject to Compartment Fires: Experimental Evaluation, *Journal of Structural Engineering* (2020). [DOI: 10.1061/\(ASCE\)ST.1943-541X.0002627](https://doi.org/10.1061/(ASCE)ST.1943-541X.0002627)

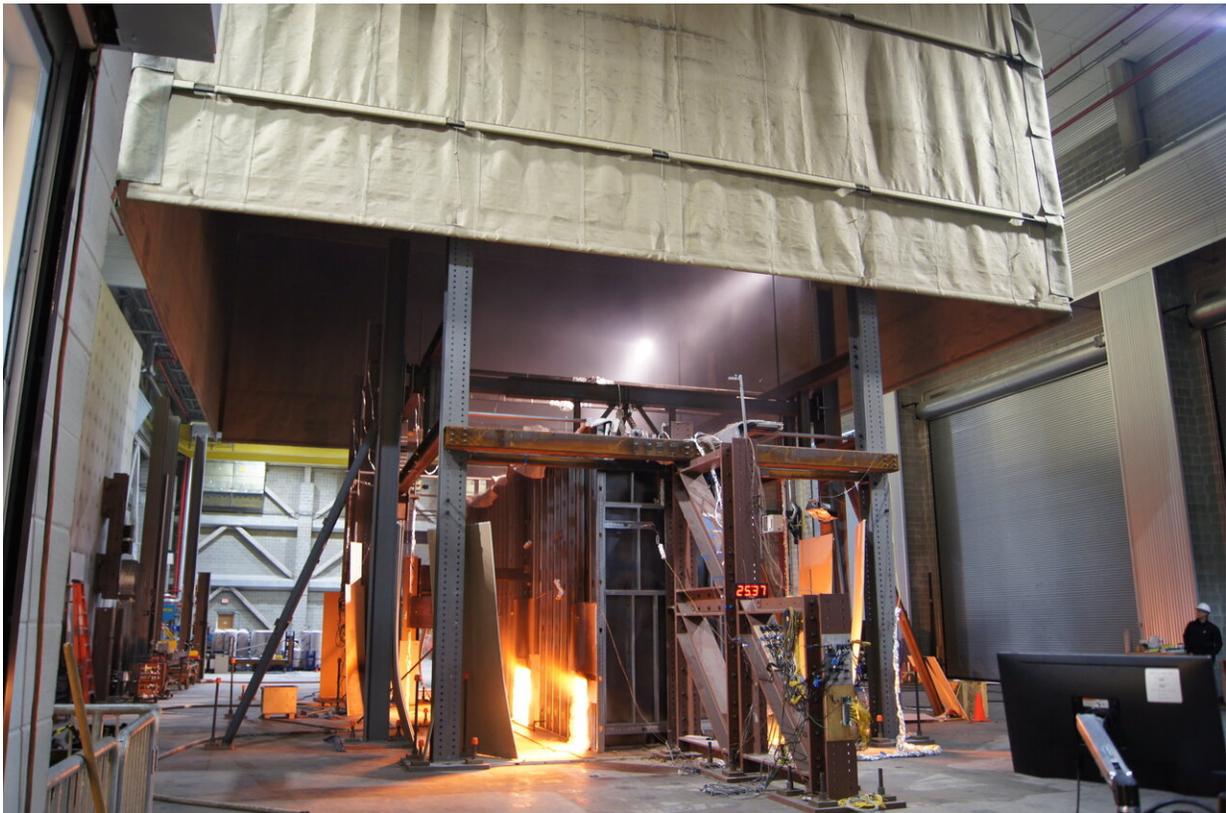
Inside a fireproof compartment, NIST researchers subjected full-scale replicas of office building floors to fires produced by three gas-fueled burners. Credit: NIST

Inside a fireproof compartment, three natural-gas fueled burners torched the floors from below, releasing heat as rapidly as a real [building](#) fire. While the compartment warmed up, various instruments measured the forces felt by the beams along with their deformation and temperature.

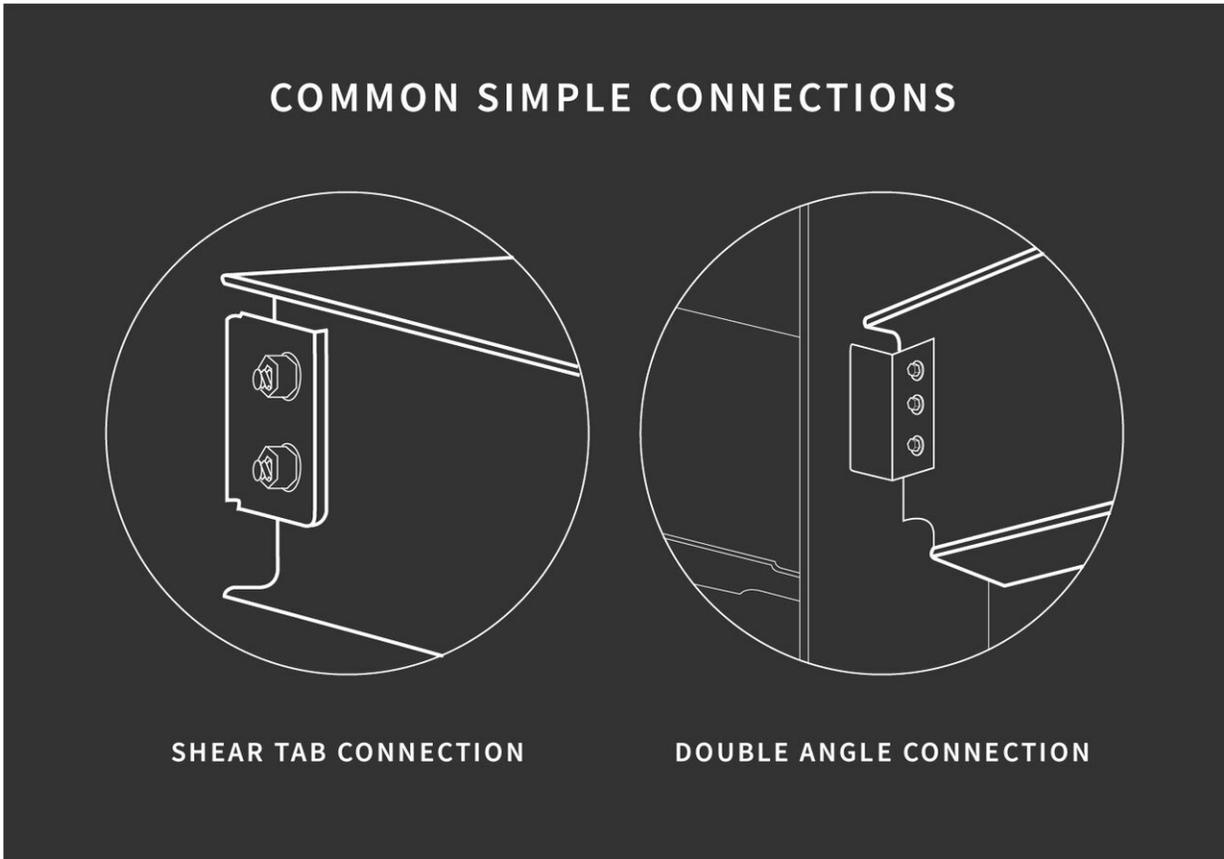
The shear tab connection (left) is a single flat plate welded to the support column and bolted onto one side of the steel beam. The double angle connection (right) is composed of two L-shaped plates, or angle legs, welded to the support column and bolted onto both sides of the steel beam. In this study, the double angle-connected beams endured greater deformations and temperatures before failing. Credit: B. Hayes/NIST

Mimicking the design of floors from high-rise office buildings, Choe and her colleagues at the NFRL formed concrete slabs atop steel beams spanning 12.8 meters (42 feet)—a typical length in office buildings and also the longest fire-tested in the United States. The floors were suspended in the air, fastened at their ends to support columns either by double angle or shear tab connections, which are differently shaped but

No floor came out of the fire tests scot-free, but some withstood more than others. After around one hour of heating, the shear tab connections of one [beam](#)—now having dipped down by more than two feet—fractured, leading to collapse. The beams with double angle connections, however, beat the heat and remained intact. That is, until they tumbled down hours after the furnaces were shut off, as the beams cooled and contracted back upwards, breaking the double angle connections.

While the study's small sample size means conclusions about buildings in general could not be drawn, Choe and her team did find that the beams with double angle connections endured greater forces and deformations from the temperature changes than those with shear tab connections.
