# Mapping performance variations to see how lithium-metal batteries fail

April 19 2021

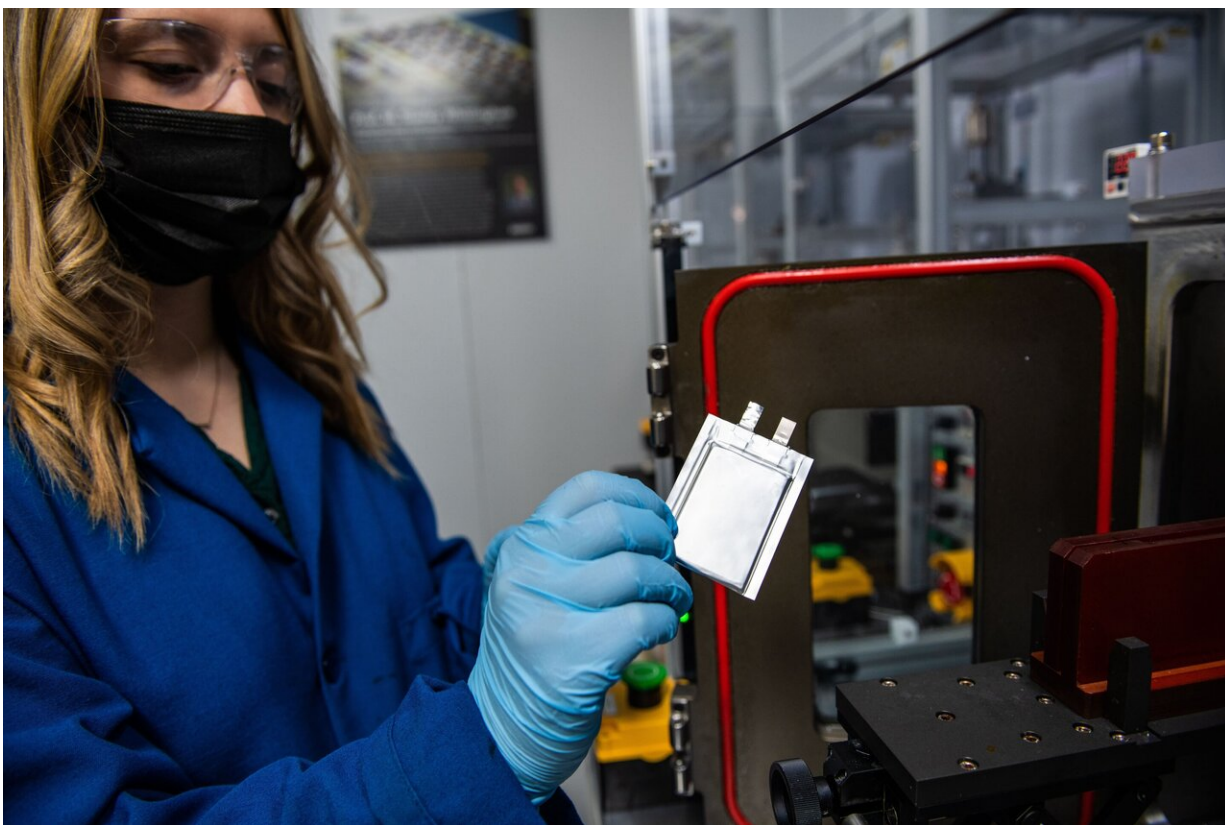
Cassidy Anderson, a PNNL post-bachelor intern and Battery500 Consortium team member, holds a pouch cell battery in PNNL's Advanced Battery Facility. The battery is enclosed in a polymer-based pouch containing an aluminum barrier layer to keep it safely sealed in an air-free environment. Credit: Pacific Northwest National Laboratory.

Widely used in industrial applications, a pouch cell is a sealed rectangular-shaped battery, which uses space much more efficiently than cylindrical cells powering household electronics. Thus, it's optimal for packing inside vehicles. In this study, scientists from DOE's Pacific Northwest National Laboratory (PNNL) used PNNL's Advanced Battery Facility to fabricate lithium-metal batteries in a prototype pouch cell geometry with multiple layers.

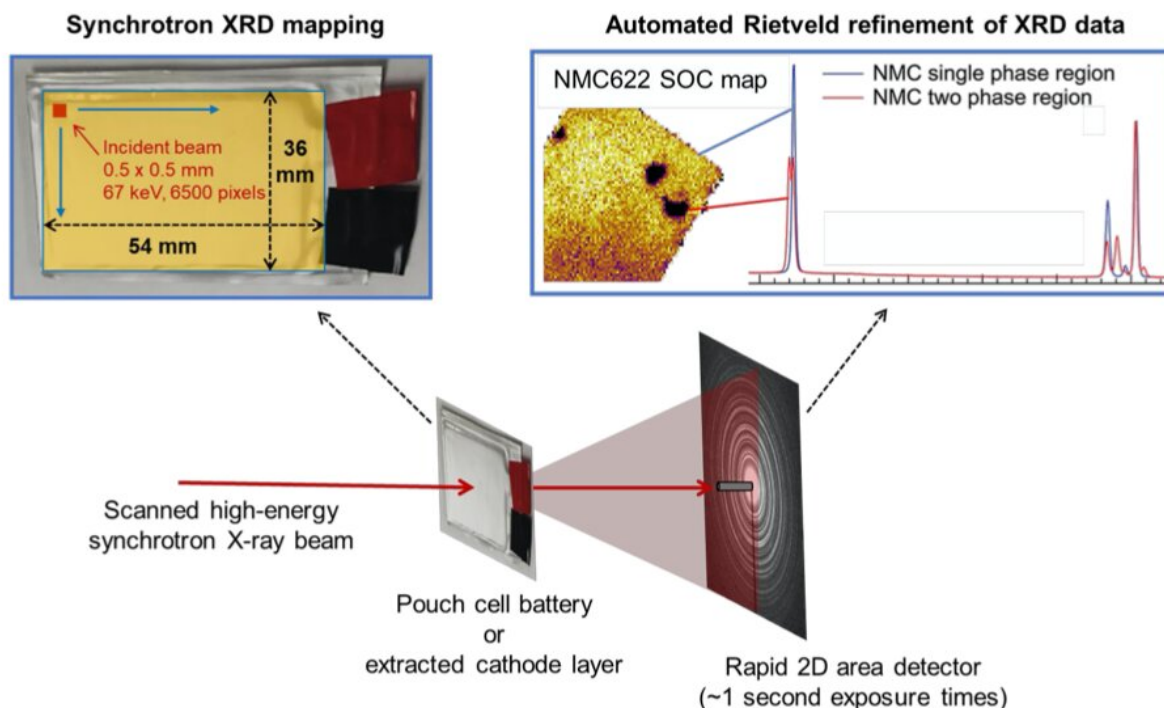
A schematic of the high-energy x-ray powder diffraction setup. Using automated software, the team mapped the battery state of charge (SOC) based on the diffraction data they collected for thousands of points across the battery. Credit: Brookhaven National Laboratory

In XPD, X-rays striking a sample only reflect at certain angles, producing a characteristic pattern. This diffraction pattern provides information on many aspects of the sample's structure, including the volume of its unit cell—the smallest repeating portion of the structure—and the positions of atoms within the unit cell.

The XPD beamline played a critical role in the experiment. With their high energy, the X-rays at this beamline can completely penetrate through battery cells, even those a few millimeters thick. The beam's high intensity and large two-dimensional area detector enabled the scientists to rapidly collect high-quality diffraction data for thousands of points across the battery.

"In this country, NSLS-II is only one of two X-ray synchrotrons suitable for high-energy diffraction studies," explained Khalifah. "For each point, we got a high-resolution [diffraction pattern](#) in about a second, allowing us to map the entire area of the battery in two hours—more than 100 times faster than if the X-rays were generated using a conventional laboratory X-ray source."

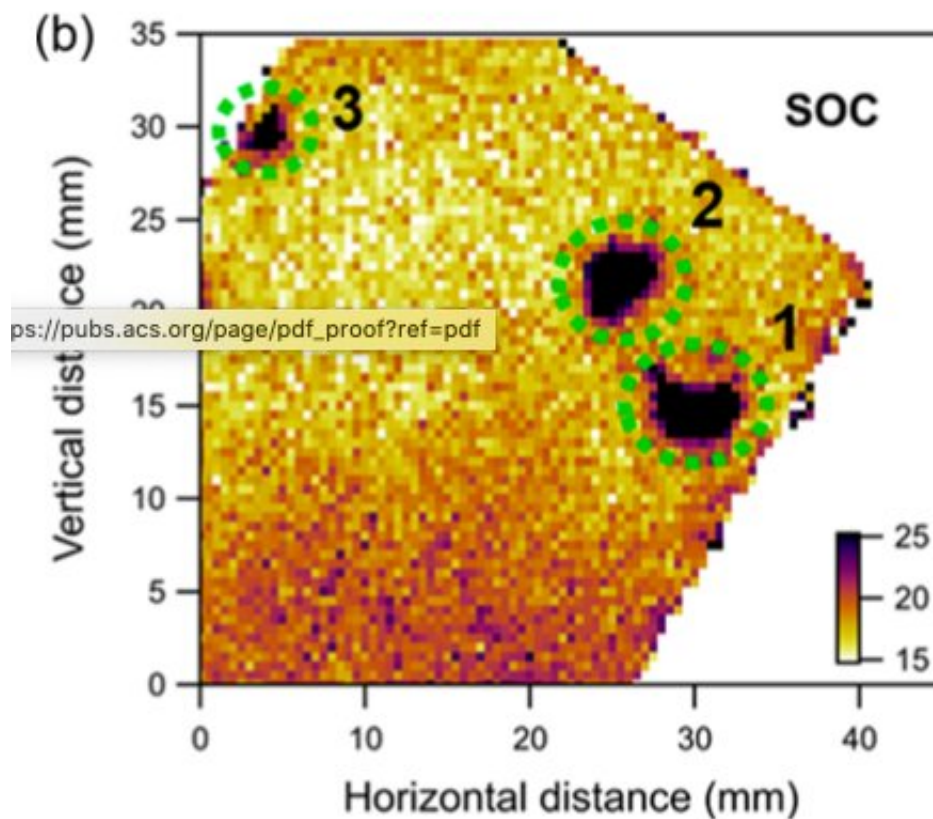
A state-of-charge map for a single cathode layer extracted from an end-of-life pouch cell after its 199th discharge cycle. The map exhibits three hotspots (numbered circles), each with a state of charge much higher than that in the rest of the cell, indicating localized failure in these locations. Credit: Brookhaven

The SOC maps revealed three "hotspots," each a few millimeters in diameter, where the local performance was much worse than that of the rest of the cell. Only a portion of the NMC cathode in the hotspots had trouble cycling; the rest remained synchronized with the cell. This finding suggested the battery capacity loss was due to partial destruction of the liquid electrolyte, as loss of the electrolyte will "freeze" the battery at its current SOC.

Other possible reasons for the battery capacity loss—consumption of the lithium-metal anode or gradual loss of lithium ions or electronic conductivity as degradation products form on the electrode surface—would not lead to the simultaneous presence of active and inactive NMC cathode in the hotspots. Follow-up experiments led by INL team members on smaller battery coin cells designed to intentionally fail through electrolyte depletion exhibited the same behavior as this large pouch cell, confirming the failure mechanism.

"Electrolyte depletion was the failure mechanism most consistent with the synchrotron X-ray and electrochemistry data," said Khalifah. "In many regions of the cell, we saw the electrolyte was partially depleted, so ion transport became more difficult but not impossible. But in the three hotspots, the electrolyte largely ran out, so cycling became impossible."

In addition to pinpointing the location of the hotspots where failure was occurring most rapidly, the synchrotron X-ray diffraction studies also revealed why failure was occurring there by providing the amount of NMC present at each position on the cathode. Regions with the worst failure typically had smaller amounts of NMC than the rest of the cell. When less of the NMC cathode is present, that part of the battery charges and discharges more quickly and completely, causing the electrolyte to be consumed more rapidly and accelerating its eventual failure in these regions. Even small reductions in the cathode amount (five percent or less) can accelerate failure. Therefore, improving manufacturing processes to produce more uniform cathodes should lead to longer-lasting batteries.
