# Collapsed bridge helps inform future flood-resistant designs

Before record rainfall in July of 2018, the Misasa Railroad Bridge spanned a small river some nine miles inland from Japan's western coast.

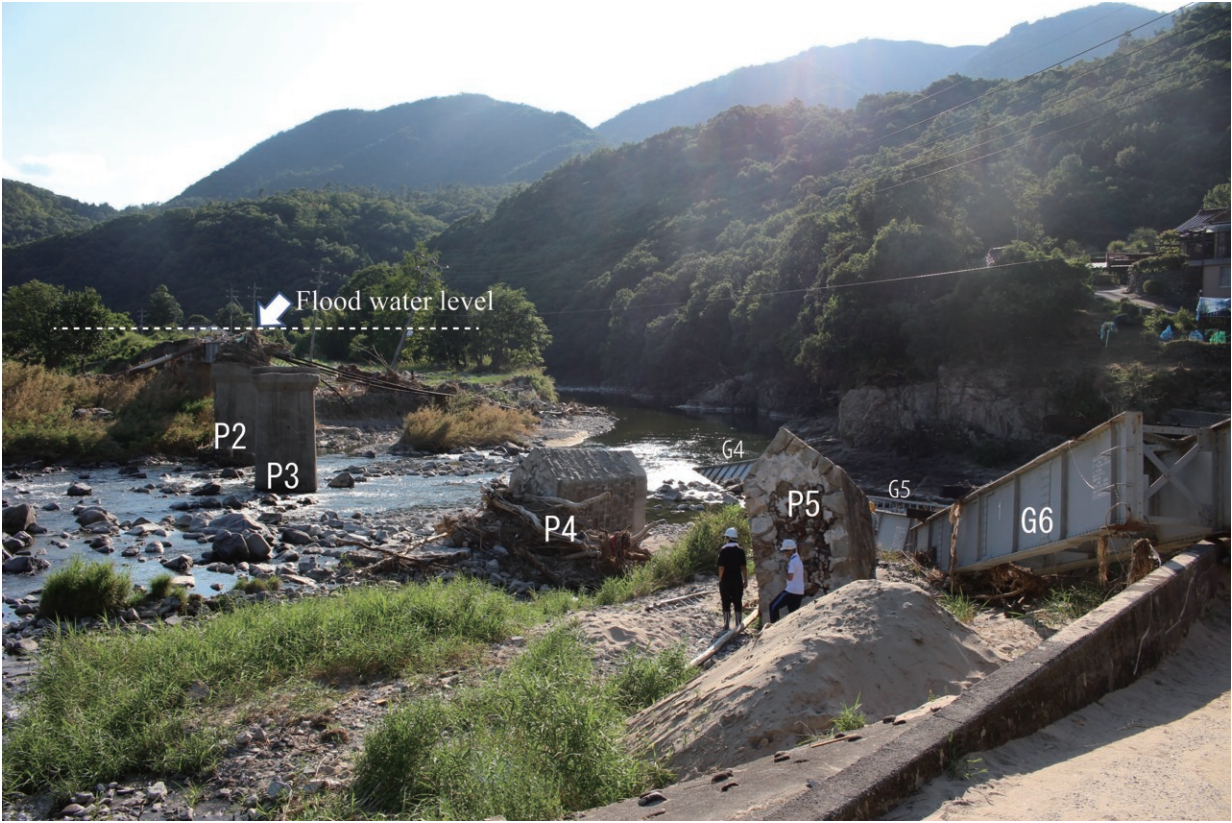
Scientists assessing the damage to the Misasa River bridge in 2018. Credit: Ichio Ario et al., Hiroshima University

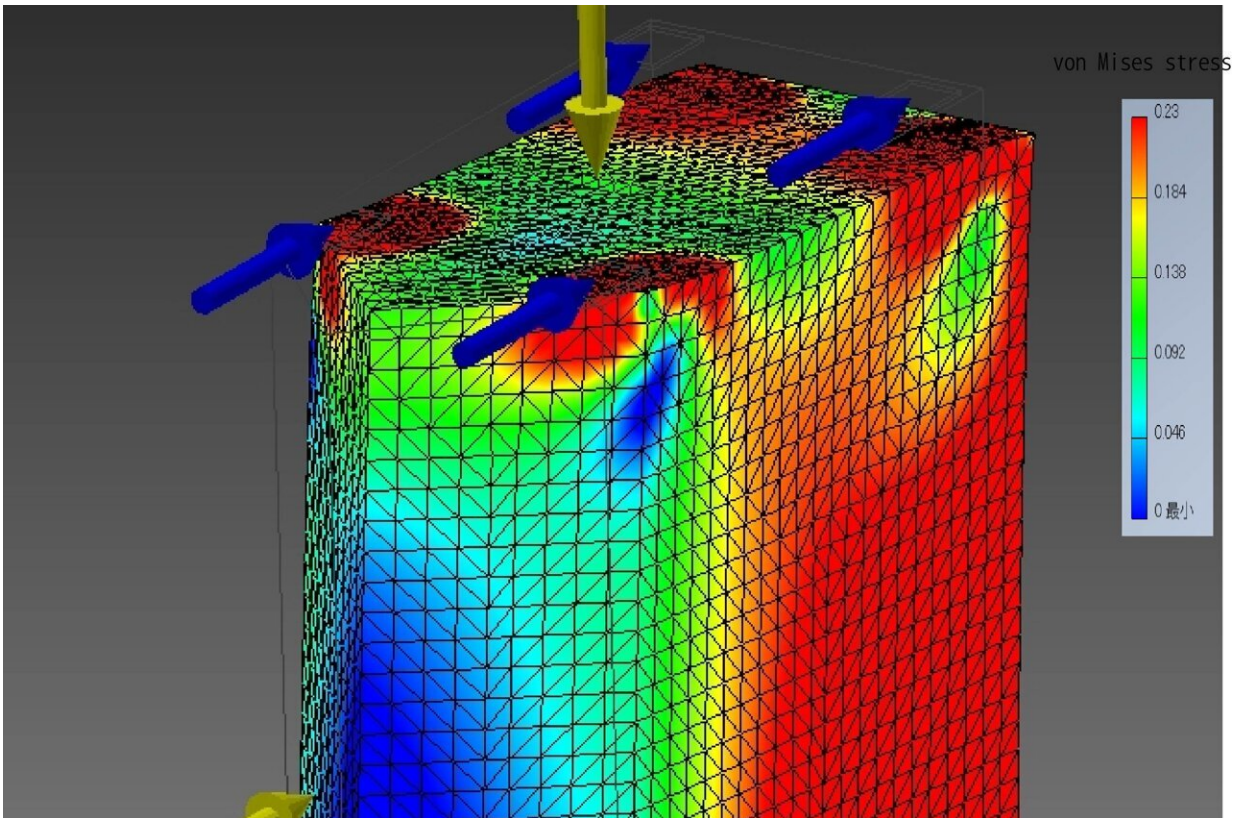
Von Mises stress distribution of FEM model of masonry pier P5 when estimated flood hydrodynamic force is applied. Credit: Ichio Ario et al., Hiroshima University

"Our [structural analysis](#) revealed the flood hydrodynamic force on the bridge girder during the flood caused the base of the stone piers supporting the bridge to collapse," Ario said. "Based on the failure processes and conditions revealed by the analysis, we identified [design elements](#) that can effectively help increase the resistivity of bridge structures on small rivers against floods."
