Crystalline fault lines provide pathway for solar cell current

September 26 2016

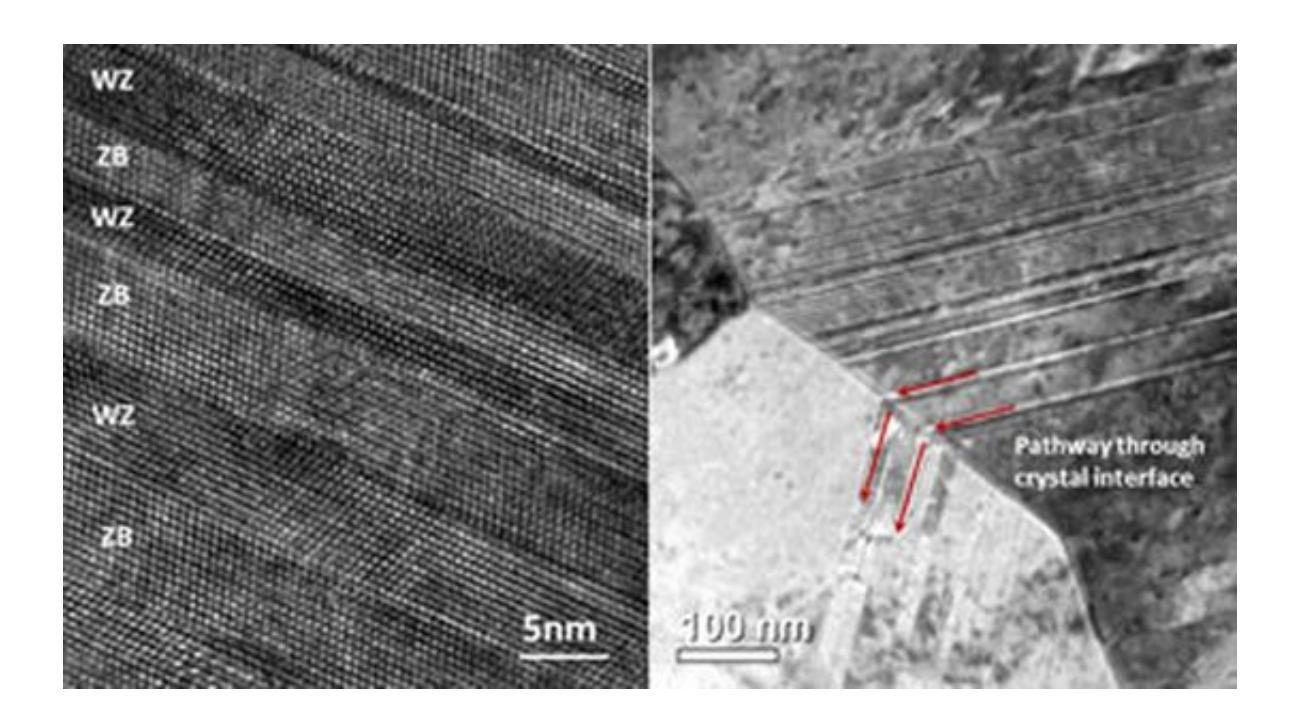
These transmission electron microscopy images taken at Brookhaven's CFN reveals how the stacking pattern of individual atoms (bright spots) shifts. The images confirmed that the bright spots of high conductivity observed with CTAFM imaging at UConn occurred at the interfaces between two different atomic alignments (left) and that these "planar defects" were continuous between individual crystals, creating pathways of conductivity (right). The labels WZ and ZB refer to the two atomic stacking sequences "wurtzite" and "zinc blende," which are the two types of crystal structures cadmium telluride can form. Credit: Brookhaven National Laboratory

CFN staff physicist Lihua Zhang used a transmission electron microscope (TEM) and UConn's results as a guide to meticulously study how atomic scale features of chloride-treated cadmium telluride related to the conductivity maps. The TEM images revealed the atomic structure of the defects, confirming that they were due to specific changes in the stacking sequence of atoms in the material. The images also showed clearly that these planar defects connected different grains in the crystal, leading to high-conductivity pathways for the movement of electrons and holes.

"When we looked at the regions with good conductivity, the planar defects linked from one crystal grain to another, forming continuous pathways of conductance through the entire thickness of the material," said Zhang. "So the regions that had the best conductivity were the ones that had a high degree of connectivity among these defects."
