## Drivetrain reliability collaborative seeks gearbox failure causes, solutions

November 9 2020

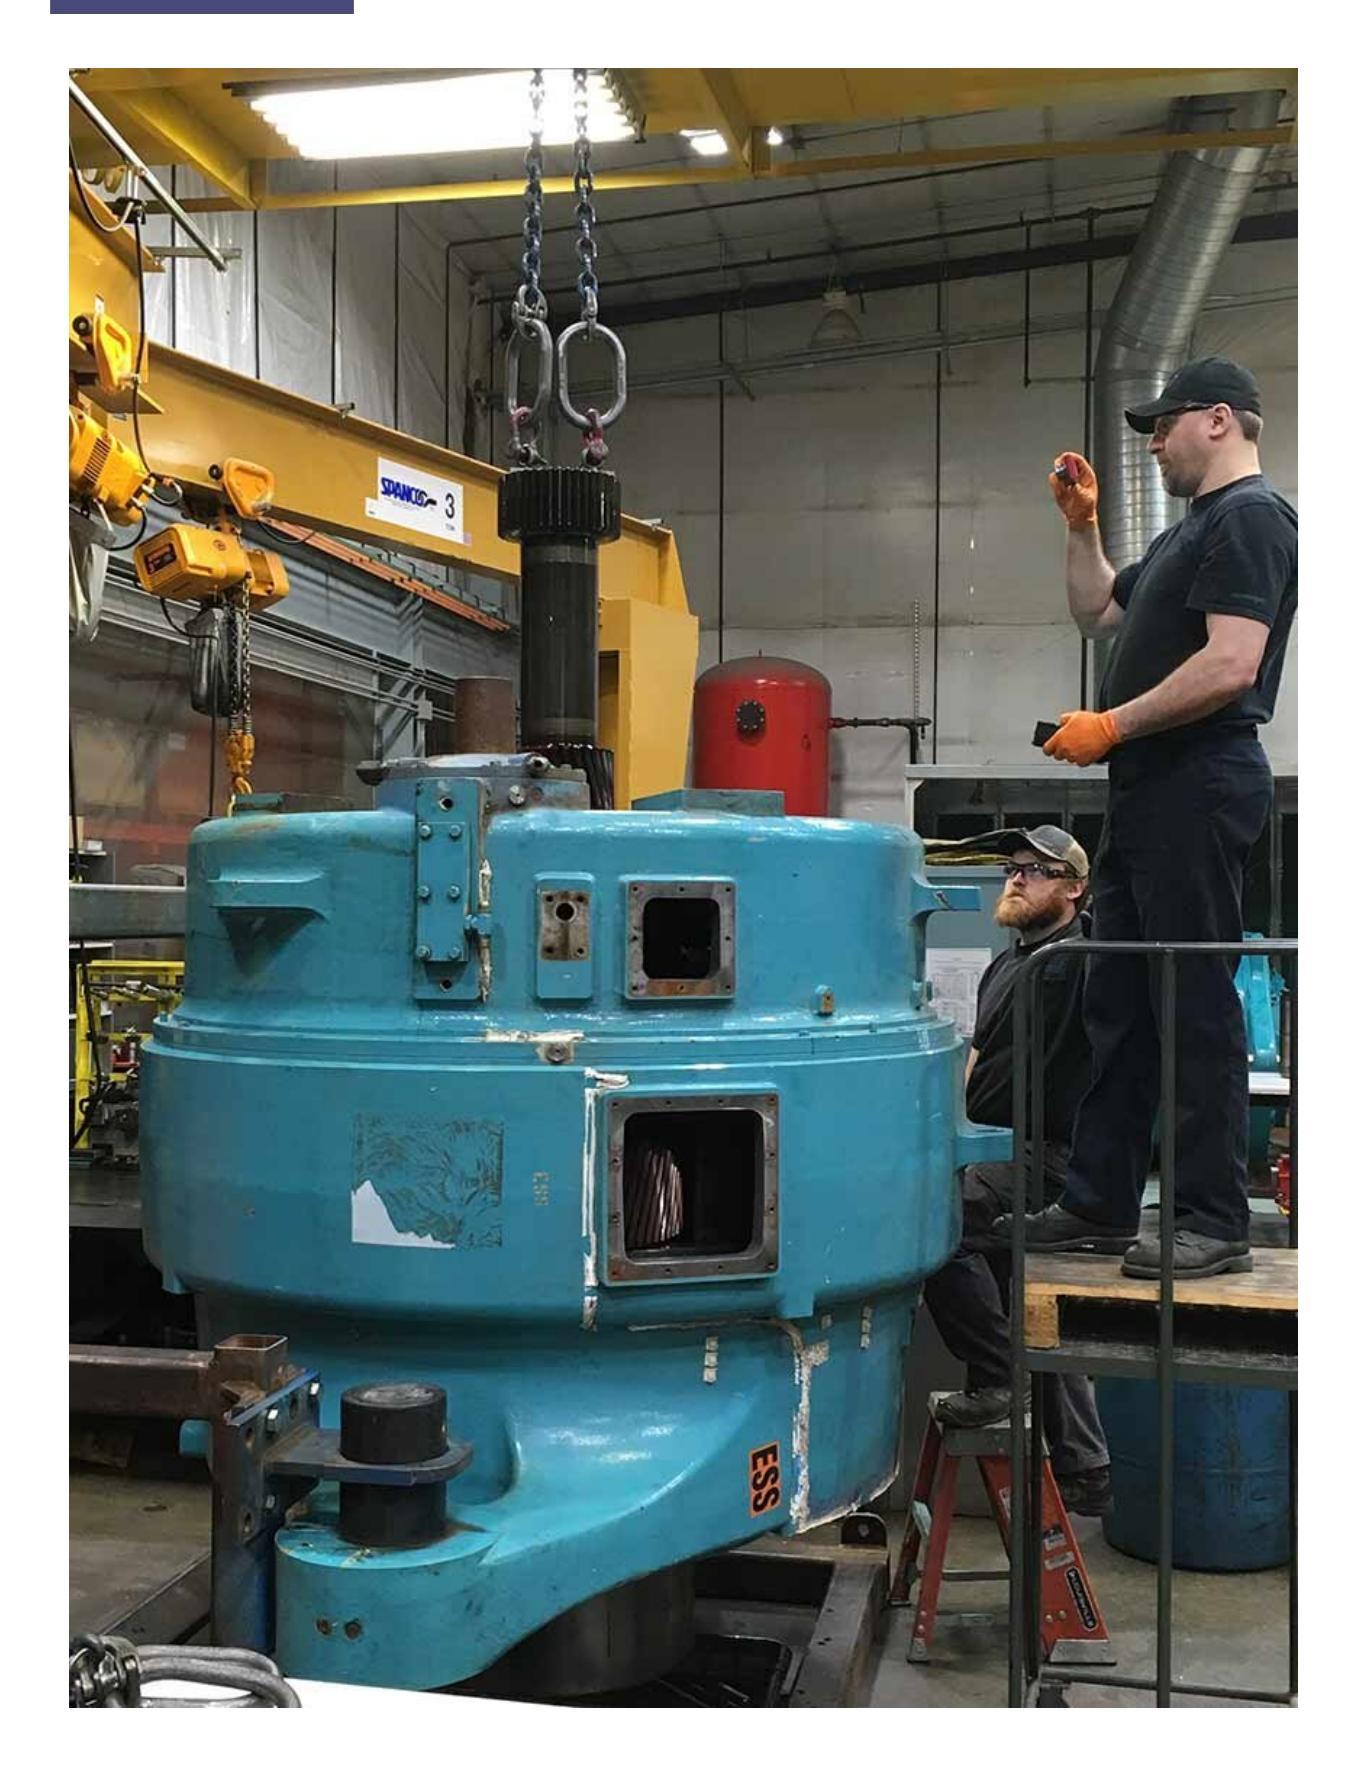
Wind plant operators disassemble and inspect a General Electric Transportation System wind turbine gearbox for damage. NREL researchers are working to understand and develop solutions to gearbox failures. Credit: Jonathan Keller, NREL

Gearboxes are designed to do this important work for 20 years or more, but often, they must be repaired or even completely replaced several years earlier. The most common reason for this is a failure mode attributed to axial or white-etching cracks (WECs) in the rolling-element bearings inside a gearbox.

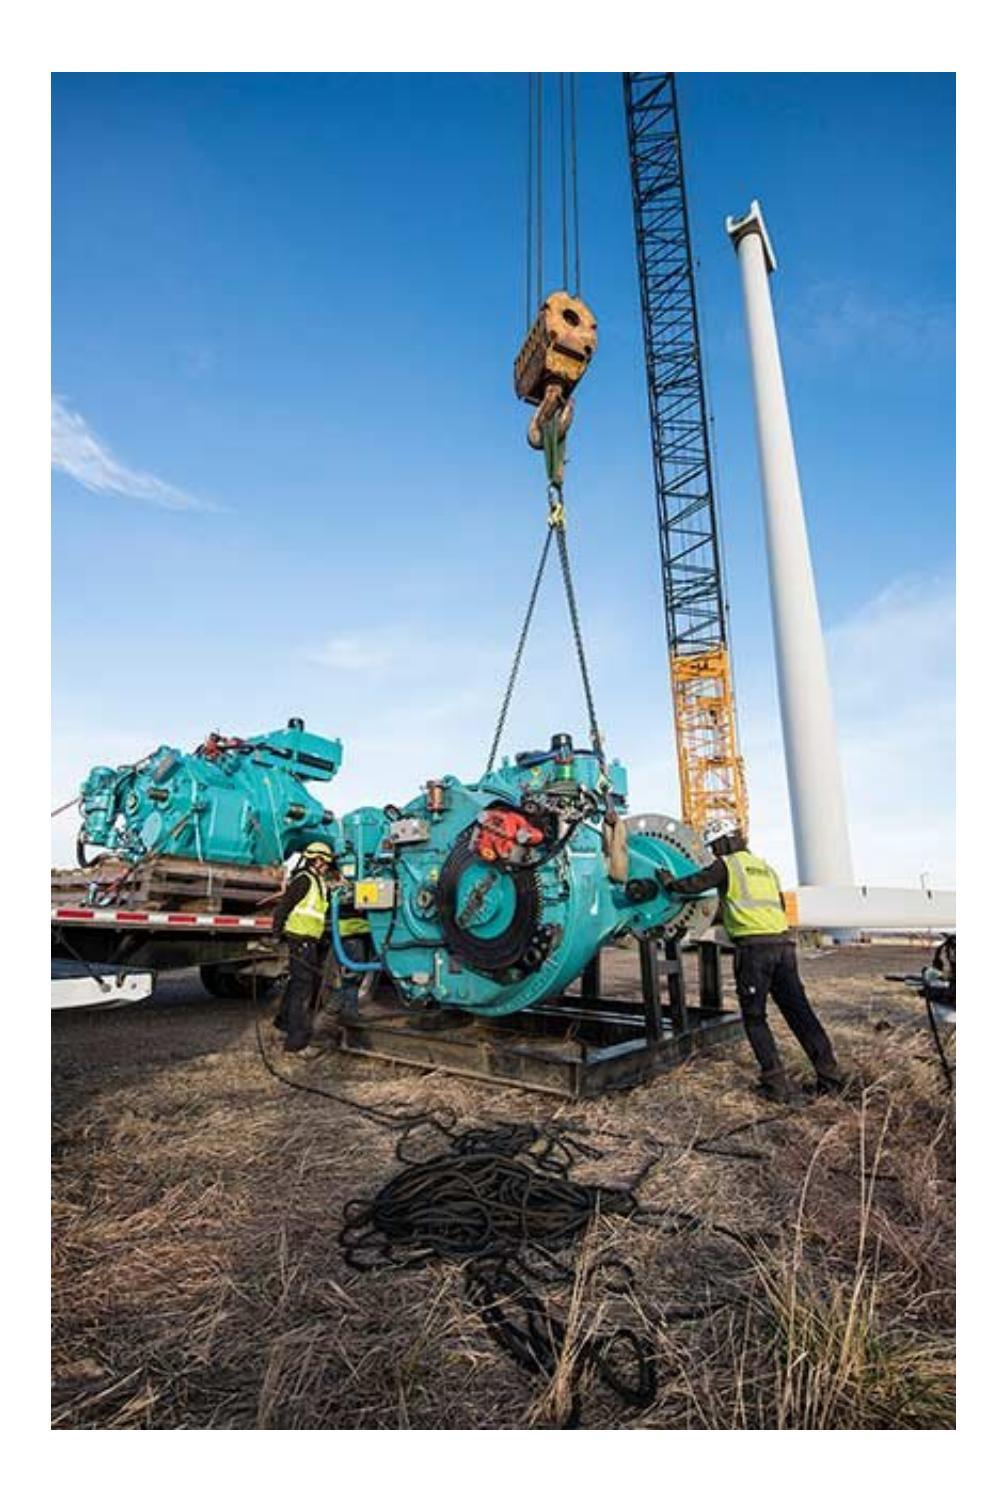
NREL researchers replace an existing gearbox (front) with a fully instrumented Winergy gearbox and SKF main bearing in the U.S.-Department-of-Energyowned GE 1.5-megawatt wind turbine at NREL's Flatirons Campus. Credit: Dennis Schroeder, NREL

One promising theory is that axial cracking is related to dynamic operating conditions in wind turbines that can result in high bearing stress and slip of the rolling elements. To create and measure these conditions, Keller and other NREL researchers outfitted a 1.5-megawatt wind <u>turbine</u> at NREL's Flatirons Campus with tailored instrumentation to gather <u>experimental data</u> at scale.

"Our findings confirmed that bearing slip under heavy loads occurs during wind turbine operations as a result of factors such as bearing design, load, speed, lubrication, and temperature," Keller said. "Using these data, we developed a roller sliding model that is scalable to different turbine and gearbox platforms and a probability of failure model that fills an industry gap in evaluating component reliability. Next, we'll work to improve the accuracy of the probability of failure model."
