Investigation into why a panel blew off a Boeing Max 9 jet focuses on missing bolts

January 10 2024, by DAVID KOENIG and TOM KRISHER

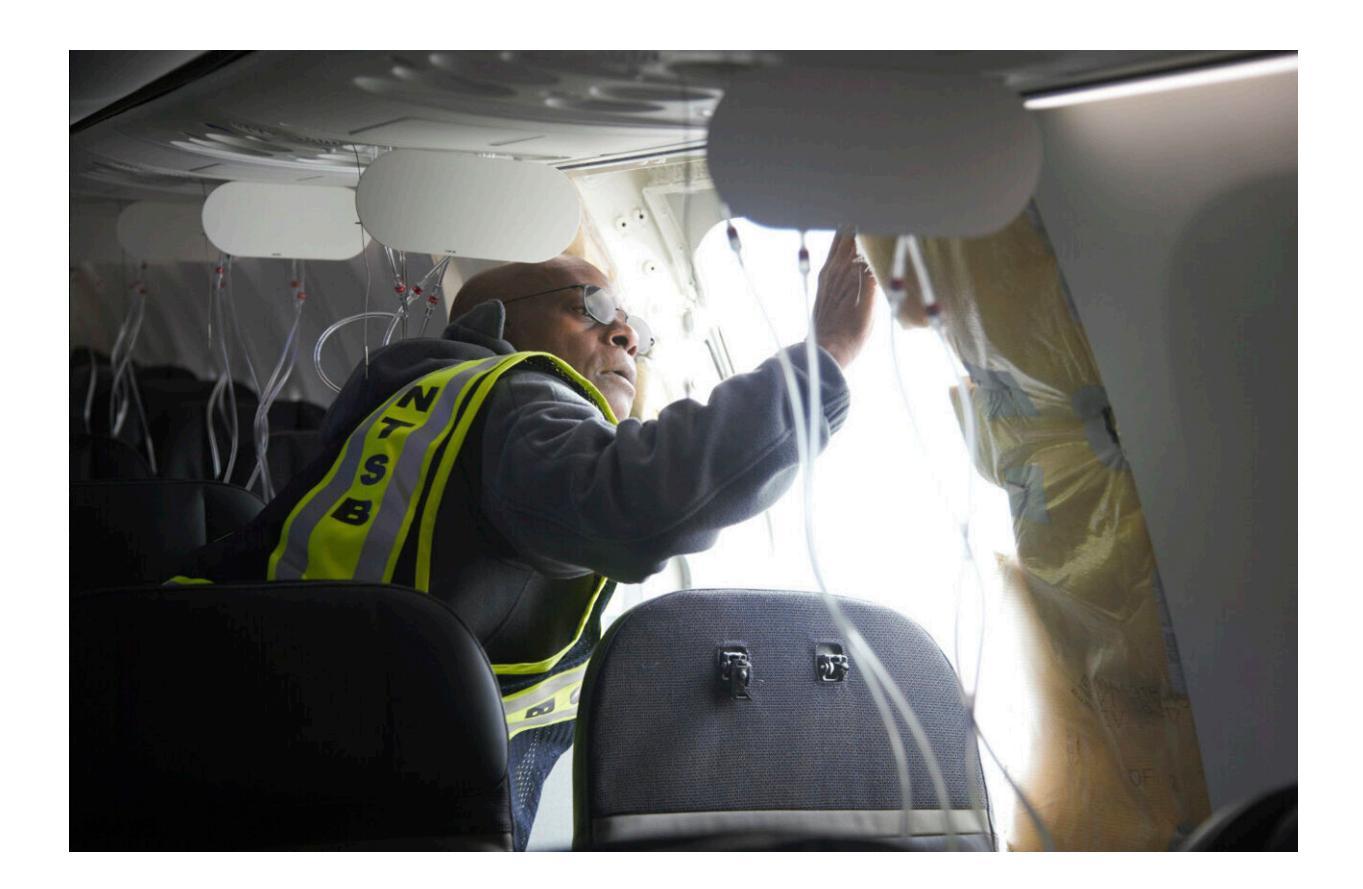
In this photo released by the National Transportation Safety Board, NTSB Investigator-in-Charge John Lovell examines the fuselage plug area of Alaska Airlines Flight 1282 on Sunday, Jan. 7, 2024, in Portland, Ore. A panel used to plug an area reserved for an exit door on the Boeing 737 Max 9 jetliner blew out Friday night shortly after the flight took off from Portland, forcing the plane to return to Portland International Airport. Credit: National Transportation Safety Board via AP

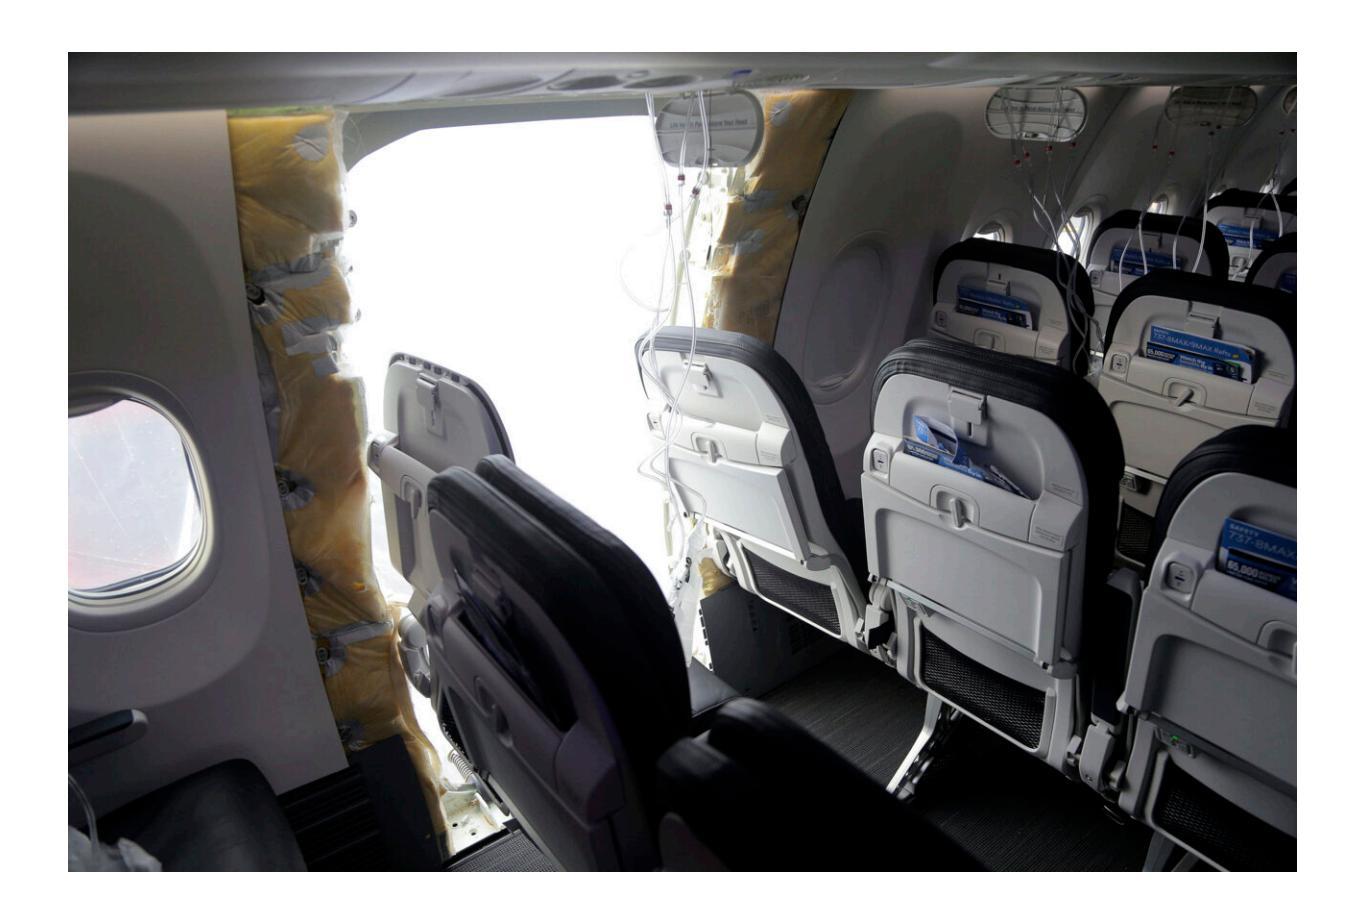
This photo released by the National Transportation Safety Board shows a gaping hole where the paneled-over door had been at the fuselage plug area of Alaska Airlines Flight 1282 on Sunday, Jan. 7, 2024, in Portland, Ore. A panel used to plug an area reserved for an exit door on the Boeing 737 Max 9 jetliner blew out Jan. 5, shortly after the flight took off from Portland, forcing the plane to return to Portland International Airport. Credit: National Transportation Safety Board via AP

During a briefing late Monday, NTSB officials described how the plug on Alaska flight 1282 rolled upward and flew off the jet. Four bolts and 12 connecting points between the plug and the door frame are supposed to prevent that from happening.

"We have not yet recovered the four bolts that restrain (the plug) from its vertical movement, and we have not yet determined if they existed there," said NTSB aerospace engineer Clint Crookshanks. "That will be determined when we take the plug to our lab in Washington, D.C."

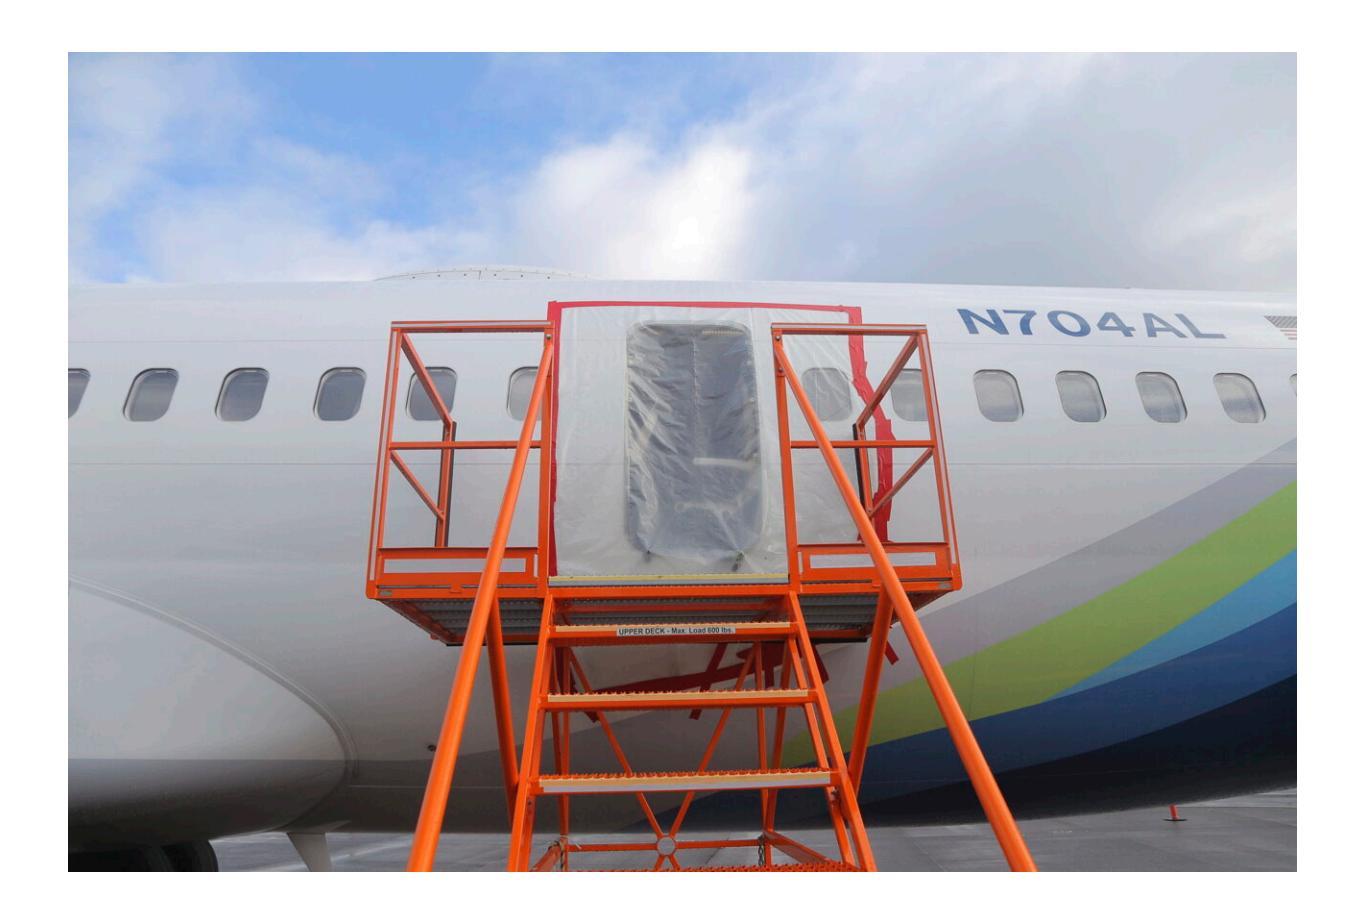
This photo released by the National Transportation Safety Board shows a gaping hole where the paneled-over door had been at the fuselage plug area of Alaska Airlines Flight 1282 on Sunday, Jan. 7, 2024, in Portland, Ore. A panel used to plug an area reserved for an exit door on the Boeing 737 Max 9 jetliner blew out Jan. 5, shortly after the flight took off from Portland, forcing the plane to return to Portland International Airport. Credit: National Transportation Safety Board via AP
