Study identifies areas in Mexico City Metro affected by land subsidence

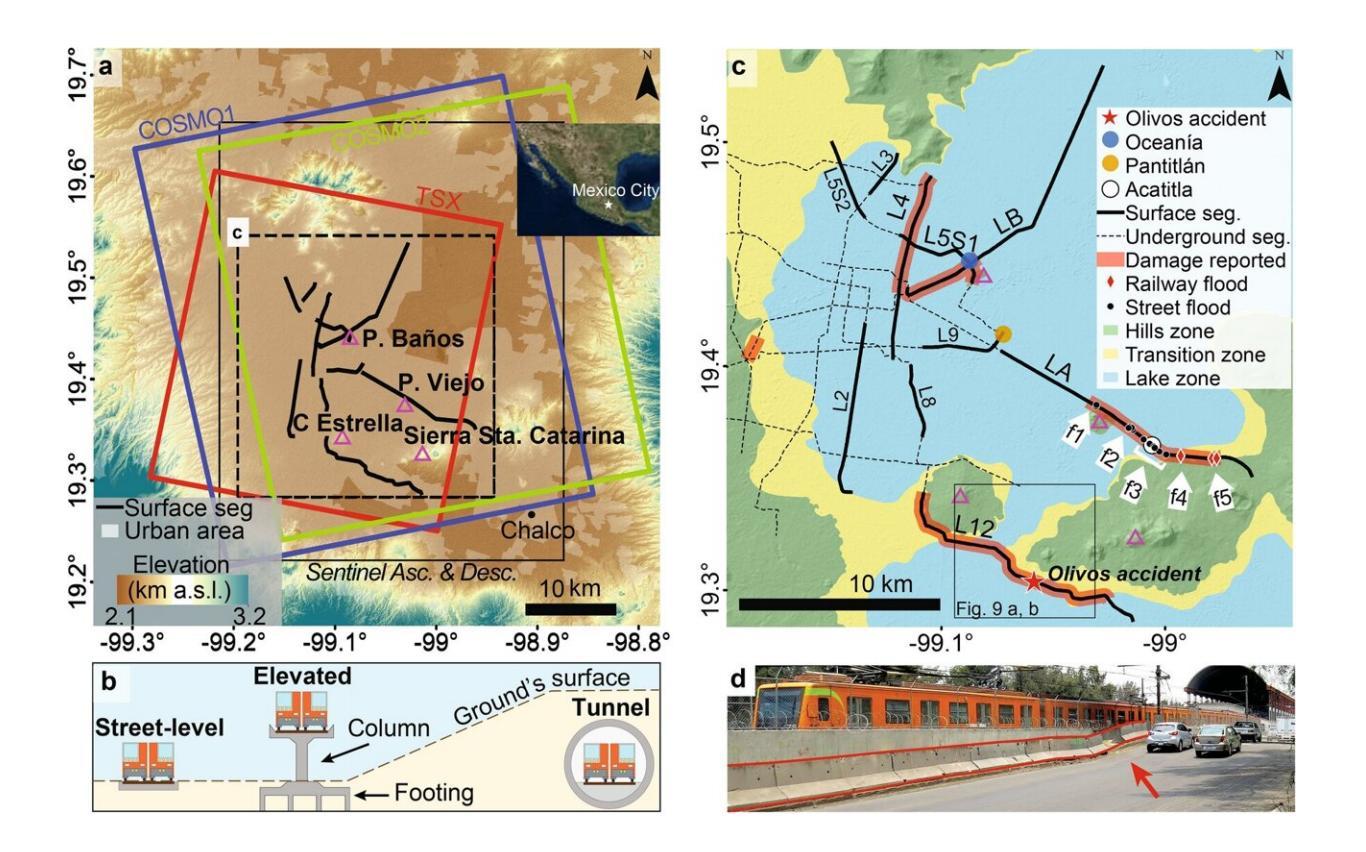
SAR datasets used in this study, railway engineering designs used by the Metro and locations of subsidence-related damage reports. (a) SRTM elevation map overlayed by the footprints of the five SAR datasets. (b) Illustration of streetlevel, elevated, and underground Metro line designs used in Mexico City. (c) Damaged segments and stations of the Metro system overlaying the city's official geotechnical zoning. (d) Differential subsidence at Acatitla Station as indicated by the tilted road traffic barriers (marked by two red lines). Credit: *Scientific Reports* (2024). DOI: 10.1038/s41598-024-53525-y

Using a remote sensing approach, the study's researchers were able to evaluate land subsidence throughout the metro's different engineering designs and determine most of the damage was observed along streetlevel and elevated segments. The observed damage includes cracks, faults, railway deformation and topographic slope changes which can lead to recurrent flooding, reduced train speed, service interruptions and accidents like the collapse of 2021.
