Images taken deep inside melted Fukushima reactor show damage, but leave many questions unanswered

March 19 2024, by Mari Yamaguchi

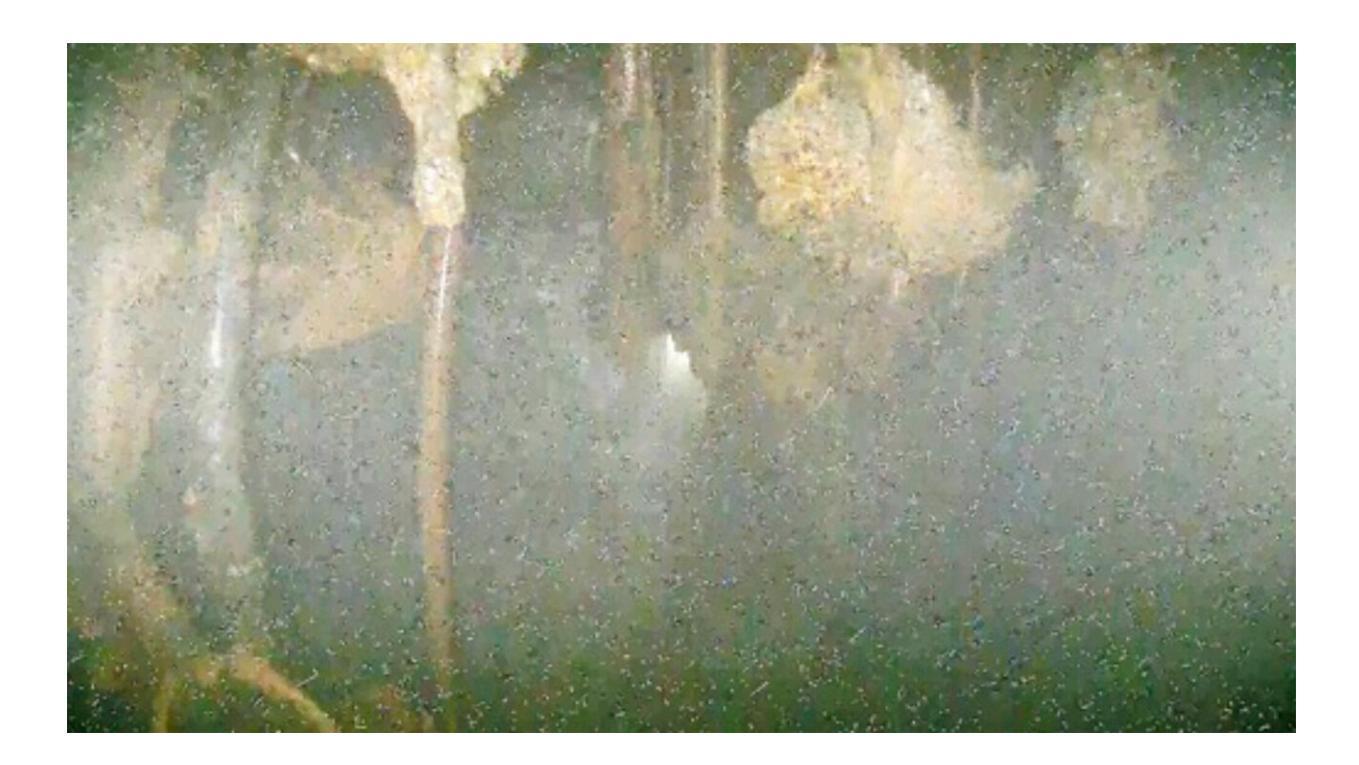
This image was taken a drone and provided by Tokyo Electric Power Company Holdings (TEPCO) shows displaced equipment and misshapen materials inside the No. 1 reactor as a drone probes the inside of the worst-hit reactor at the wrecked Fukushima Daiichi nuclear power plant in Okuma town, northeastern Japan, on March 14, 2024. Images taken by two miniature drones sent inside a badly damaged reactor at the Fukushima nuclear plant show displaced key control equipment and other materials but leave many questions unanswered, underscoring the daunting task of decommissioning the plant.Credit: TEPCO via AP

The high-definition color images captured by the drones show brown objects with various shapes and sizes dangling from various locations in the pedestal. Parts of the control-rod drive mechanism, which controls the nuclear chain reaction, and other equipment attached to the core were dislodged.

TEPCO officials said they were unable to tell from the images whether the dangling lumps were melted fuel or melted equipment without obtaining other data such as <u>radiation levels</u>. The drones did not carry dosimeters to measure radiation because they had to be lightweight and maneuverable.

The <u>drone</u> cameras could not see the bottom of the reactor core, in part because of the darkness of the containment vessel, officials said. Information from the probe could help future investigations of the melted debris which are key to developing technologies and robots for its removal, they said.

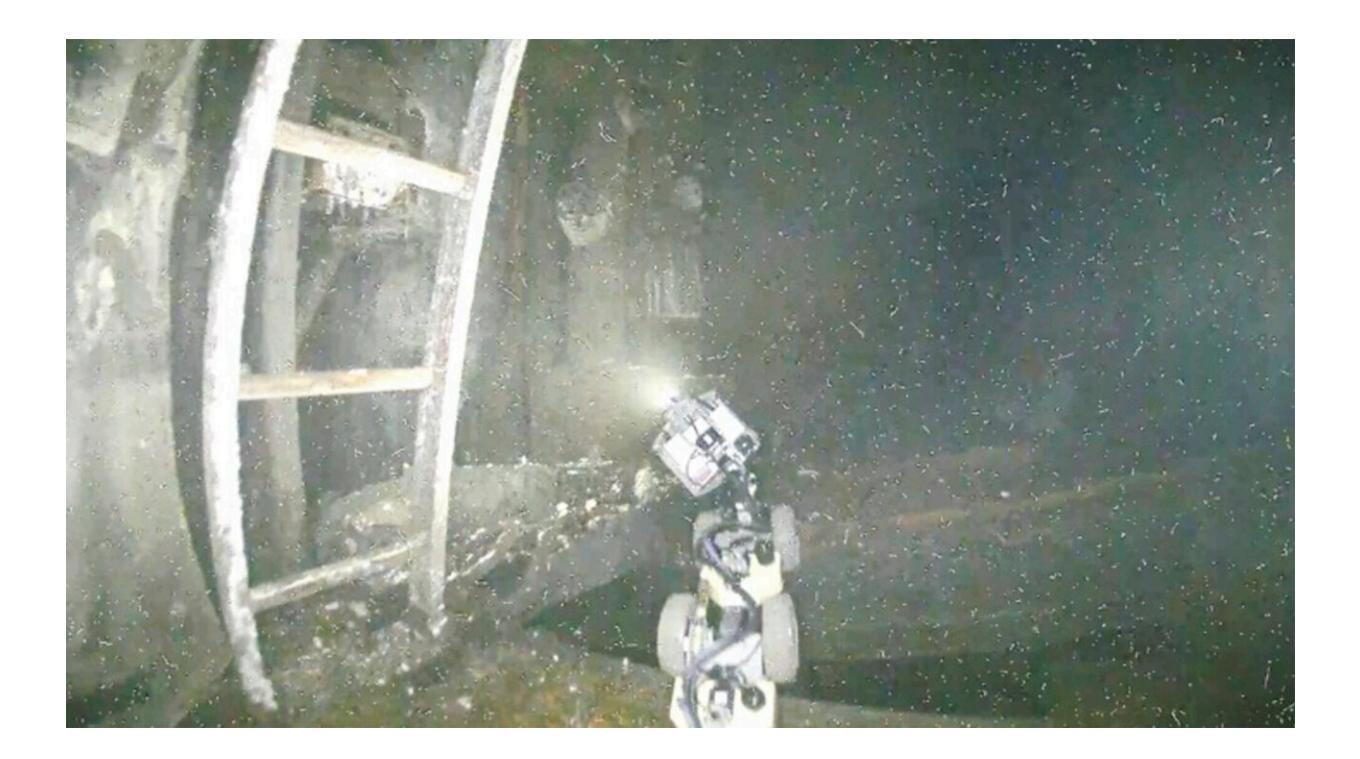
This image taken by a drone and provided by Tokyo Electric Power Company Holdings (TEPCO) shows the snake-shaped robot designed to assist a drone inside the No. 1 reactor as a drone probes inside of the worst-hit reactor at the wrecked Fukushima Daiichi nuclear power plant in Okuma town, northeastern Japan, on March 14, 2024. Credit: TEPCO via AP

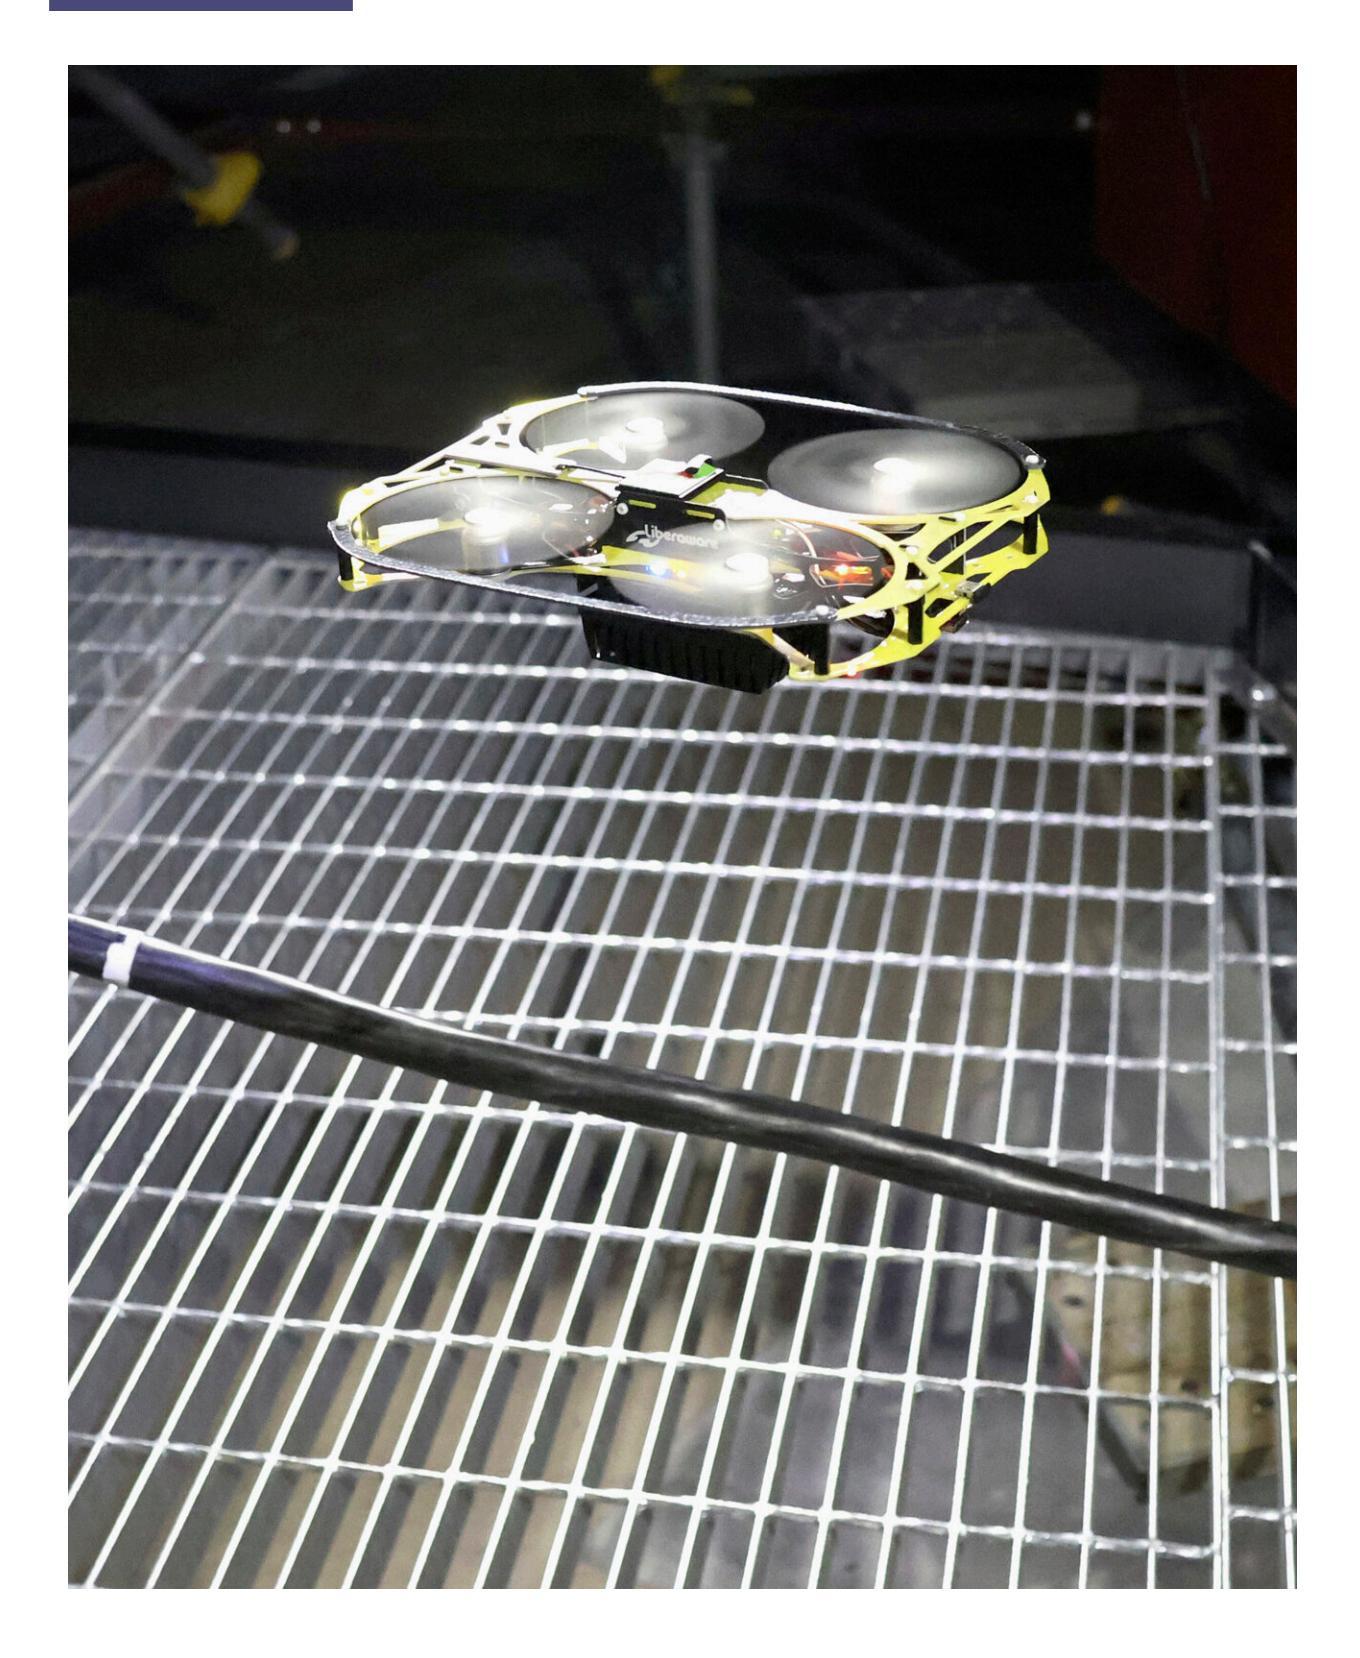
This photo shows a drone designed to probe at the crippled Fukushima Daiichi nuclear power plant, while in demonstration in Naraha town, northeast of Japan,
