# Crystalline fault lines provide pathway for solar cell current

September 26 2016

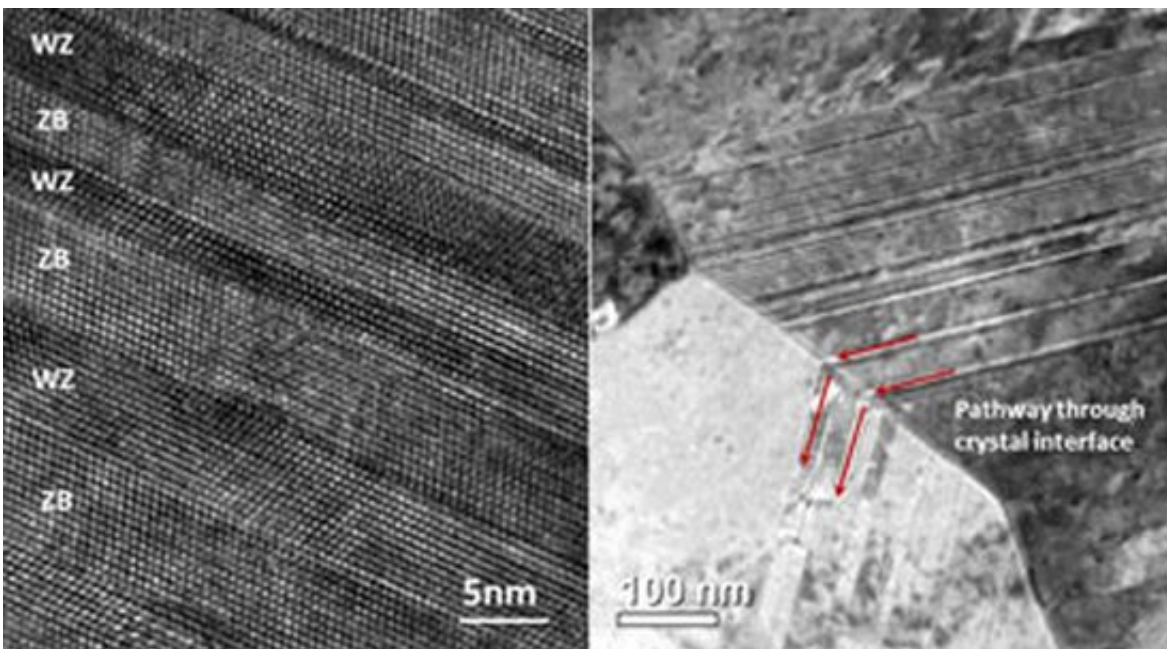
These transmission electron microscopy images taken at Brookhaven's CFN reveals how the stacking pattern of individual atoms (bright spots) shifts. The images confirmed that the bright spots of high conductivity observed with CTAFM imaging at UConn occurred at the interfaces between two different atomic alignments (left) and that these "planar defects" were continuous between individual crystals, creating pathways of conductivity (right). The labels WZ and ZB refer to the two atomic stacking sequences "wurtzite" and "zinc blende," which are the two types of crystal structures cadmium telluride can form. Credit: Brookhaven National Laboratory

CFN staff physicist Lihua Zhang used a transmission electron microscope (TEM) and UConn's results as a guide to meticulously study how atomic scale features of chloride-treated cadmium telluride related to the conductivity maps. The TEM images revealed the atomic structure of the defects, confirming that they were due to specific changes in the stacking sequence of atoms in the material. The images also showed clearly that these planar defects connected different grains in the crystal, leading to high-conductivity pathways for the movement of electrons and holes.

"When we looked at the regions with good conductivity, the planar defects linked from one crystal grain to another, forming continuous pathways of conductance through the entire thickness of the material," said Zhang. "So the regions that had the best conductivity were the ones that had a high degree of connectivity among these defects."
