AI taught to rapidly assess disaster damage so humans know where help is needed most

Deep Learning-based Building Damage Identification

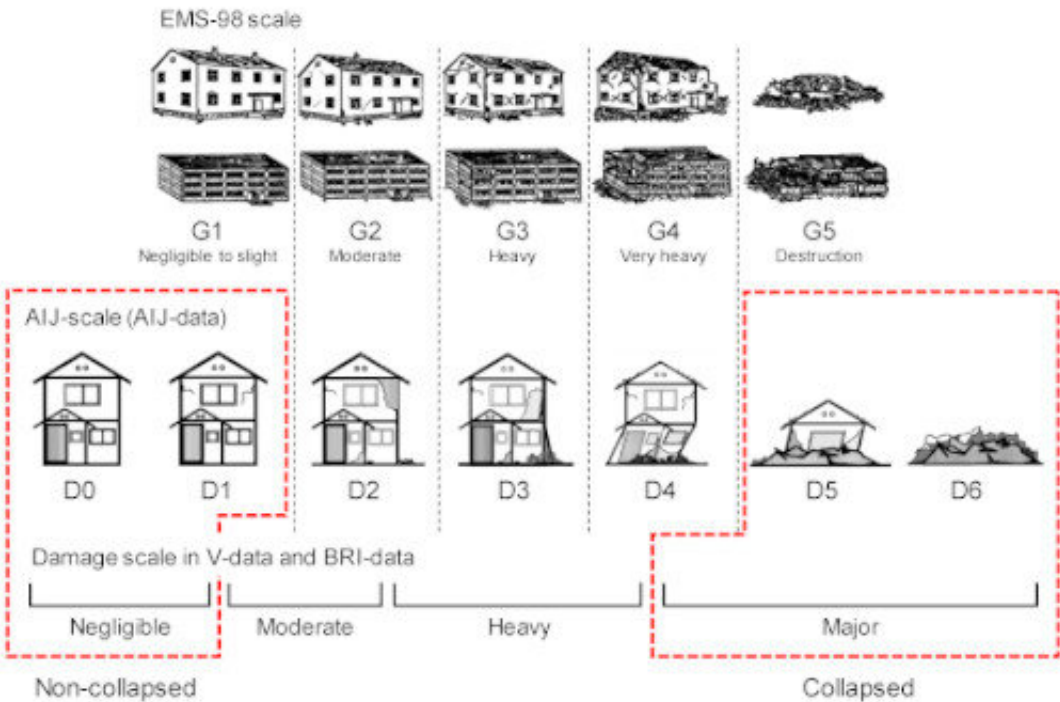
A comparison of the damage scales used by the Architectural Institute of Japan or AIJ scale and the European Macroseismic Scale or EMS-98. Hiroshima University researchers trained the AI to classify D0-D1 damage as non-collapse while D5-D6 is interpreted as collapsed. Credit: Hiroyuki Miura

It works by classifying buildings as collapsed, non-collapsed, or blue tarp-covered based on the seven damage scales (D0-D6) used in the 2016 Kumamoto earthquakes by the Architectural Institute of Japan.

A [collapsed building](#) is defined as D5-D6 or major damage. Non-collapse is interpreted as D0-D1 or negligible damage. Intermediate damage, which was rarely considered in previous CNN models, is designated as D2-D3 or moderate damage.
