AI taught to rapidly assess disaster damage so humans know where help is needed most

September 30 2020

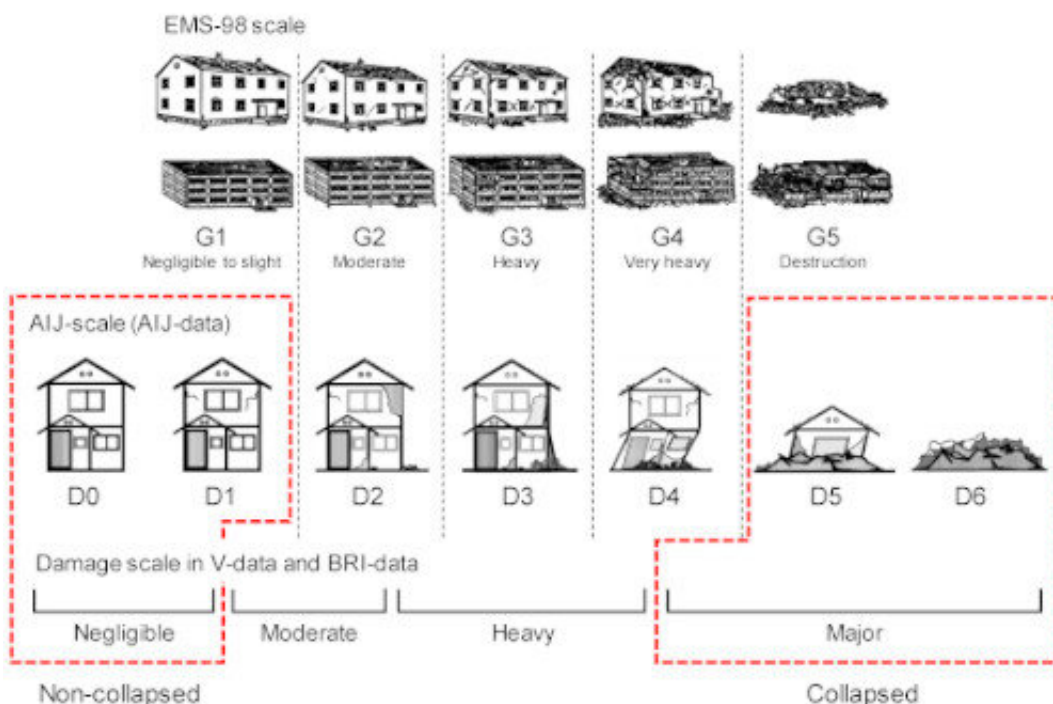
A comparison of the damage scales used by the Architectural Institute of Japan or AIJ scale and the European Macroseismic Scale or EMS-98. Hiroshima University researchers trained the AI to classify D0-D1 damage as non-collapse while D5-D6 is interpreted as collapsed. Credit: Hiroyuki Miura

It works by classifying buildings as collapsed, non-collapsed, or blue tarp-covered based on the seven damage scales (D0-D6) used in the 2016 Kumamoto earthquakes by the Architectural Institute of Japan.

A [collapsed building](#) is defined as D5-D6 or major damage. Non-collapse is interpreted as D0-D1 or negligible damage. Intermediate damage, which was rarely considered in previous CNN models, is designated as D2-D3 or moderate damage.

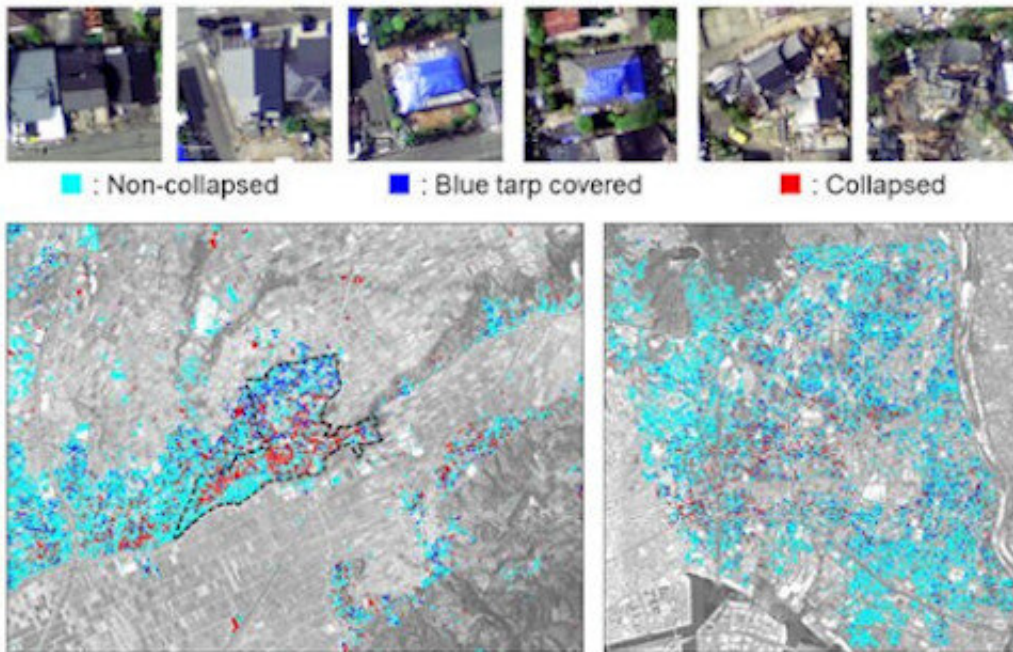
Deep Learning-based Building Damage Identification

The distribution of damage estimated by the convolutional neural network model for Mashiki town in the 2016 Kumamoto earthquake (L) and Nishinomiya City in the 1995 Kobe earthquake (R). Hiroshima University researchers created a post-disaster damage assessment CNN model that does not need pre-disaster images to make an evaluation. Credit: Hiroyuki Miura

Researchers trained their CNN model using post-disaster aerial images and [building](#) damage inventories by experts during the 1995 Kobe and 2016 Kumamoto earthquakes.

The researchers overcame the challenge of identifying buildings that suffered intermediate damage after confirming that blue tarp-covered structures in photos used to train the AI predominantly represented D2-D3 levels of devastation.
