# Newly found Fukushima plant contamination may delay cleanup

January 27 2021, by Mari Yamaguchi

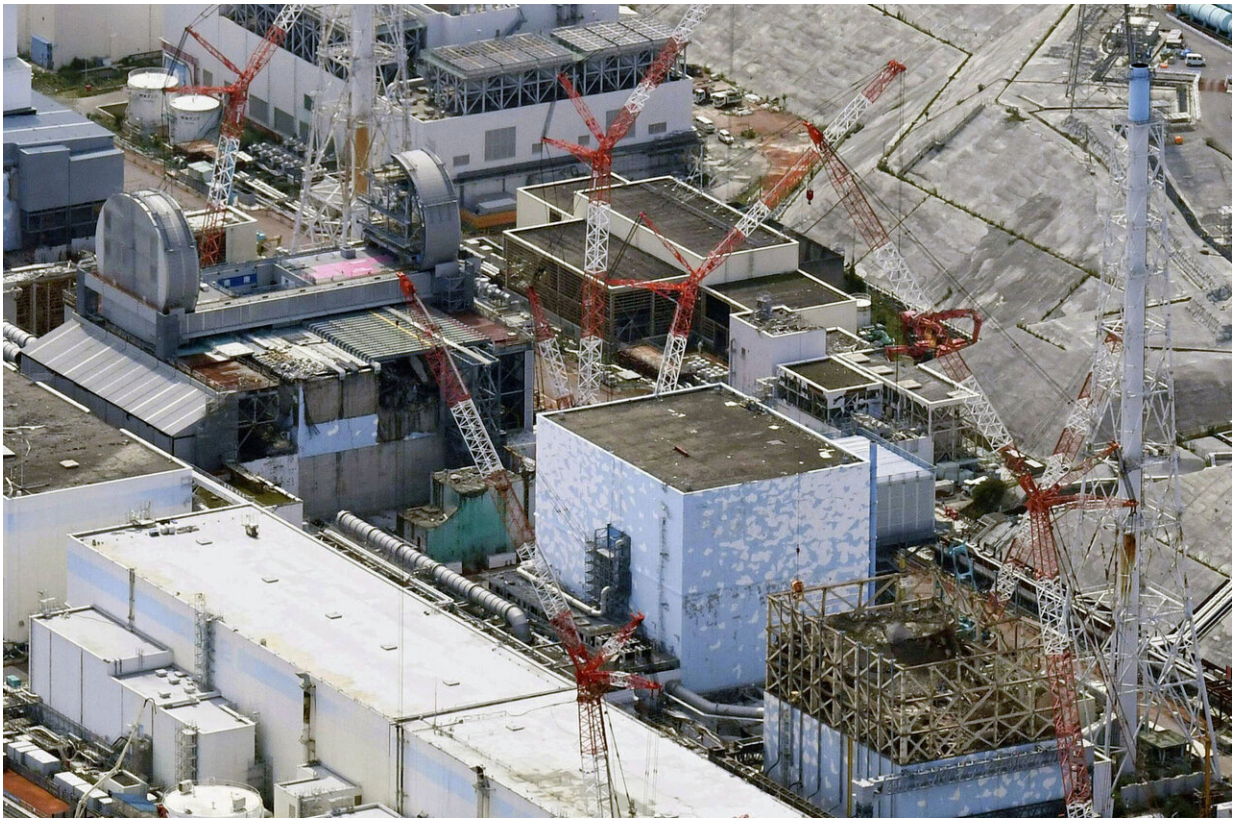
This Sept. 4, 2017, aerial file photo shows Fukushima Dai-ichi nuclear power plant's reactors, from bottom at right, Unit 1, Unit 2 and Unit 3, in Okuma, Fukushima prefecture, northeastern Japan. A draft investigation report into the 2011 Fukushima nuclear meltdown, adopted by Japanese nuclear regulators Wednesday, Jan. 27, 2021, says it has detected dangerously high levels of radioactive contamination at two of the three reactors, adding to concerns about decommissioning challenges. The interim report said data collected by investigators showed that the sealing plugs sitting atop the No. 2 and 3 reactor

containment vessels were as fatally contaminated as nuclear fuel debris that had melted and fell to the bottom of the reactors following the March 2011 tsunami and earthquake. (Daisuke Suzuki/Kyodo News via AP, File)

The interim report said data collected by investigators showed that the sealing plugs sitting atop the No. 2 and 3 [reactor](#) containment vessels were as fatally contaminated as nuclear fuel debris that had melted and fell to the bottom of the reactors following the March 2011 tsunami and earthquake.

The experts said the bottom of the sealed plug, a triple-layered concrete disc-shaped lid 12 meters (39 feet) in diameter sitting atop the primary containment vessel, is coated with high levels of radioactive Cesium 137.

The No. 1 reactor lid was less contaminated, presumably because the plug was slightly knocked out of place and disfigured due to the impact of the hydrogen explosion, the report said.

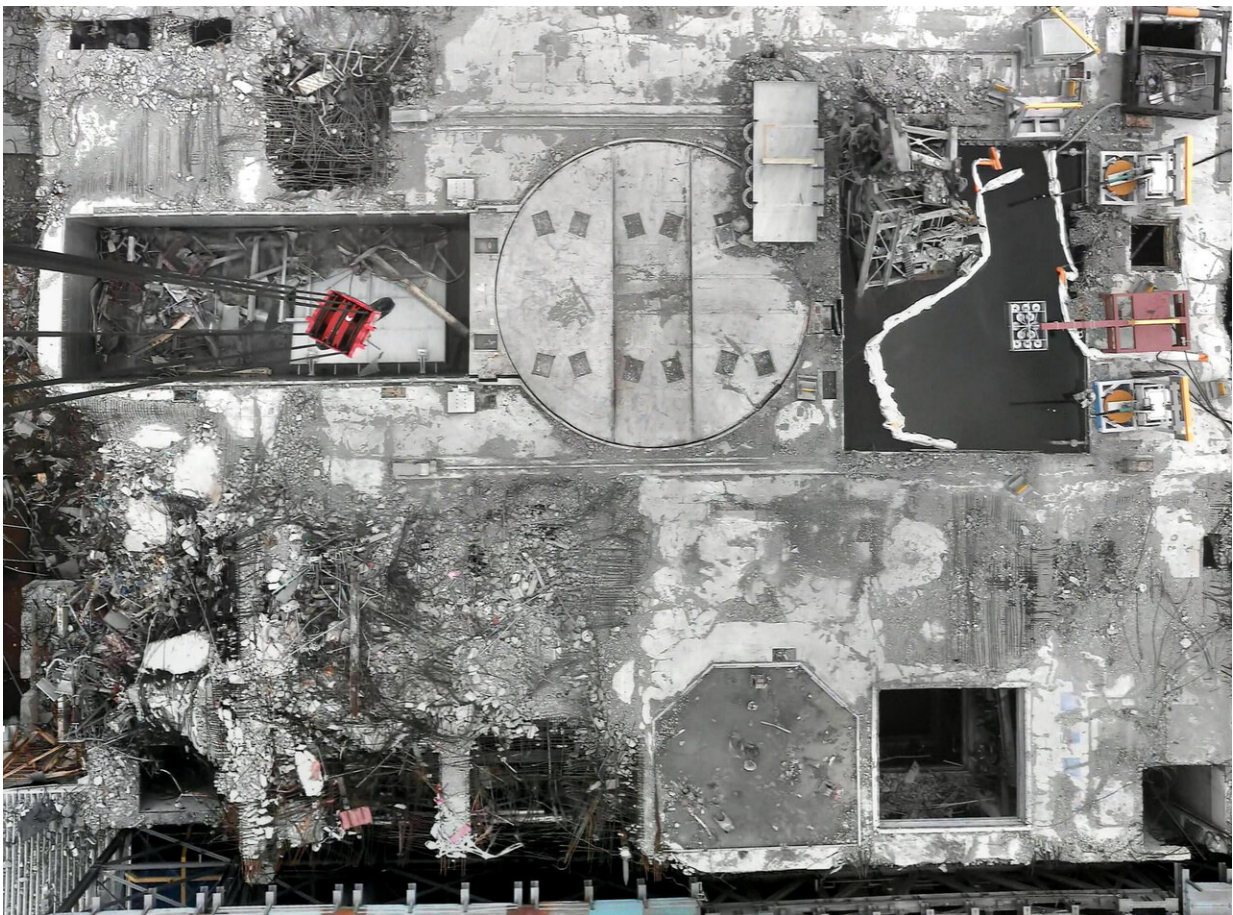
This Jan. 31, 2014, image released by Tokyo Electric Power Company Holdings shows the aerial view of the No. 3 reactor, with its roof blown off and shield plug (circle in the middle) exposed, in Okuma town, Fukushima prefecture, northeastern Japan. A draft investigation report into the 2011 Fukushima nuclear meltdown, adopted by Japanese nuclear regulators Wednesday, Jan. 27, 2021,

says it has detected dangerously high levels of radioactive contamination at two of the three reactors, adding to concerns about decommissioning challenges.(Tokyo Electric Power Company Holdings via AP)
