New AI tool 85% accurate for recognizing and classifying wind turbine blade defects

March 31 2021, by Megan Cox

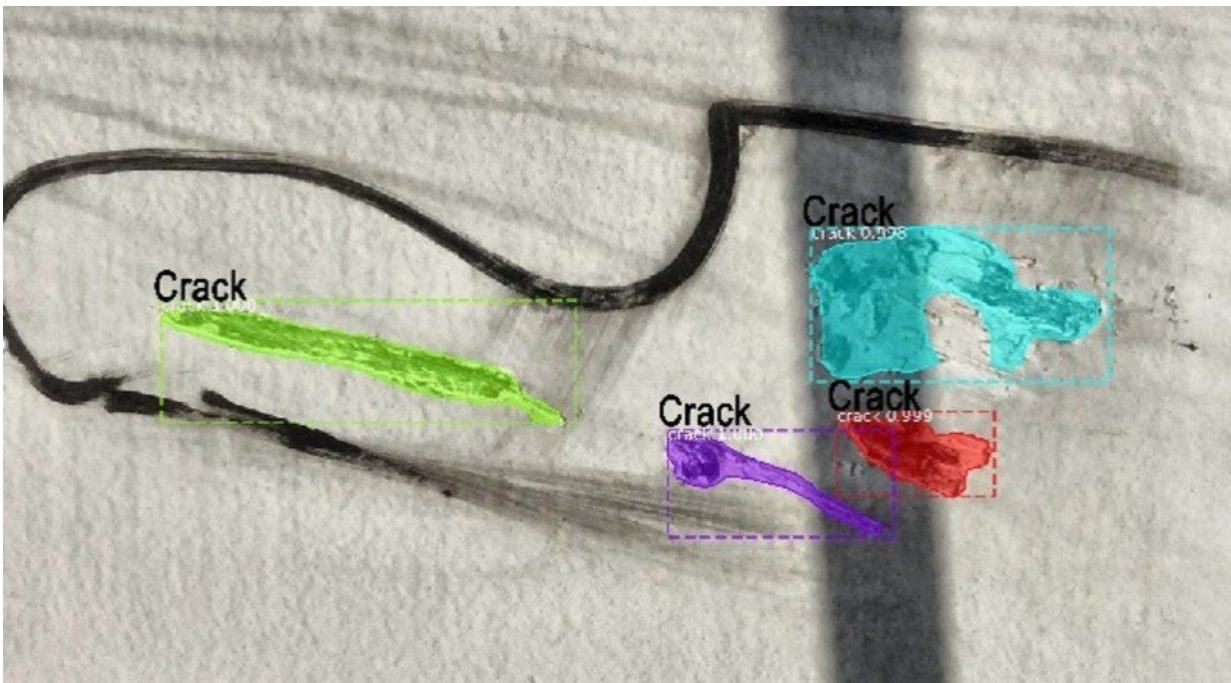
Crack detection using the AI technology. Credit: Loughborough University

Using image enhancement and augmentation methods, and AI algorithms (namely the Mask R-CNN deep learning algorithm), the system analyses images then highlights defect areas and labels them by type.

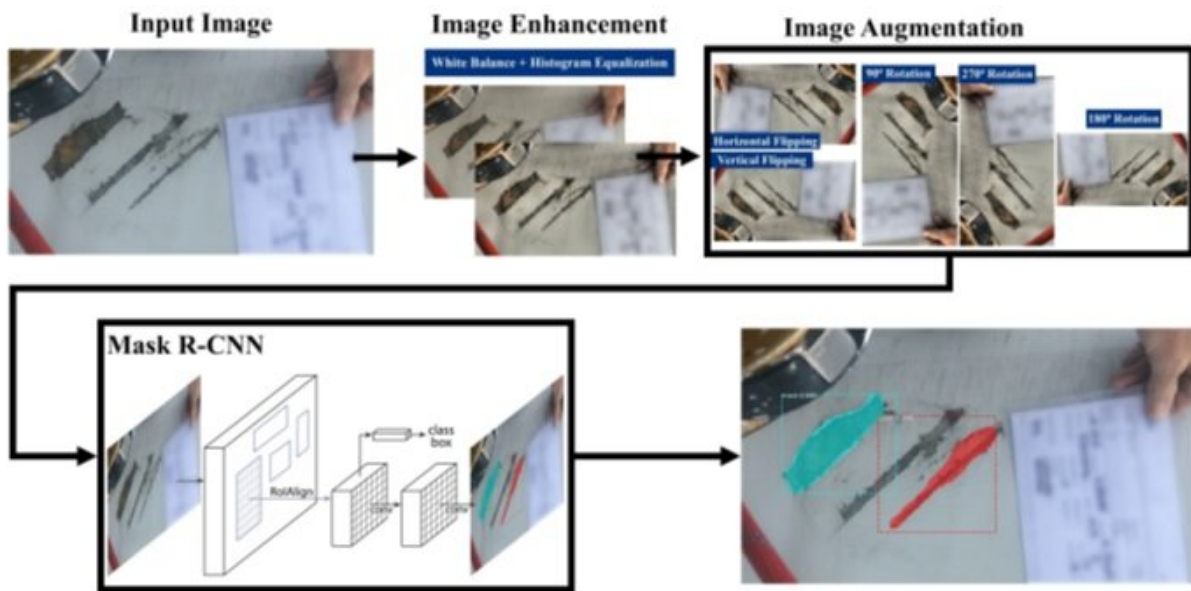
A step-by-step image for how the AI works. Credit: Loughborough University

"The images are pre-processed to enhance the AI-based detection process and currently, we are working on increasing accuracy further by exploring improvements to pre-processing the images and extending the AI algorithm."
