School concrete crisis: How Raac has been used well beyond its expiry date

September 8 2023, by Juan Sagaseta

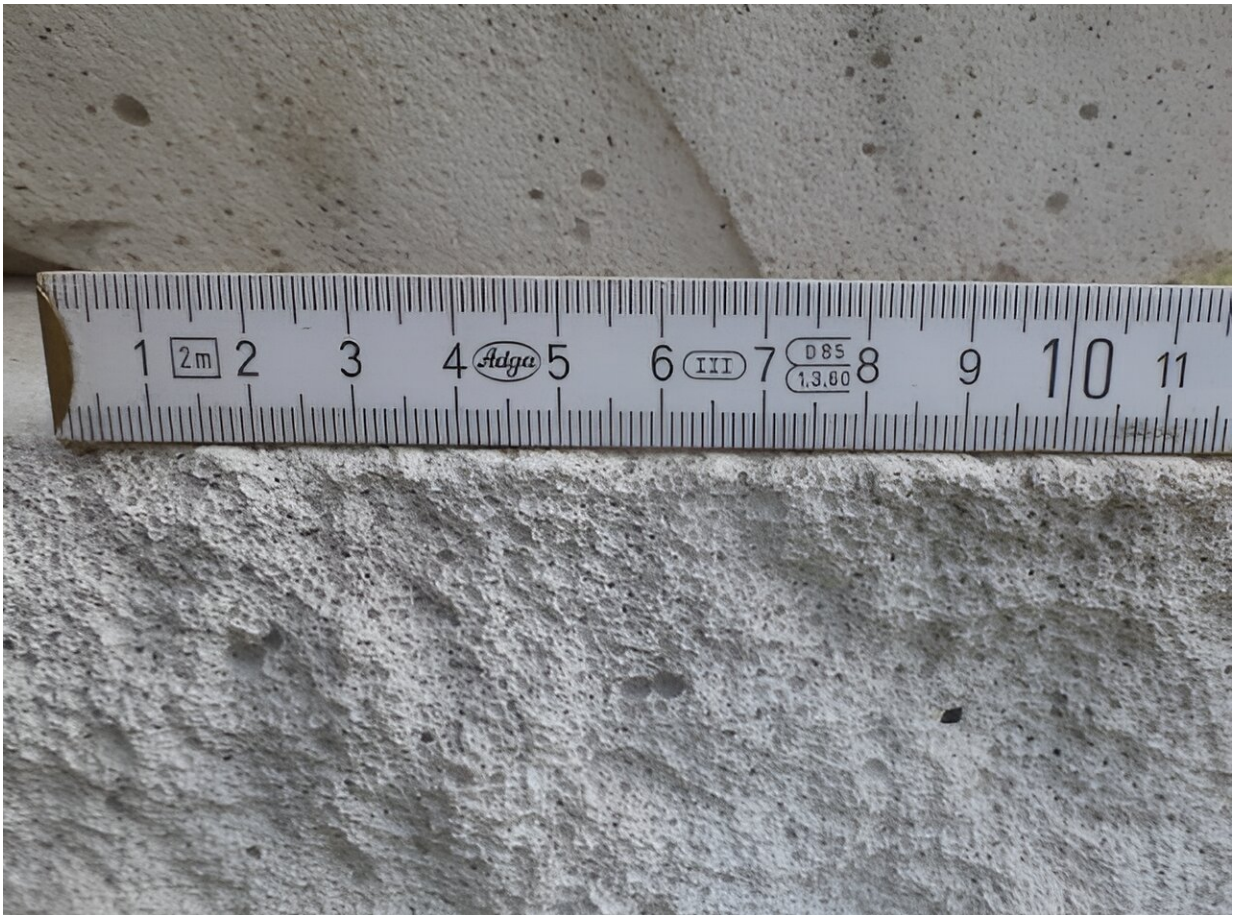
Air is inserted into Raac during construction, making it a light-weight material.
Credit: [Wikimedia](#), [CC BY-SA](#)

Developed in 1950s and 1960s, Raac—also known as "aircrete"—is an aerated concrete, that is reinforced with steel bars or "rebar." Air is injected into it during construction, which means it is more than two times lighter than regular concrete (it can even float on water). A cross-section of a slab looks a lot like an Aero chocolate bar.
