# How to prevent America's aging buildings from collapsing: Four high-profile disasters send a warning

January 17 2024, by Abieyuwa Aghayere

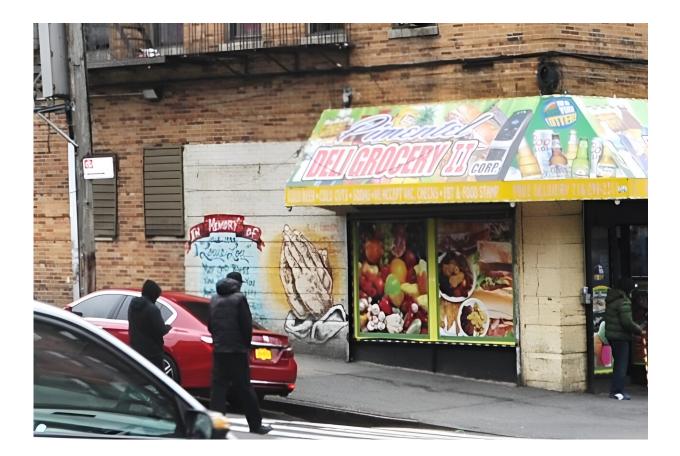
A corner column in the New York City building that collapsed in December 2023 had a large crack in 2020, as this photo in a city buildings department report shows. Credit: <u>NYC Buildings Department</u>

In the New York City apartment building, a visible, vertical crack in the corner column, which should have been a glaring red flag, was ignored. The <u>NYC Buildings Department commissioner</u> recently said that "The Department of Buildings does not have enough of its own staff to inspect every building in New York City."

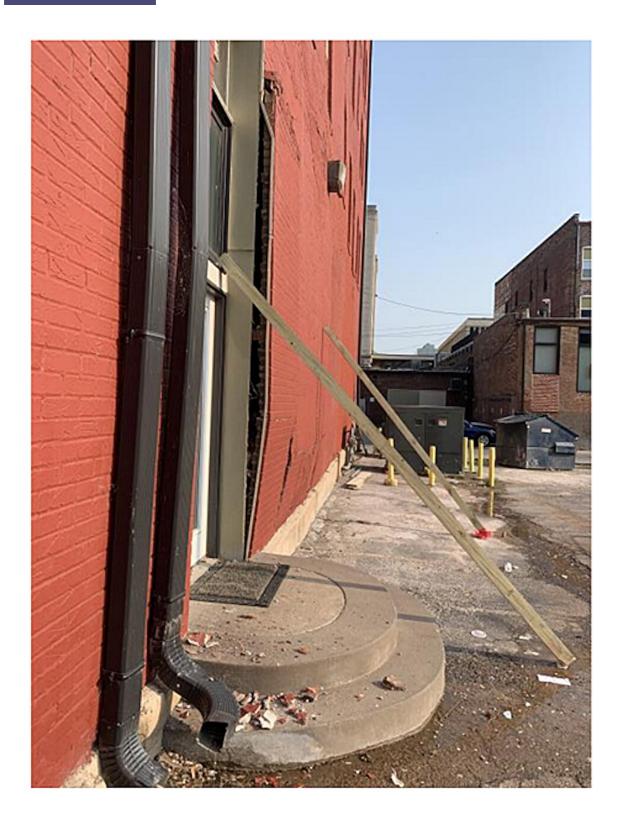
Bowed exterior masonry wall at the Davenport, Iowa, building in May 2023, before the building partially collapsed. Credit: <u>City of Davenport</u>

pointed to a history of improper maintenance, and photos show clear signs of trouble, such as walls that were bowed.

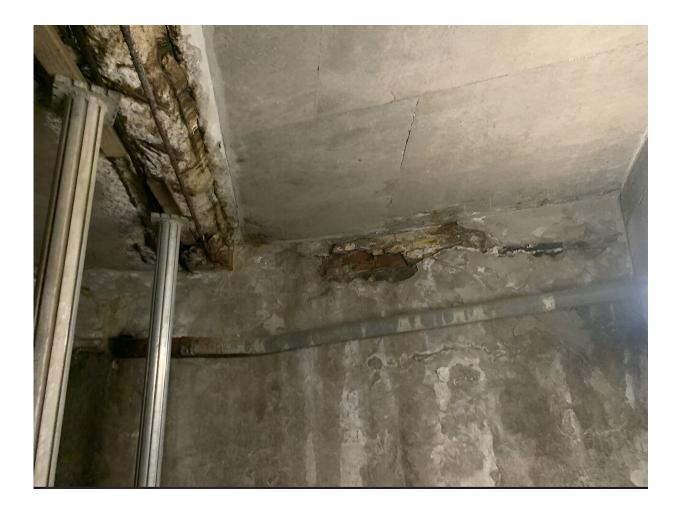
Deteriorating reinforced concrete and rusted or exposed reinforcing steel are warning signs to watch for. Credit: Jensen/BRV Engineering

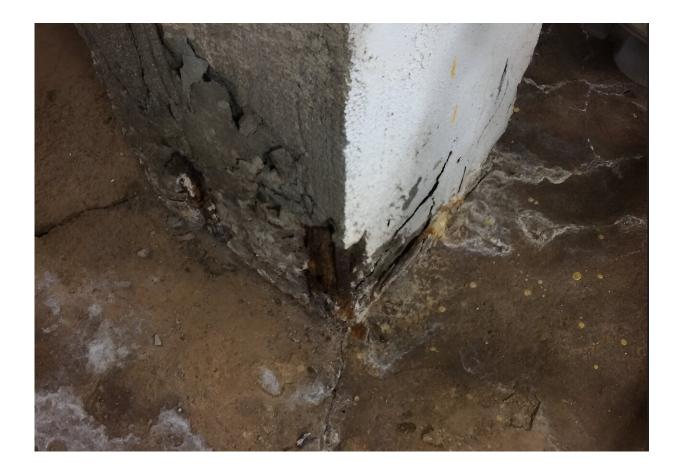
Signs of a degrading concrete column exposed to de-icing salt and moisture in a basement. Credit: Jensen/BRV Engineering
