# Baltimore bridge collapse: A bridge engineer explains what happened, and what needs to change

March 27 2024, by Colin Caprani

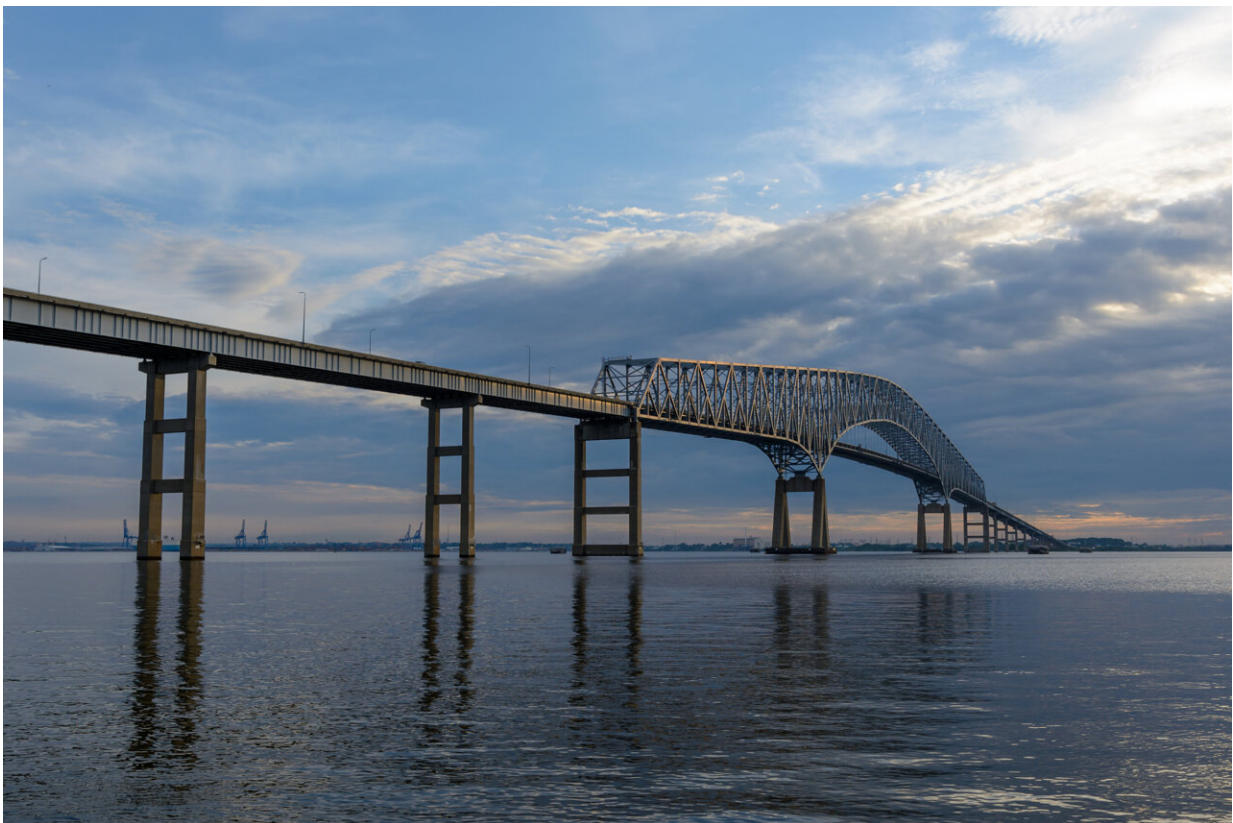
Francis Scott Key Bridge in Baltimore, showing the pier struck by the cargo ship and the sections of bridge which collapsed as a result. Credit: [F Vasconcellos / Wikimedia, CC BY-SA](#)

The Francis Scott Key Bridge was built through the mid 1970s and opened in 1977. The main structure over the navigation channel is a "continuous truss bridge" in three sections or spans.

The bridge rests on four supports, two of which sit each side of the navigable waterway. It is these two piers that are critical to protect against ship impacts.

And indeed, there were two layers of protection: a so-called "dolphin" structure made from concrete, and a fender. The dolphins are in the water about 100 meters upstream and downstream of the piers. They are

intended to be sacrificed in the event of a wayward ship, absorbing its energy and being deformed in the process but keeping the ship from hitting the bridge itself.

Once the massive ship had made it past both the dolphin and the fender, the pier—one of the bridge's four main supports—was simply incapable

of resisting the impact. Given the size of the vessel and its likely speed of around 8 knots (15 kilometers per hour), the impact force would have been [around 20,000 tons](#).
