Now you see it: Sony picture taken with curved CMOS sensor

8 July 2014, by Nancy Owano

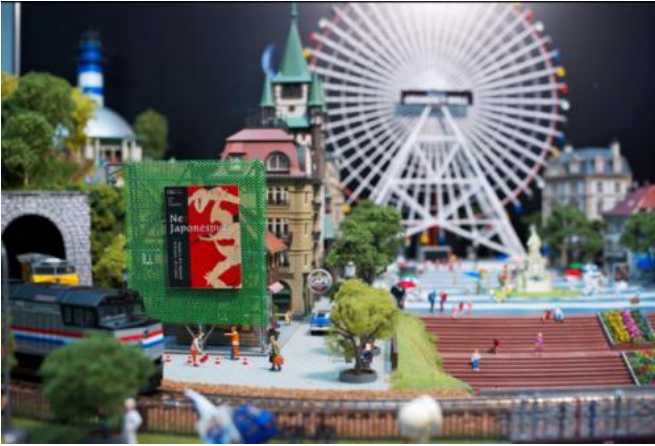
People are talking about Sony's first curved-sensor photo shown on Nikkei.jp, seen as a big deal because the company's technology signifies better-quality images and possibly cheaper lenses to come. This is capturing attention as the first picture taken with a Sony curved image sensor. The sensor that Sony has constructed is a prototype. As Nick Sutrich in AndroidHeadlines noted on Tuesday, the prototype sensor is a much smaller [resolution](#) than the full-frame sensors that Sony is to send off to production. Sheldon Pinto wrote in TechTree that "What it indicates is that Sony is pretty sure that the technology works and is effective compared to the standard sensors that are now used in everything from mobile phones to professional [cameras](#)."

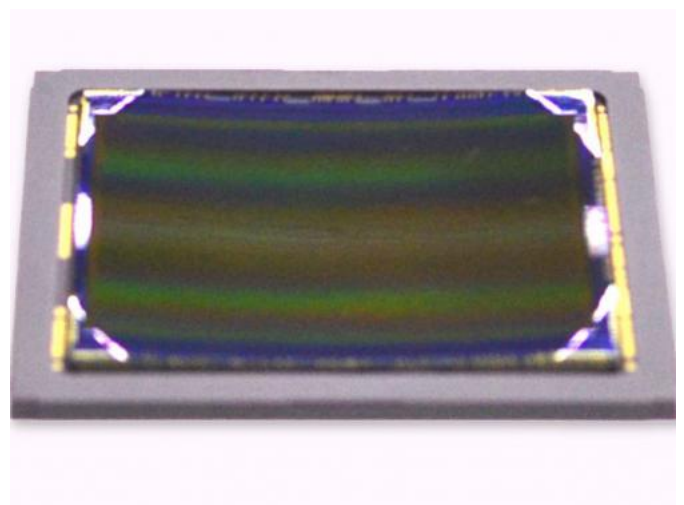
Mirrorless Rumors summed up the reaction of tech sites this week that the image in and of itself does not deliver startling impact but is of historical significance. "That image doesn't look [exciting](#) at all but it's precious because it's actually the first photo taken with a Sony curved sensor!"

Engadget said, as the first image shown from Sony's curved CMOS sensor, the image indicates "a possible new direction for its digital camera division." DPReview's Sanyal commented that "some may view this image as being 'historic' and others will appreciate the simple fact that Sony's curved sensor technology is not [simply](#) a concept in its early stages of development."
