AI taught to rapidly assess disaster damage so humans know where help is needed most

September 30 2020

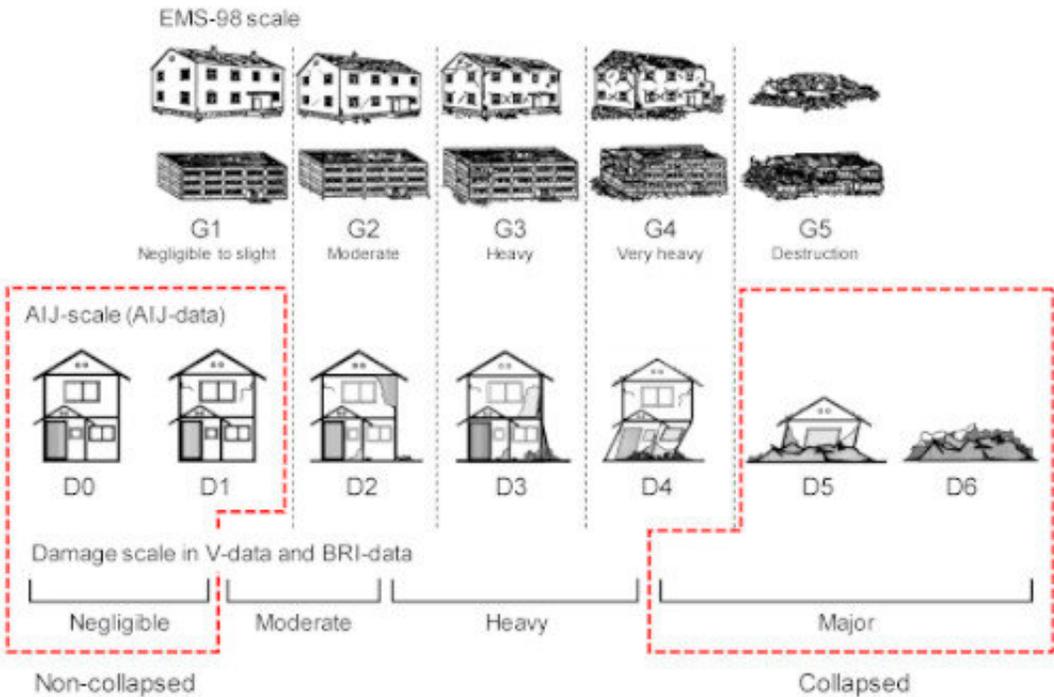
A comparison of the damage scales used by the Architectural Institute of Japan or AIJ scale and the European Macroseismic Scale or EMS-98. Hiroshima University researchers trained the AI to classify D0-D1 damage as non-collapse while D5-D6 is interpreted as collapsed. Credit: Hiroyuki Miura

It works by classifying buildings as collapsed, non-collapsed, or blue tarp-covered based on the seven damage scales (D0-D6) used in the 2016 Kumamoto earthquakes by the Architectural Institute of Japan.

A [collapsed building](#) is defined as D5-D6 or major damage. Non-collapse is interpreted as D0-D1 or negligible damage. Intermediate damage, which was rarely considered in previous CNN models, is designated as D2-D3 or moderate damage.

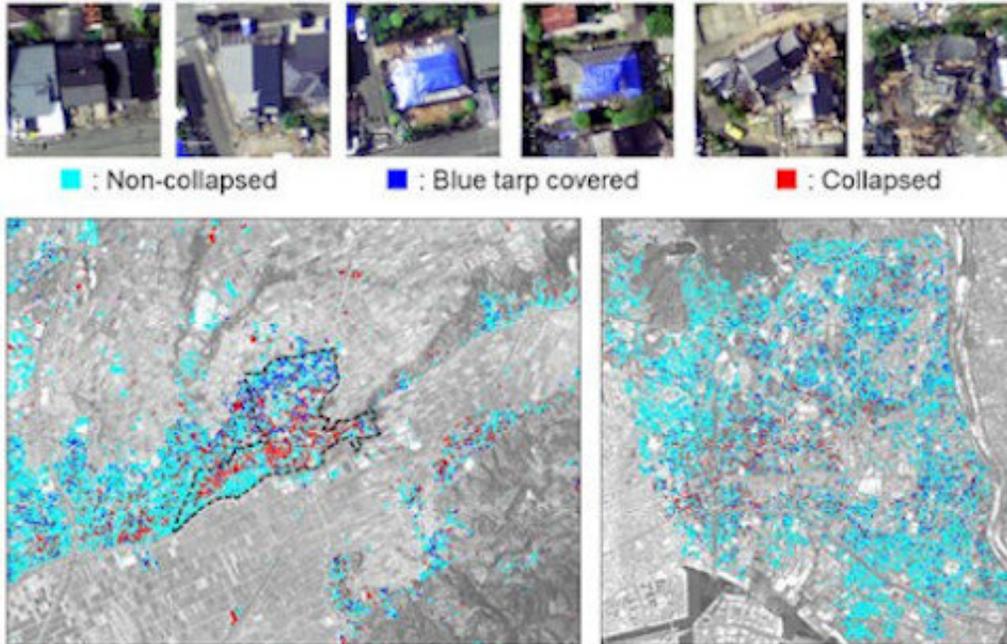
Deep Learning-based Building Damage Identification

The distribution of damage estimated by the convolutional neural network model for Mashiki town in the 2016 Kumamoto earthquake (L) and Nishinomiya City in the 1995 Kobe earthquake (R). Hiroshima University researchers created a post-disaster damage assessment CNN model that does not need pre-disaster images to make an evaluation. Credit: Hiroyuki Miura

Researchers trained their CNN model using post-disaster aerial images and [building](#) damage inventories by experts during the 1995 Kobe and 2016 Kumamoto earthquakes.

The researchers overcame the challenge of identifying buildings that suffered intermediate damage after confirming that blue tarp-covered structures in photos used to train the AI predominantly represented D2-D3 levels of devastation.

Since ground truth data from field investigations of structural engineers were used to teach the AI, the team believes its evaluations are more reliable than other CNN models that depended on visual interpretations of non-experts.

When they tested it on post-disaster aerial images of the September 2019 typhoon that hit Chiba, results showed that damage levels of approximately 94% of buildings were correctly classified.
