Hurricane straps keep roofs on houses and can improve safety during tornadoes

29 July 2021, by Gregory Kopp

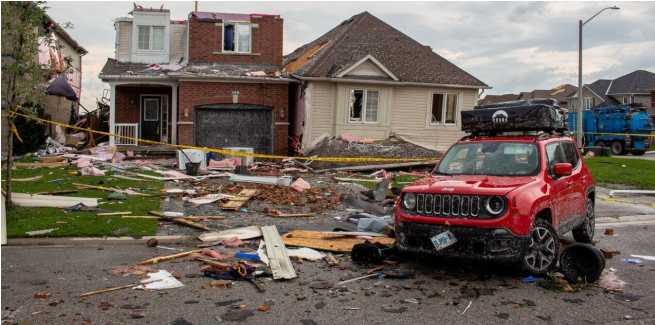
Some of the worst damage from the EF-2 tornado that struck the Ontario city of Barrie on July 15. Credit: Northern Tornadoes Project, Author provided

The [Northern Tornadoes Project](#) survey in the immediate aftermath of the recent tornado in Barrie indicated that several homes did not meet the building code requirements because of missing toe nails.
